ROAD SAFETY AUDIT

Route 28 between Bourne Rotary and Otis Rotary

Town of Bourne

April 2013

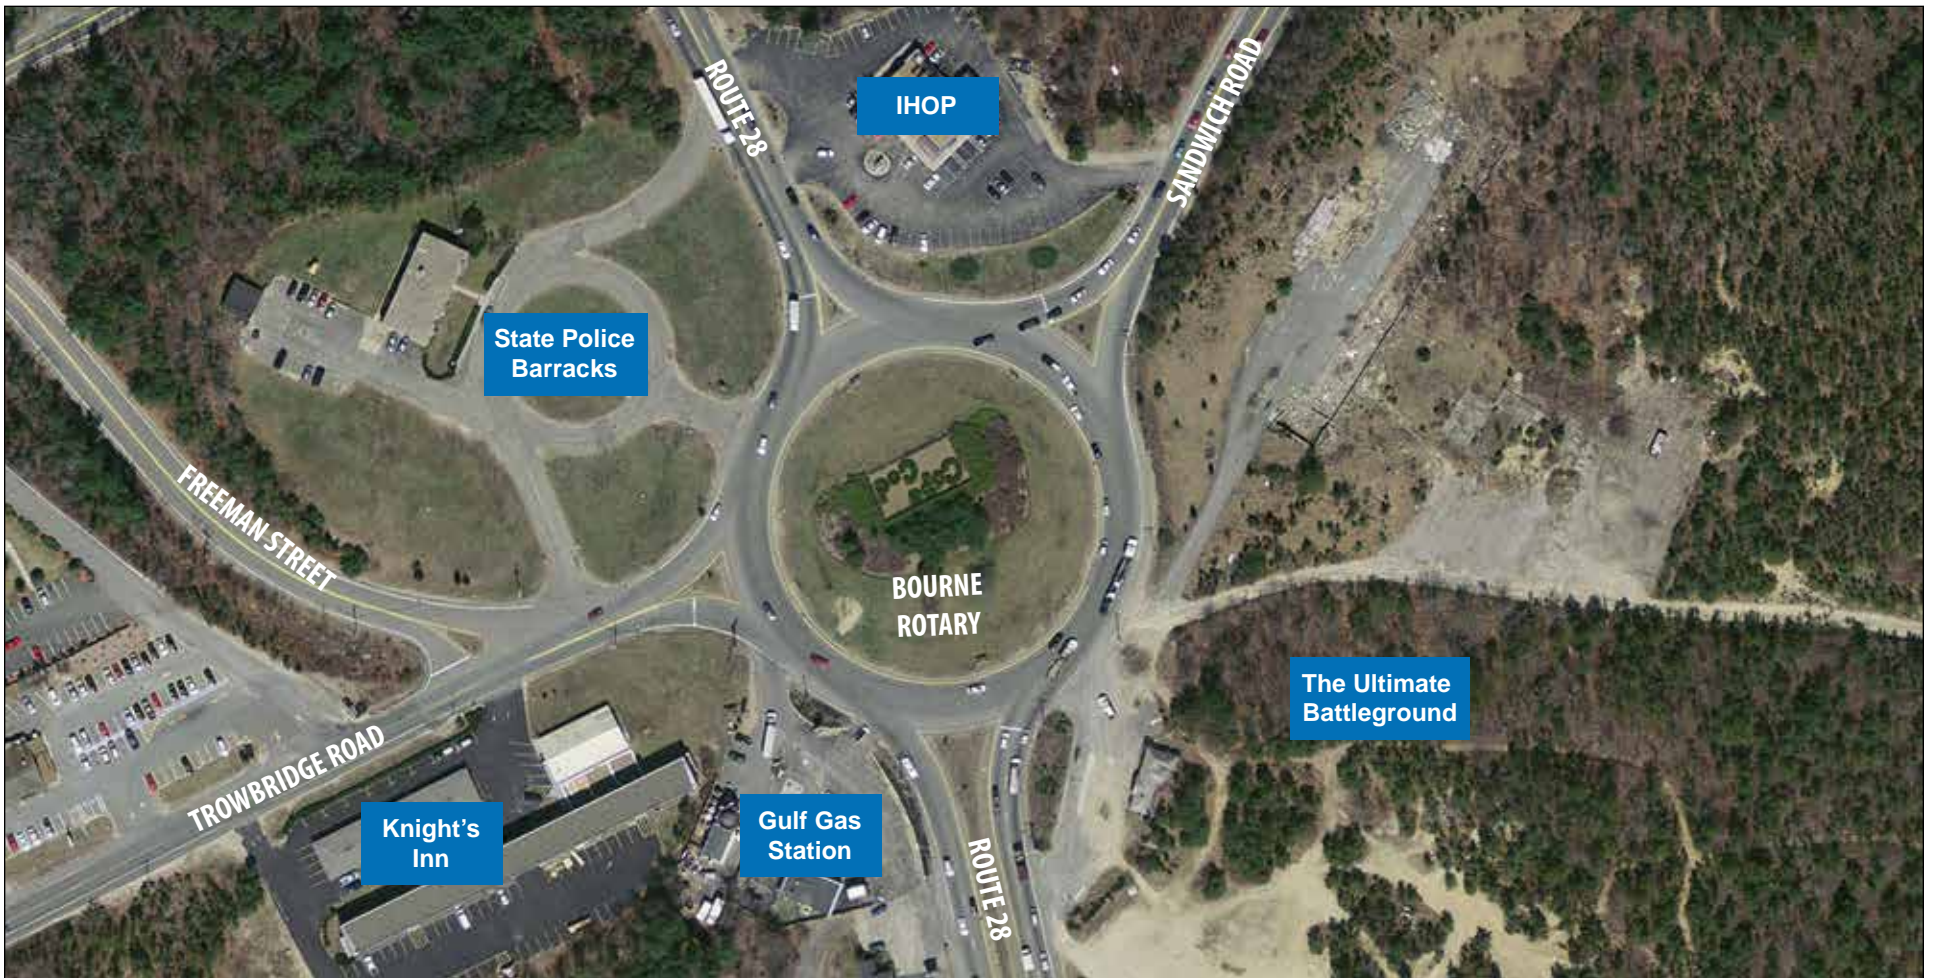
Figure 2. Bourne Rotary

The ***Bourne Rotary*** is a two-lane rotary with four approaches. The Trowbridge Road eastbound approach consists of one lane in each direction. The Route 28 northbound and southbound approaches each consist of two lanes in each direction; this allows vehicles to travel to and from the rotary onto Route 28 from the inside and outside lanes. The Sandwich Road westbound approach consists of one travel lane in each direction. In addition to the roadway approaches, three driveways also have direct access to the rotary. A Massachusetts State Police barracks driveway is located on the northwest corner of the rotary, between the Trowbridge Road eastbound and Route 28 southbound approaches; a dirt driveway accessing The Ultimate Battleground is located on the southeast corner of the rotary, just east of the Route 28 northbound approach; and two driveways for a Gulf gas station are located on the southwest corner of the rotary, just west of the Route 28 northbound approach. The speed limit is 25 mph within the Bourne Rotary. The rotary has an inner radius of approximately 150 feet. An aerial image of the Bourne Rotary is shown in **Figure 2**.

The RSA team noted that there is very little advance guide signage indicating the street names route numbers, and/or destinations of the available exits from the rotary. The only guide signage for exits to the rotary are within the rotary itself. This can create confusion, especially among drivers that are unfamiliar with the rotary, since motorists may not know when their exit is approaching until they read a sign located at the exit itself. There is no existing signage that indicates which lane a vehicle should be in if it is exiting the rotary or continuing to circulate. This lack of direction can cause angle crashes between vehicles exiting the rotary from the inside lane and vehicles remaining in the rotary in the outside lane. Twenty-nine crashes occurred between vehicles exiting the rotary onto Route 28 southbound from the inside lane and vehicles continuing around the rotary in the outside lane. Three similar crashes involved vehicles exiting to Sandwich Road, and one similar crash occurred involving a vehicle attempting to exit to Route 28 northbound occurred.

Team members also noted that some of the existing guide signage is too small to read, and that some motorists slow down unexpectedly to read guide signage.

RSA team members noted that the posted speed limits along the Route 28 northbound approach to the rotary are very closely spaced. According to speed regulations provided by MassDOT, the speed limit changes from 55 mph to 40 mph approximately 0.36 miles south of the Bourne Rotary. After another 0.23 miles the speed limit drops again, to 25 mph just 0.13 miles from the rotary, resulting in a 64% reduction in speed over less than a quarter-mile. Thirteen rear-end crashes occurred along the Route 28 northbound approach to the Bourne Rotary, including three that involved three vehicles and four that resulted in personal injury. For comparison, only four rear-end crashes occurred along the Route 28 southbound approach to the rotary. “Reduced Speed Ahead” (W3-5) signs are provided between the 40 mph speed limit signage and the 25 mph speed limit signage to warn motorists of these changes in the speed limit; however, these signs

RSA team members also noted that there are no pavement markings along the Trowbridge Road eastbound and Sandwich Road westbound approaches that indicate the intended number of travel lanes entering the rotary. Each is wide enough for two vehicles to stack at the entrance to the rotary; however, allowing multiple entrance lanes may cause confusion.

RSA team members noted that the decorative vegetation facing Route 28 southbound traffic entering the rotary, spelling out “Cape Cod”, may be distracting for motorists. It was also noted that the height of the vegetation behind the Cape Cod topiary in the center of the rotary may make it difficult for motorists to judge the speed of circulating traffic. However, team members said anecdotally that the number and severity of crashes through the rotary has dropped dramatically since the mound was built.

There are four driveways that allow direct access to the Bourne Rotary. The driveway to The Ultimate Battleground is not paved and does not have a defined edge. A team member stated that the driveway often floods, and water flows into the rotary. There are also two driveways that serve the Gulf gas station and the American Lobster Mart. Team members noted that the easternmost of the two driveways is located extremely close to the Route 28 southbound exit, causing confusion when vehicles exit the Gulf driveway. Eight crashes involved vehicles exiting the Gulf gas station into the rotary; six occurred at the easternmost of the two driveways.

Team members also noted that there are currently two driveways to the IHOP along Route 28 northbound, north of the rotary. Team members stated that Route 28 southbound vehicles approaching the rotary often turn left across faster-moving northbound traffic in order to access IHOP, and that vehicles turning left out of IHOP onto the Route 28 southbound approach to the rotary often find themselves in the northbound travel lanes waiting for a gap to form in the

southbound queue. It was also noted that vehicles often cut through the IHOP parking lot to avoid the rotary.

RSA team members noted that vehicles often enter the Bourne Rotary from Route 28 at high speeds, which may contribute to motorist frustration within the rotary and interfere with vehicles being able to exit the rotary safely. It was noted that, since Route 28 traffic enters and exits as two lanes, vehicles entering from Sandwich Road or Trowbridge Road must compete with fast-moving Route 28 through traffic in order to navigate the rotary. A team member noted that Route 28 northbound traffic is not adequately deflected, and high travel speeds are able to be maintained through the rotary.

A team member noted that, while a sidewalk is provided over the Bourne Bridge, there are no sidewalks around the Bourne Rotary. Pedestrians currently cut through the State Police barracks to access Trowbridge Road, despite a “Do Not Enter” sign at the driveway entrance.

2. Remove the guide signage from the center island of the rotary.
3. Remove guide signage that is too small for circulating traffic to read. Replace with MUTCD-compliant signage if the signage is deemed necessary. Ensure that all guide signage visible from the rotary or the approaches to the rotary is useful and necessary.

4. Provide larger “Reduced Speed Ahead” signage (W3-5) along the Route 28 northbound approach to the rotary. Consider whether more gradually reducing the speed limit along the approach would reduce the number of rear-end crashes.

5. Continue enforcing speeding violations within the rotary and along approaches to the rotary.
6. As part of long-term planning efforts, consider the safety benefits of providing overhead signage to improve motorist visibility.

7. Consider the safety benefits of providing longitudinal markings and arrow pavement markings within the rotary, including dashed pavement markings to assist entering and exiting vehicles, as part of the upcoming Route 28 corridor resurfacing project.

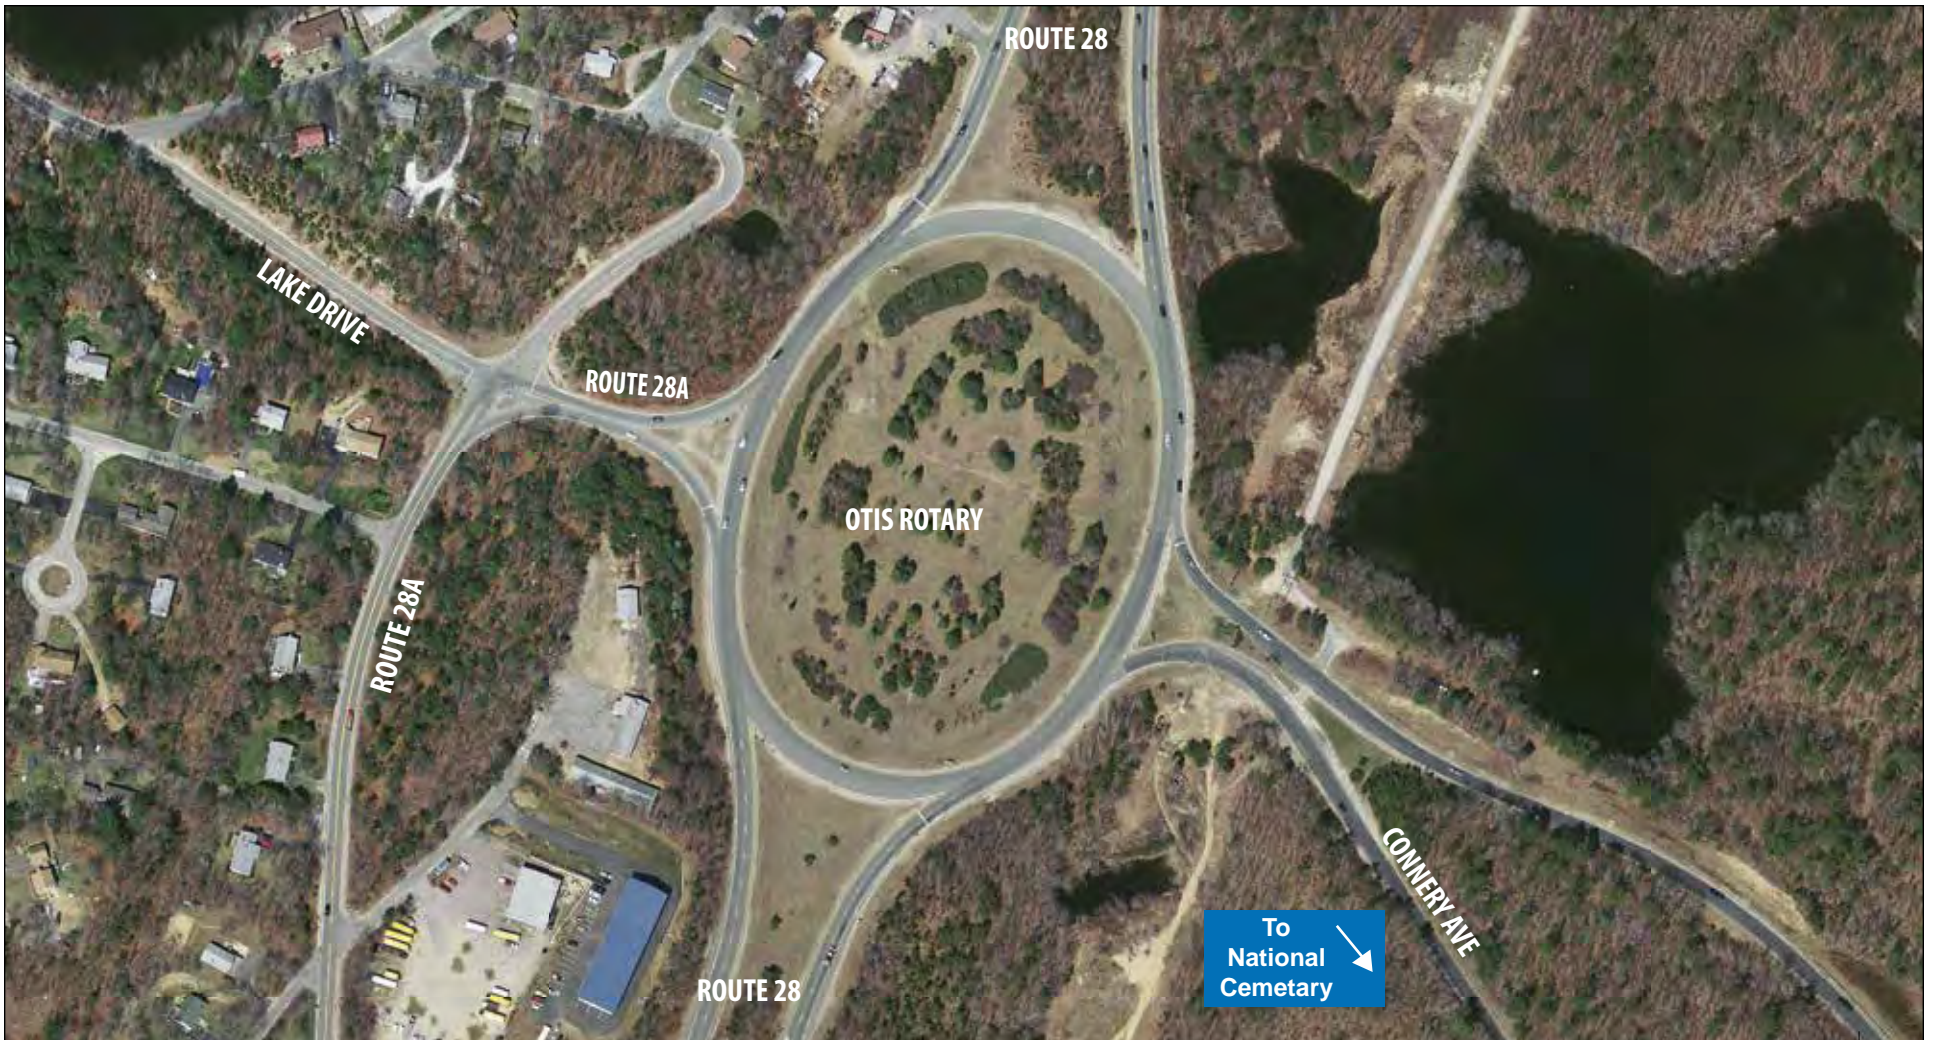
Figure 3. Otis Rotary

The ***Otis Rotary*** is an oval-shaped, two-lane rotary with four approaches. The Route 28A eastbound approach consists of one travel lane in each direction. The Connery Avenue westbound approach consists of one travel lane in each direction. The Route 28 northbound and southbound approaches each consist of two travel lanes in each direction, allowing vehicles to travel into and out of the rotary using both travel lanes. The diameter of the rotary is approximately 550 feet from east to west, but approximately 775 feet from north to south. This skewed geometry allows through traffic on Route 28 northbound or southbound to continue through the rotary along Route 28 without slowing down significantly. Public safety officials attending the RSA stated that vehicles often travel through the rotary at speeds that exceed the posted speed limit on the Route 28 mainline, which is generally 55 mph. The posted speed limit approaching the Otis Rotary is 25 miles per hour from Route 28 northbound and is 35 mph from Route 28 southbound. An aerial image of the Otis Rotary is shown in **Figure 3**.

RSA team members also noted that the sharp curve radius along the Connery Avenue exit from the rotary can be unexpected.

RSA team members noted that the area between the Route 28 northbound approach and Connery Avenue is susceptible to flooding. One out-of-control crash was reported in the area that occurred on wet pavement conditions.

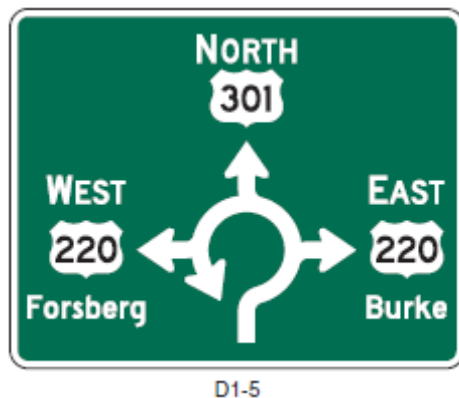
A diagrammatic guide sign shows each exit within the rotary before a vehicle enters the rotary (Source: MUTCD).
