CAPE COD
COMMISSION

Town of Mashpee Road Safety Audit – Mashpee Rotary

FINAL August 2019

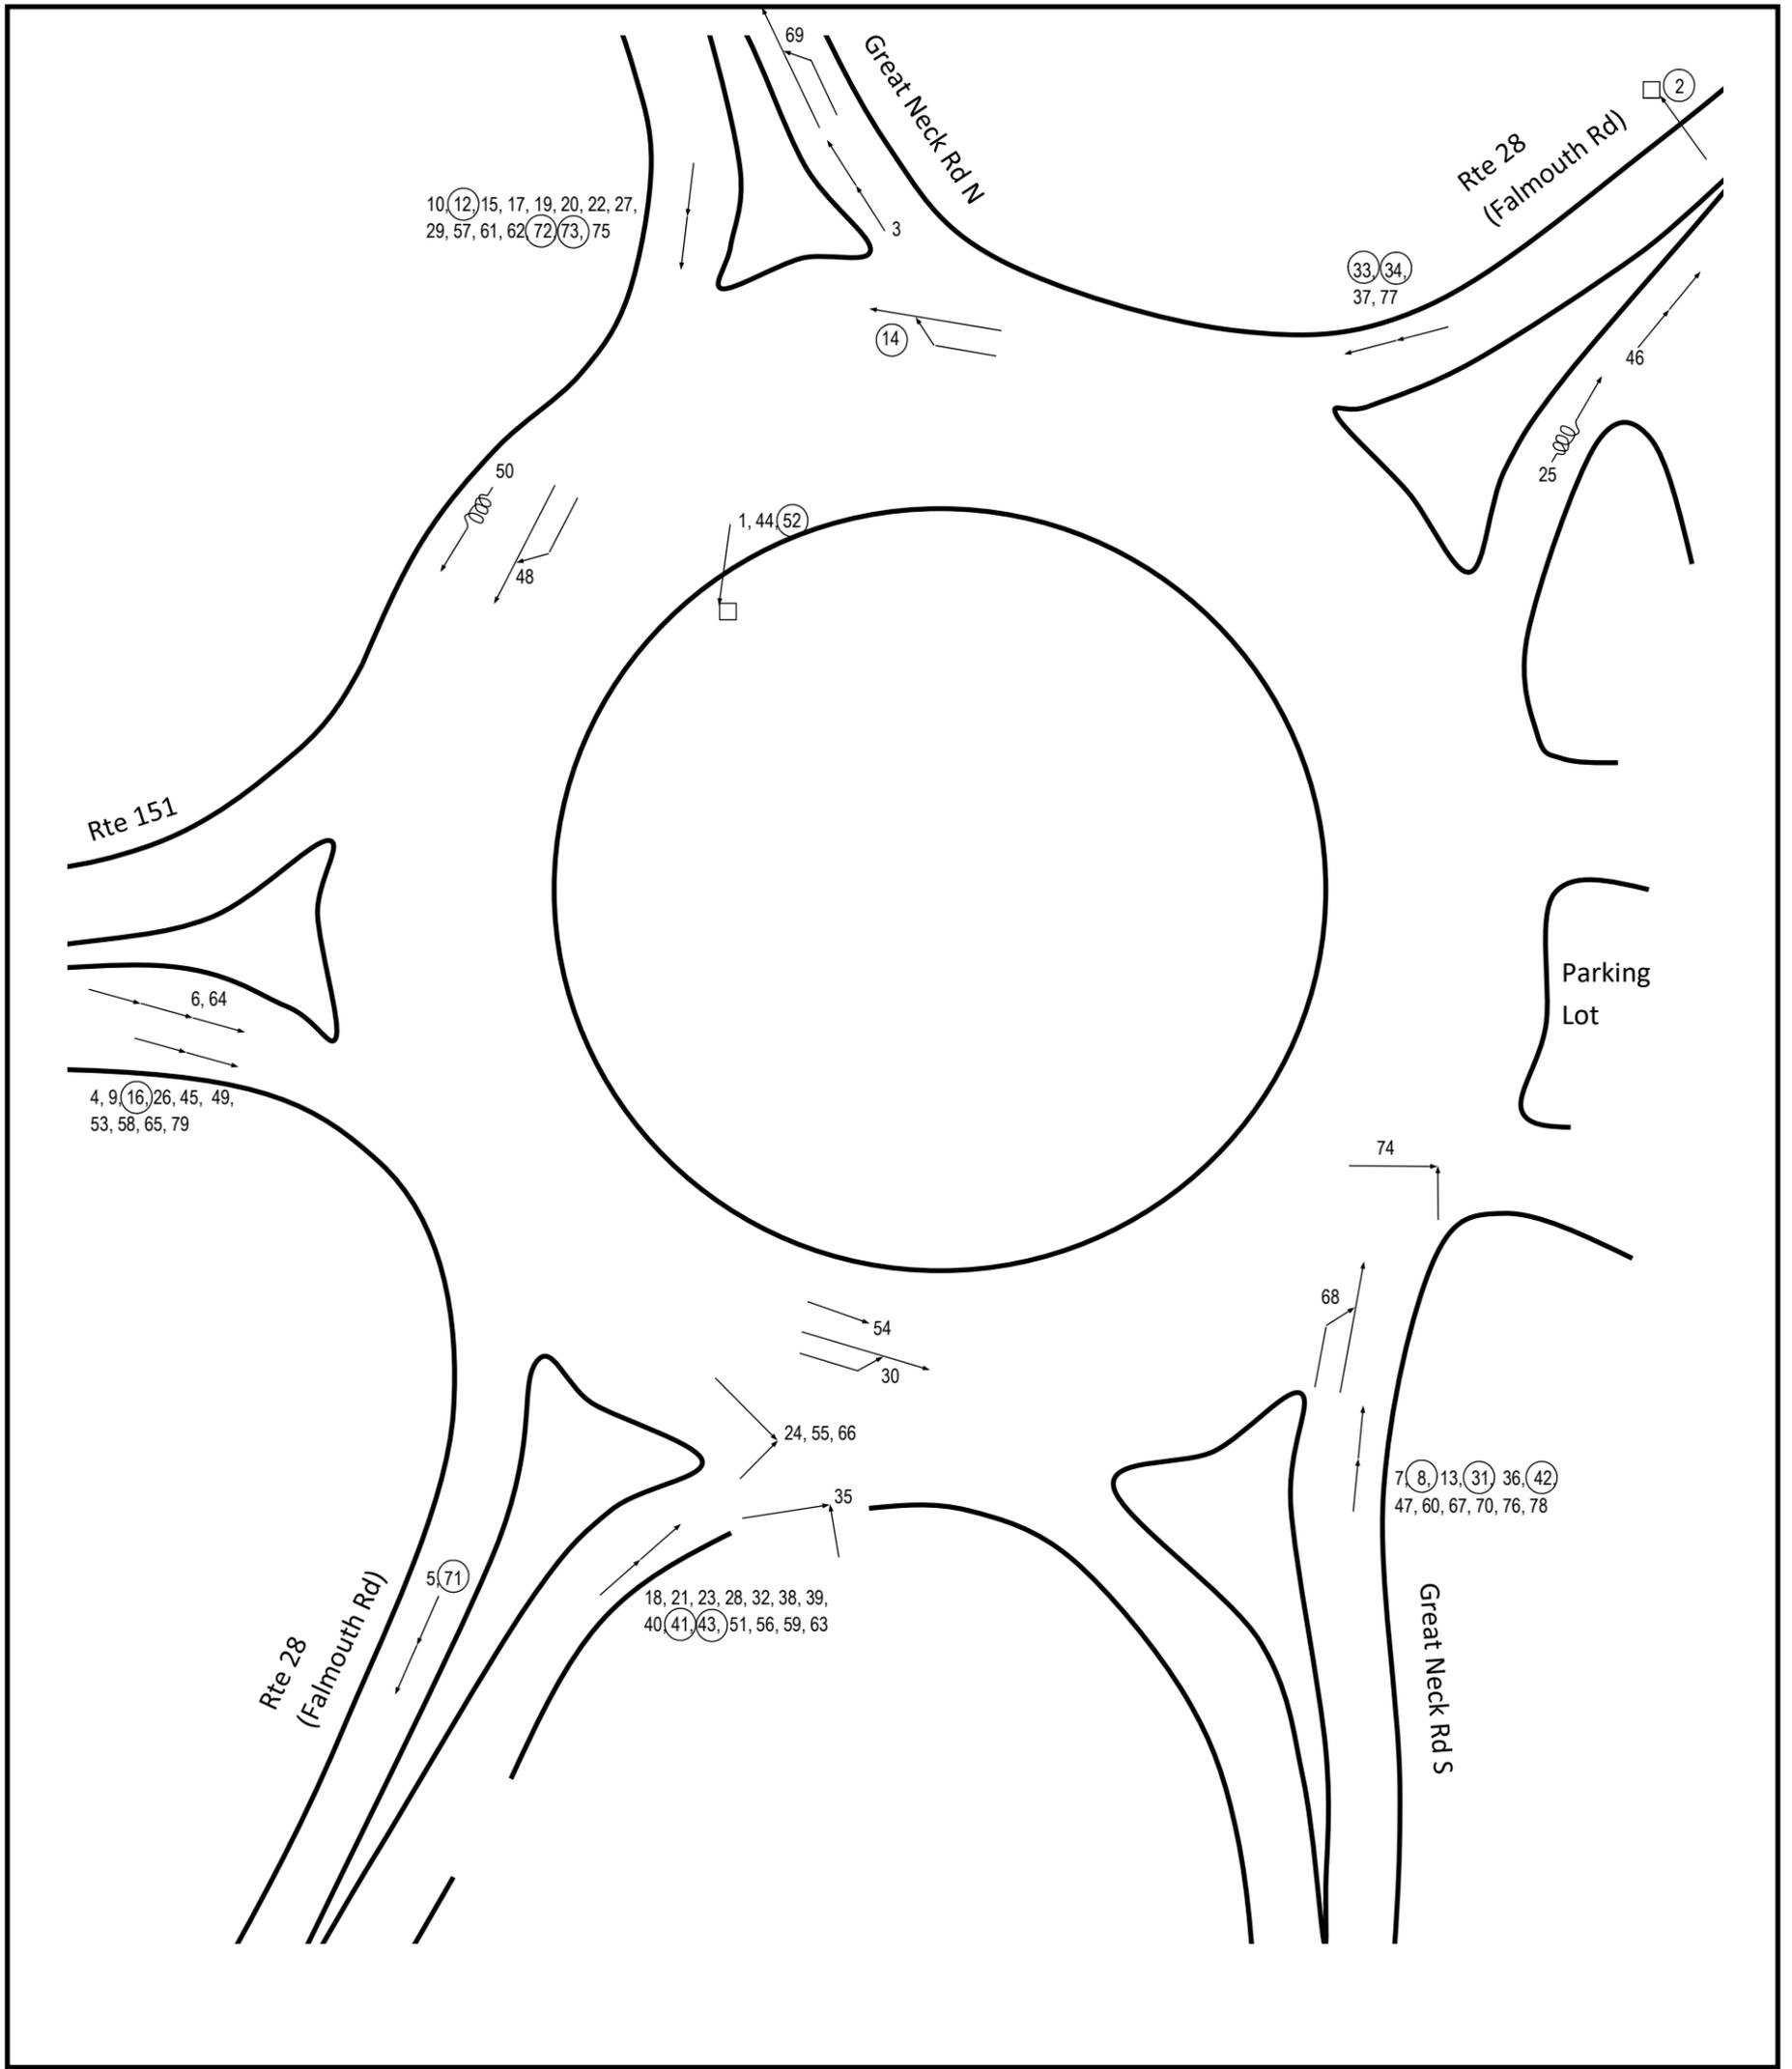
CRASH DIAGRAM

- High speeds and heavy traffic volumes prevent adequate gaps for vehicles to enter the rotary, specifically noted for Great Neck Road North where there is a heavy conflicting entering volume from Route 28 westbound. Lack of adequate gaps may contribute to the high number of rear-end crashes observed at the rotary entrances (i.e. crash #13, 57,62,72).

- Inadequate gaps also present a safety issue as vehicles may drive more aggressively during congested periods and attempt to take a shorter gap as seen with the three angle collisions on Route 28 eastbound (See crash # 24, 55, 66).
