## CAPE COD COMMISSION

# 2006 Transportation Safety Report

Bourne: Route 28 Otis Rotary  
Harwich: Route 137/Route 39  
Orleans: Route 6A/Route 28

December 2006

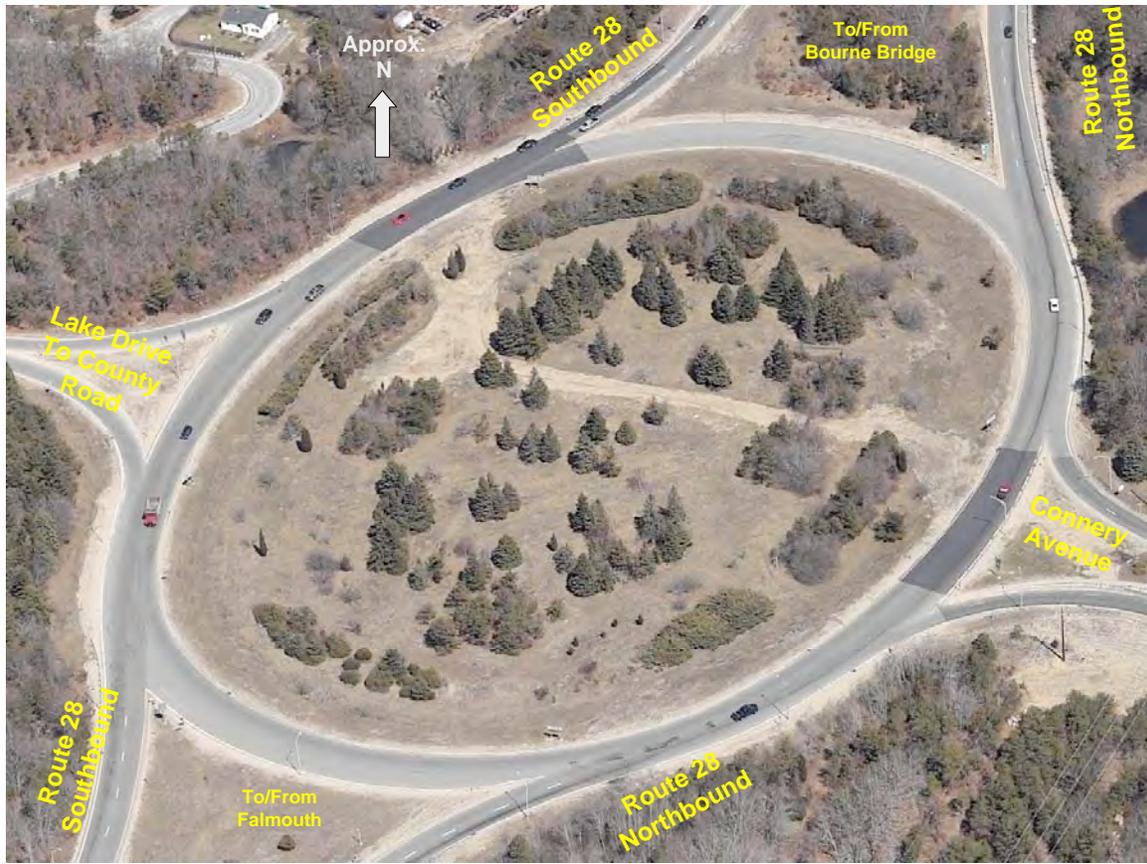
**Figure 2 - Bourne: Otis Rotary Roadway**

The geometry of the Otis Rotary differs from most of the other rotaries on Cape Cod and is shown in the following figure. The large radius and oval configuration provide for Route 28 through-traffic to maintain a high rate of speed. In fact, the curvature of some interior segments of the rotary is of such a smaller radius that vehicles are likely to travel at a lower speed while in the rotary than during entry.

Route 28 south of the rotary operates as a limited access highway with two lanes in each direction separated by a vegetated median. To the north, Route 28 northbound operates as a limited access highway with occasional u-turn locations installed in the vegetated median; Route 28 southbound provides local access to businesses along the western side.

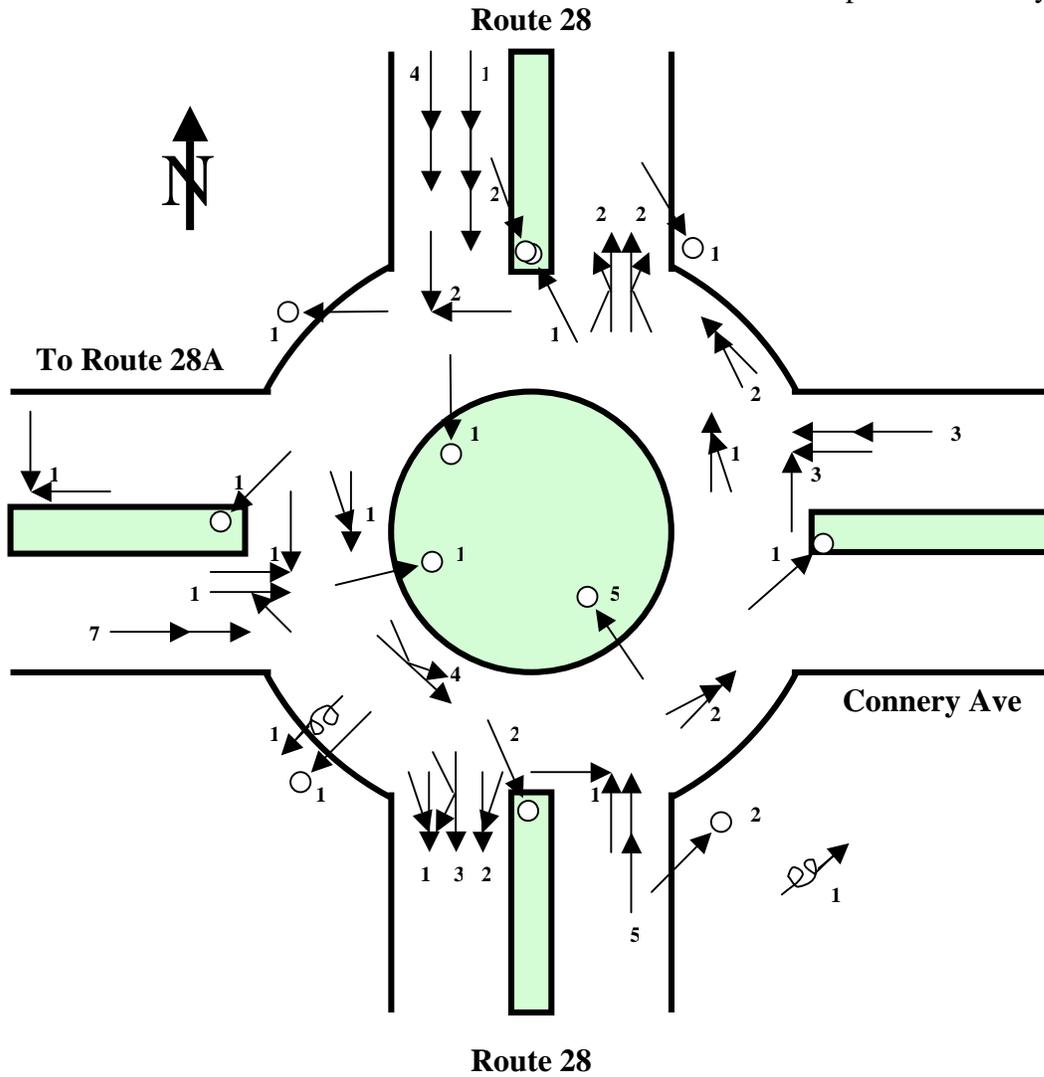
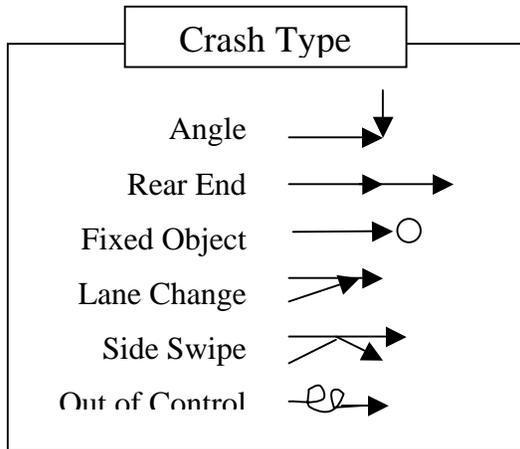
**Figure 3 - Crash Diagram [Otis]**

Source: Canalside Commons traffic study, VAI, December 2005

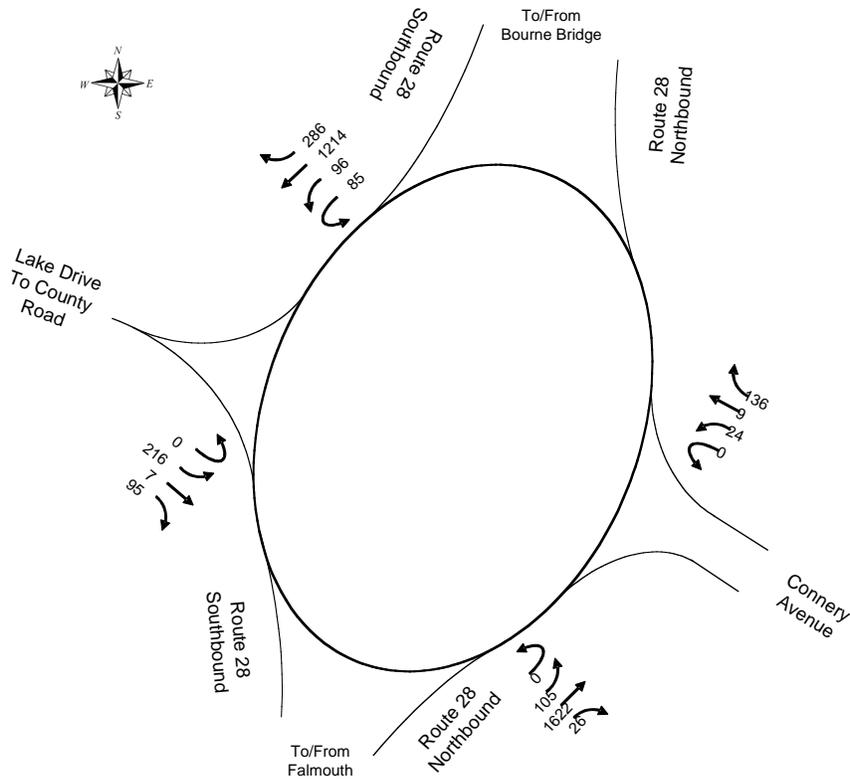
**Figure 4 – Summer Weekday P.M. Traffic Volumes [Otis]**

*Source: adjusted traffic counts by VAI, Inc., summer 2005*

The Otis Rotary serves approximately 23,000 entering vehicles per day on an annual average basis. An average summer day includes approximately 35,000 entering vehicles.

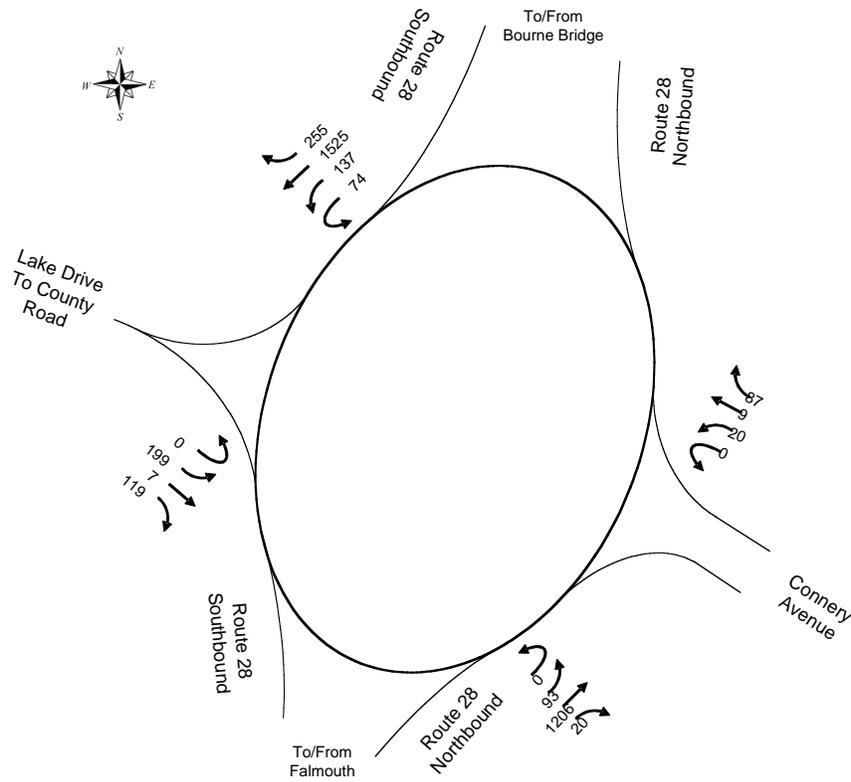
**Figure 5 - Summer Saturday Midday Traffic Volumes [Otis]**

*Source: adjusted traffic counts by VAI, Inc., summer 2005*

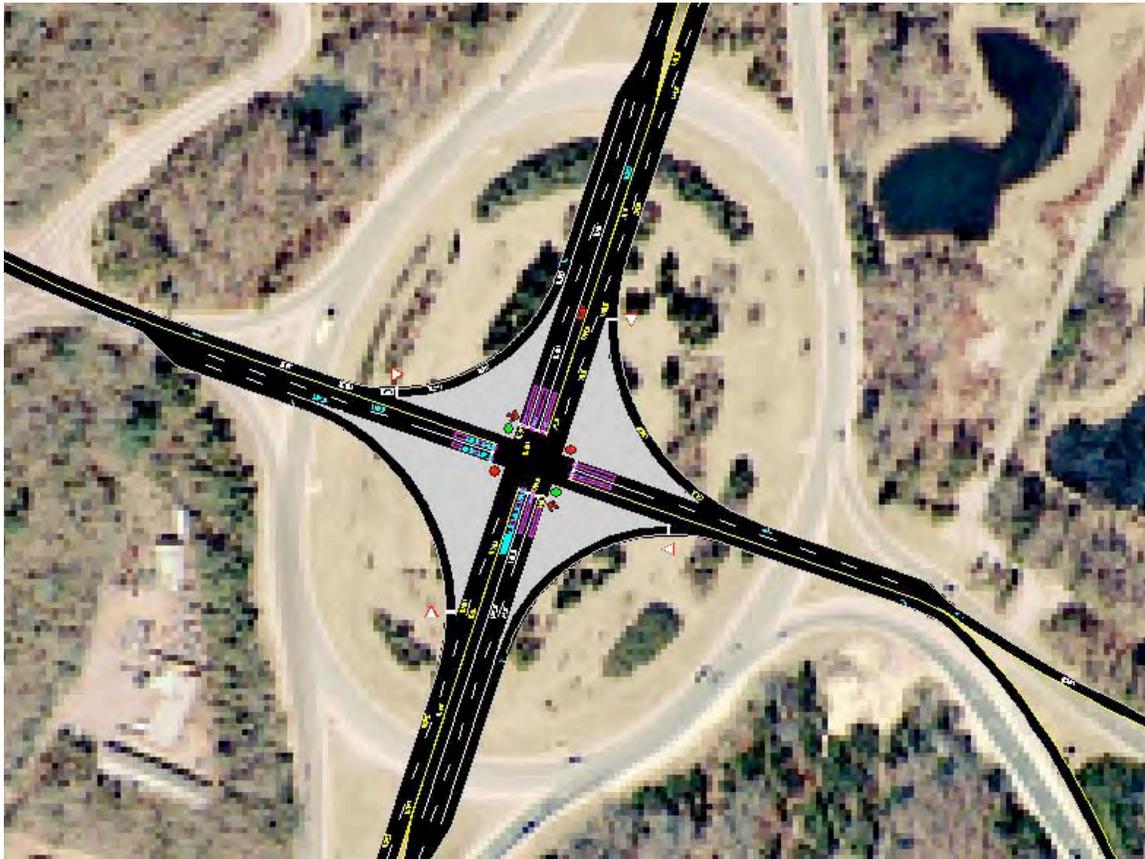
**Figure 7 - Signalized Intersection Alternative [Otis-2]**

[Otis-2] Replace rotary: install at-grade signalized intersection

This alternative would involve realignment and construction of an at-grade signalized intersection. Most of the existing rotary pavement would be removed. The facility would include:

- Two through lanes
- Right & left turn lanes
- Dual left turns – Route 28A

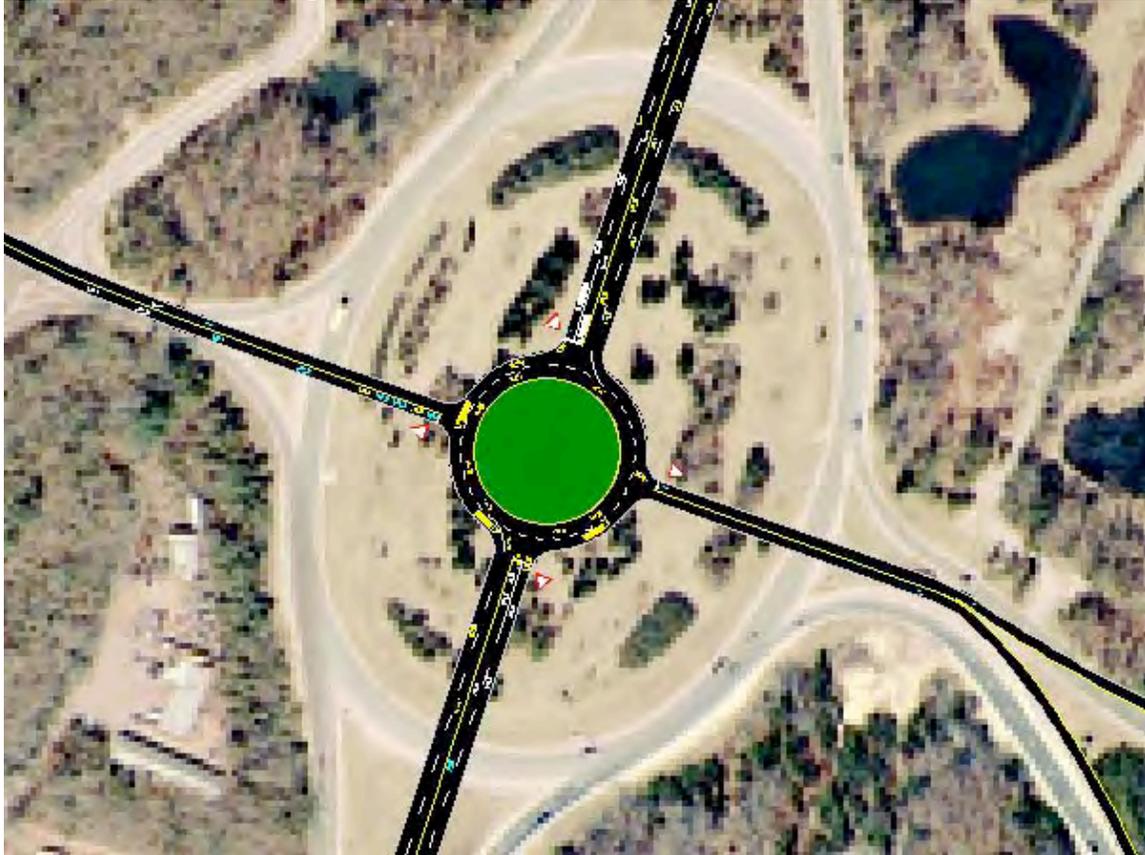
**Figure 8 - Modern Roundabout Alternative [Otis-3]**

[Otis-3] Reconfigure rotary: redesign as modern roundabout

This alternative would include the signage and striping principles described in alternative Otis-1. In addition, the large oval configuration would be removed and replaced with a smaller circular roundabout. Entering roadways would be aligned in a manner to encourage lower entry speeds (as compared to circulating traffic).

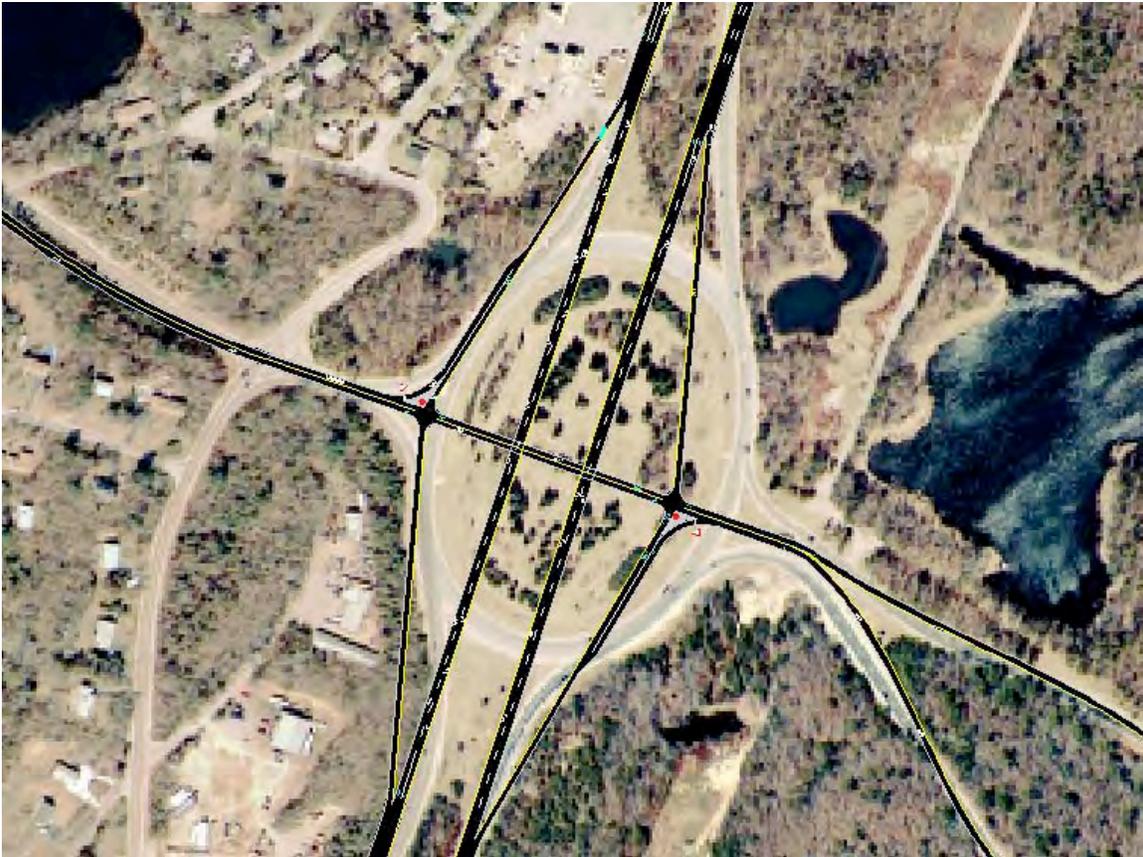
**Figure 9 - Diamond Interchange [Otis-4]**

[Otis-4] Replace rotary: grade separation and diamond interchange

This alternative totally removes the rotary and includes construction of new road segments with direct connections of Route 28. It appears that the interchange ramps would fit within the existing layout. Under this alternative, the ramps would be unsignalized.

As a short-term improvement, it is recommended that the rotary be restriped for 2-lanes with improved signage (alternative “Otis-1”). The grade-separation alternative (“Otis-4”) is recommended for consideration as the long-term solution for this location due to its expected benefits to traffic flow and safety.

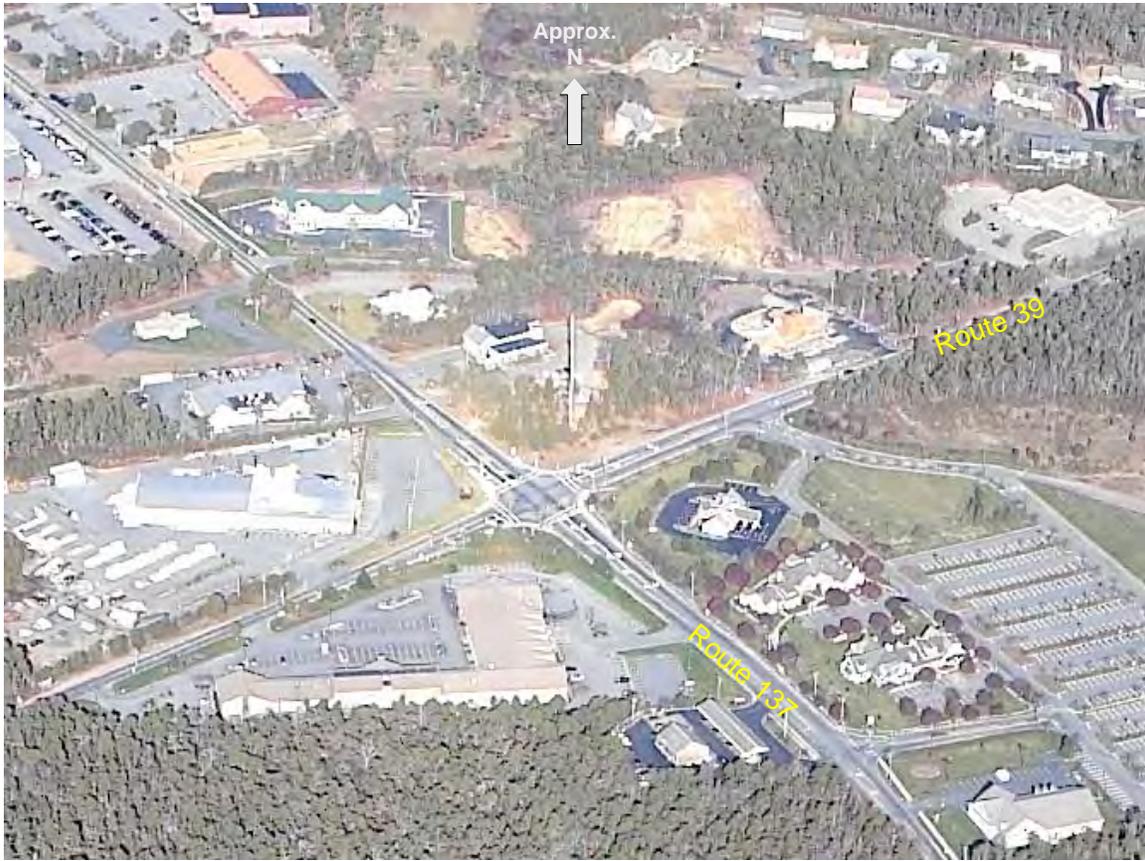
**Figure 10 - Route 137/Route 39 Intersection**

The following figures show the intersection in the context of the surrounding land uses. Curb cuts are identified in proximity to the intersection. In 2006 the intersection was upgraded to provide a left-turn lane, a through lane, a right-turn lane and a crosswalk. The signalization includes a pedestrian phase. Before the 2006 upgrade, the intersection geometry was as follows: Route 137 Southbound had a left-turn lane, a through lane, and a right turn lane; Route 137 Northbound has a left turn lane and a wide through/right turn lane; Route 39 Westbound and Eastbound both had a left turn/through lane and a dedicated right turn lane.

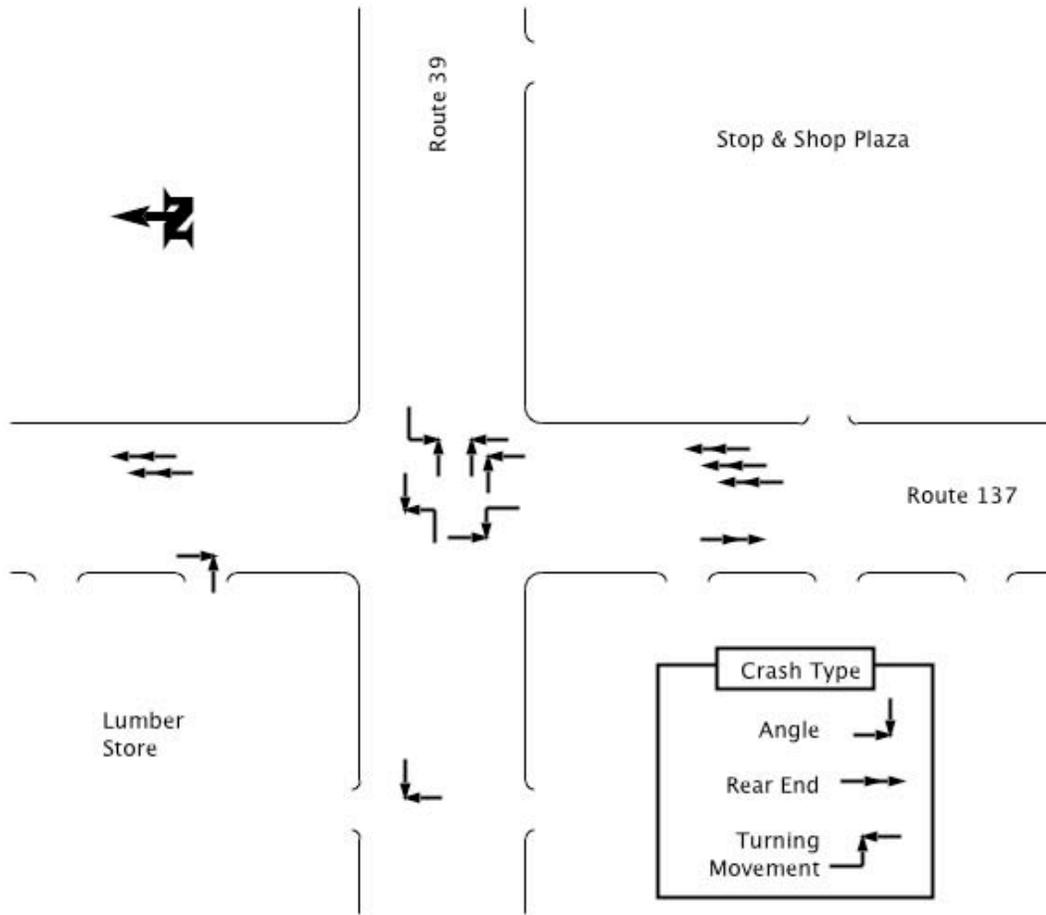
**Figure 12 - Crash Diagram [137/39]**

*Source: Town of Harwich Police Department Accident Reports (2000, 2001)*

A detailed analysis of crashes at this location has indicated that about half are in fact found to occur at the driveways of nearby parcels as shown in the figure on the following page.

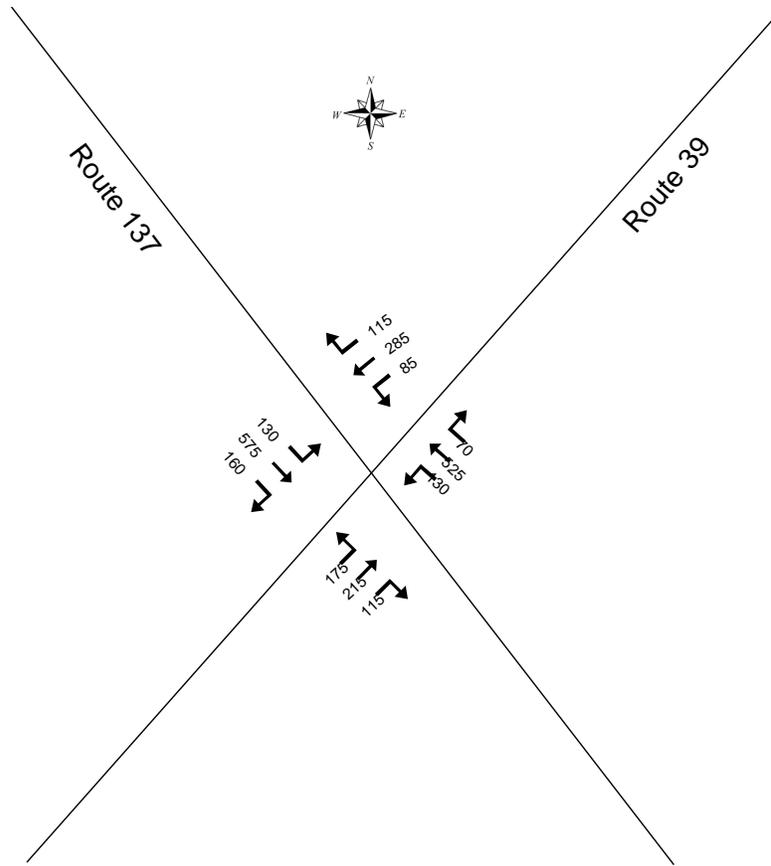
**Figure 13 - Traffic Volumes – Summer Weekday P.M. Peak Hour [137/39]**

*Source: VHB forecasted traffic after Stop & Shop expansion*

The following diagrams show the hourly turning movements at the intersection during summer weekday p.m. peak hour and Saturday midday. The following table presents delay and Level of Service (LOS) information for the previous “Existing” geometry and future scenarios. The future scenarios include without and with mitigation (as-built lane configuration). This information was prepared by a private developer as part of a traffic study.

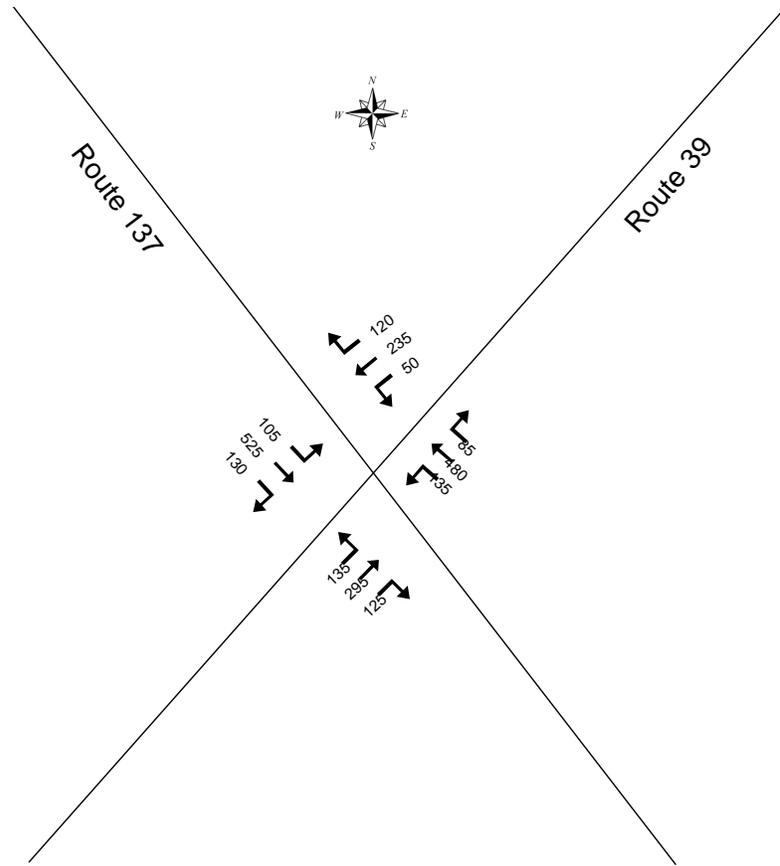
**Figure 14 - Traffic Volumes Summer Saturday Midday [137/39]**

*Source: VHB forecasted traffic after Stop & Shop expansion*

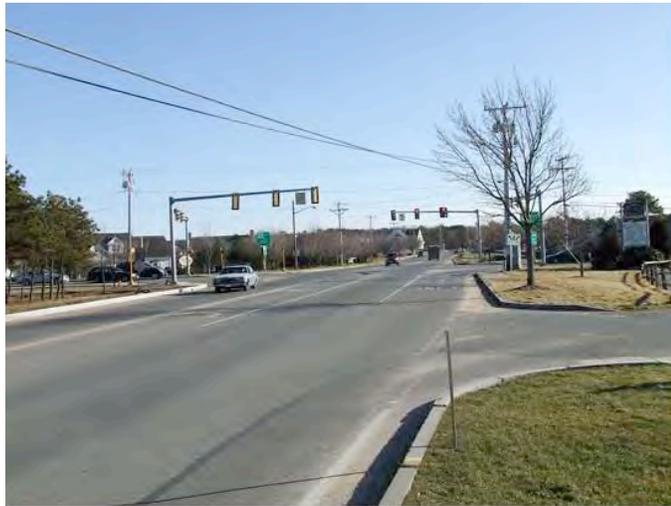
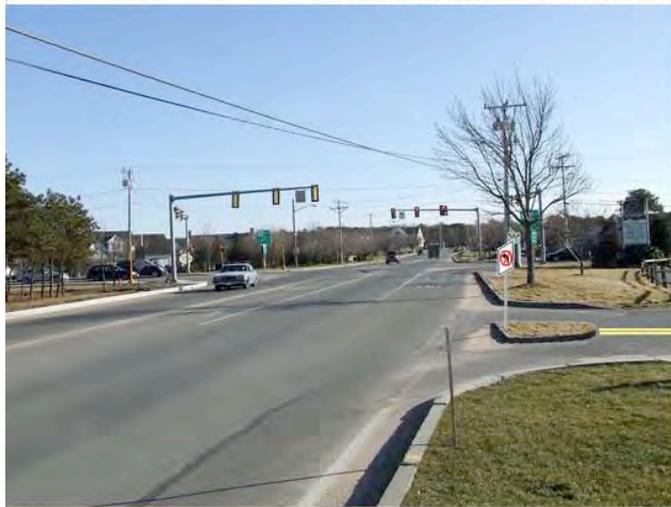
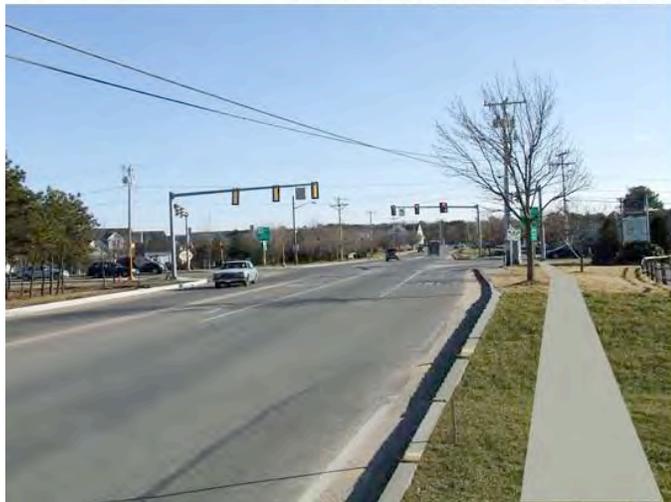
**Figure 15 – Access Management Alternatives [137/39]**

The following figures illustrate access management principles by restricting or eliminating turning movements at a driveway near the intersection. In this example, the parcel has additional access at another driveway at a safer location (away from intersection turning lanes).

**Existing**

**Turn Restrictions**

**Driveway Closure  
with Sidewalk**

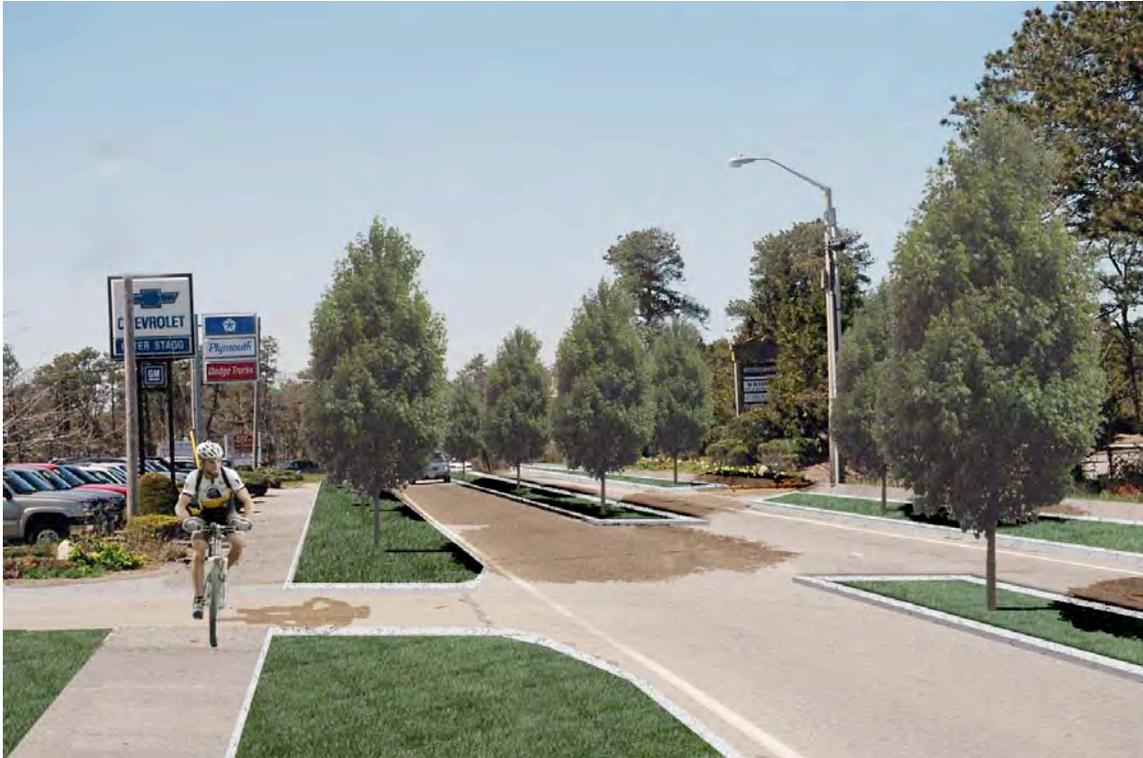
**Figure 16 - Raised Median, Sidewalk [137/39]**

*Source: The Cecil Group*

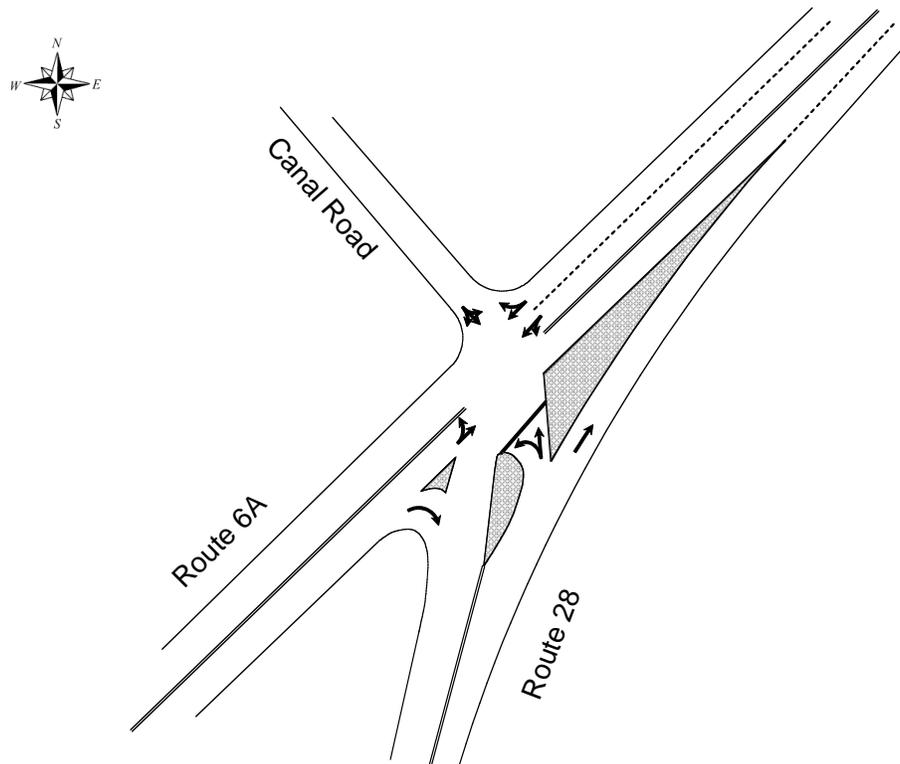
**Figure 17 - Route 6A/Route 28 Intersection Diagram**

- Route 6A/Route 28 (northern leg): two approach lanes; one wide (approx. 24 feet width) exit lane
- Route 6A (south leg): one approach lane; one exit lane
- Route 28 (east leg): one approach lane dividing to a through/left lane and a dedicated right turn lane; one exit lane
- Canal Road (western leg): one approach lane; one exit lane

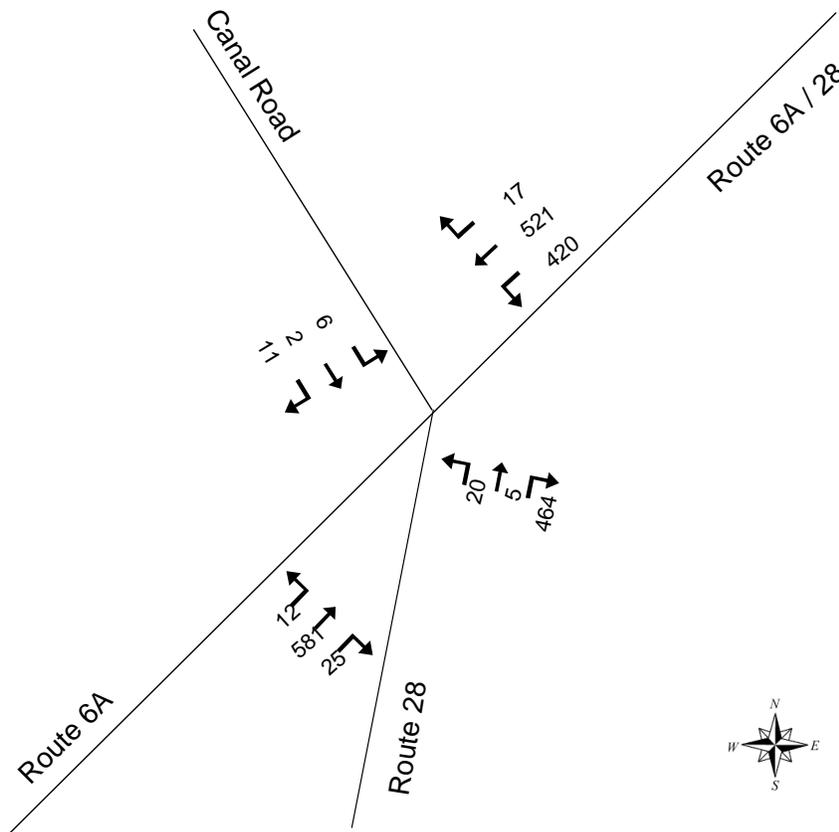
**Figure 21 - Summer PM Peak Hour Traffic Volumes [6A/28]**

The following diagrams show the hourly turning movements at the intersection during summer weekday p.m. peak hour and Saturday midday. The following table presents delay and Level of Service (LOS) information for the existing geometry and three alternatives (these alternatives are discussed in the next section of the report).

*Source: adjusted max 2006 CCC traffic count*
