Proposed Fence Alignment “Concept 6”

Provincetown Municipal Airport
Provincetown, MA

Northern Section

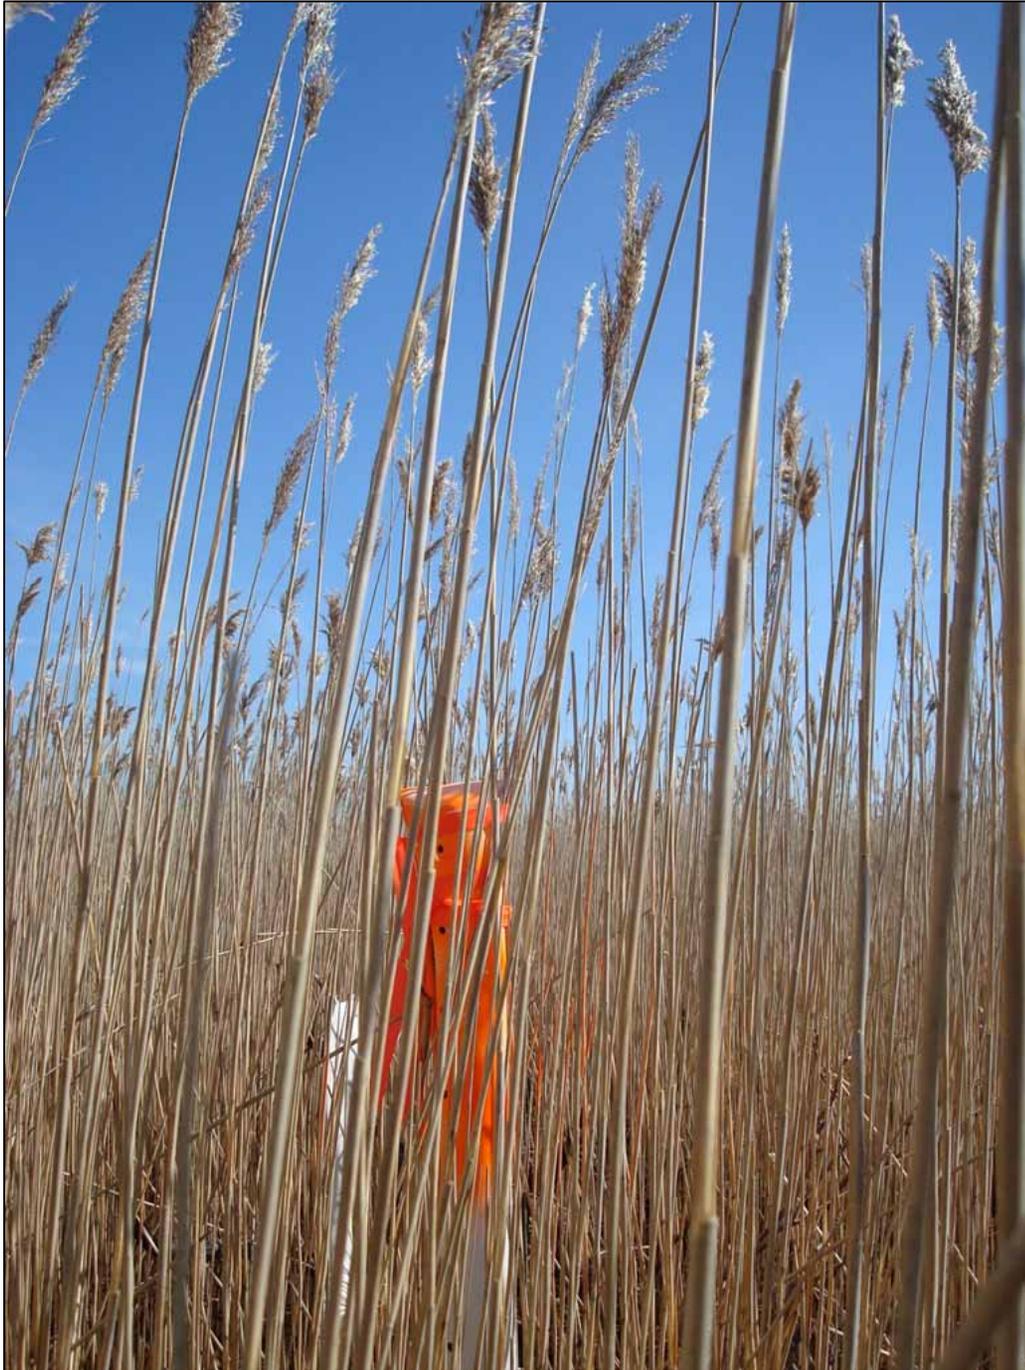
Approximate location of proposed fence alignment near fence stake #1202. Vegetation maintenance will be limited to the cutting of Phragmites.

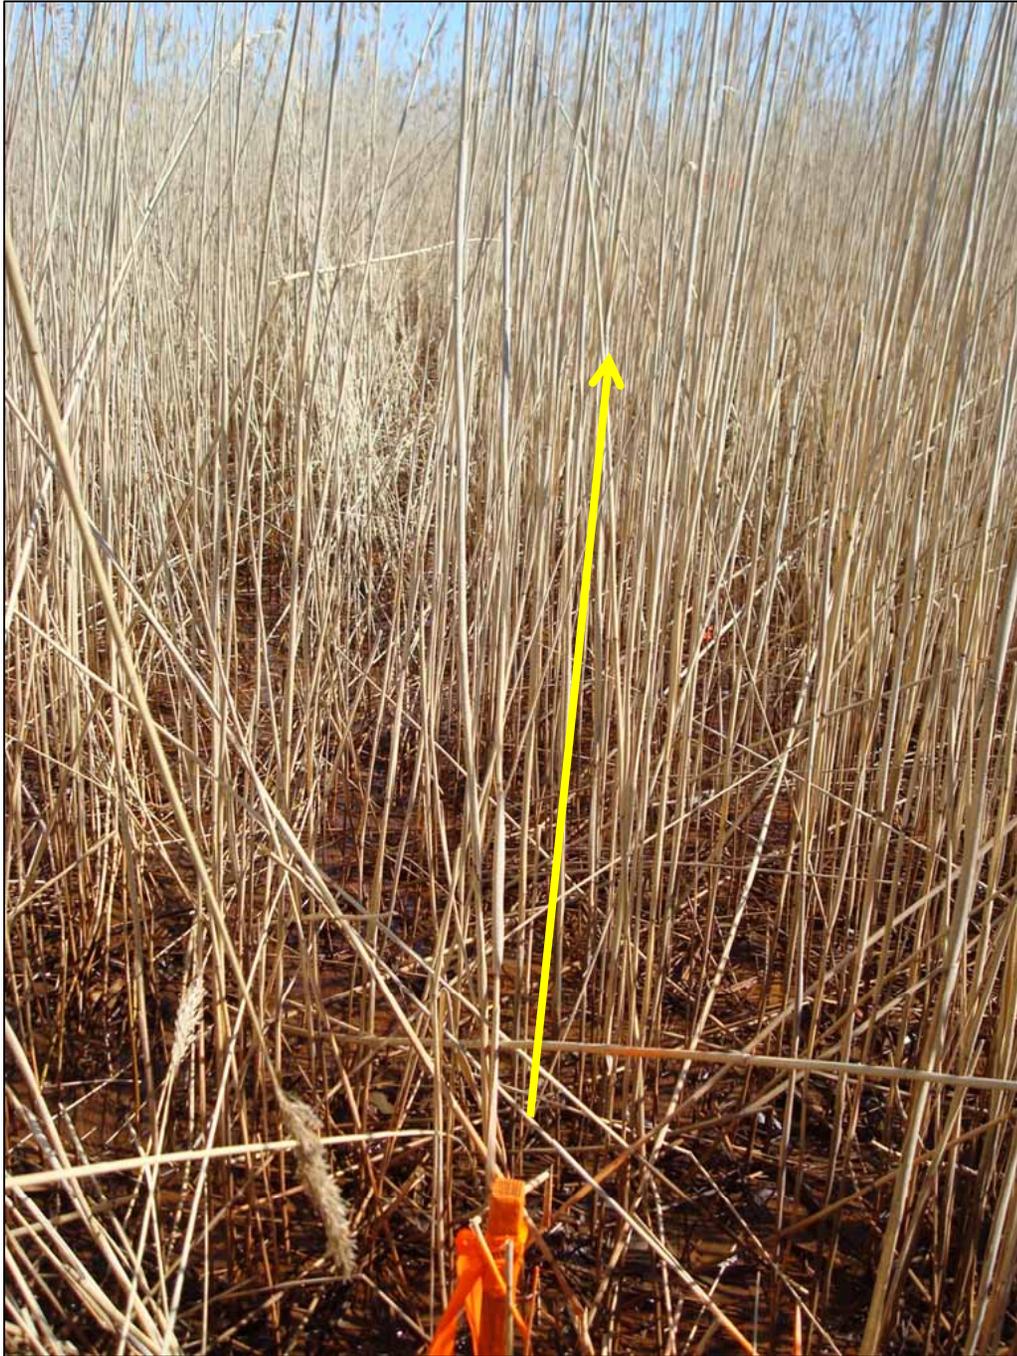
Approximate location of proposed fence alignment near fence stake #1204. Vegetation maintenance will be limited to the cutting of Phragmites.

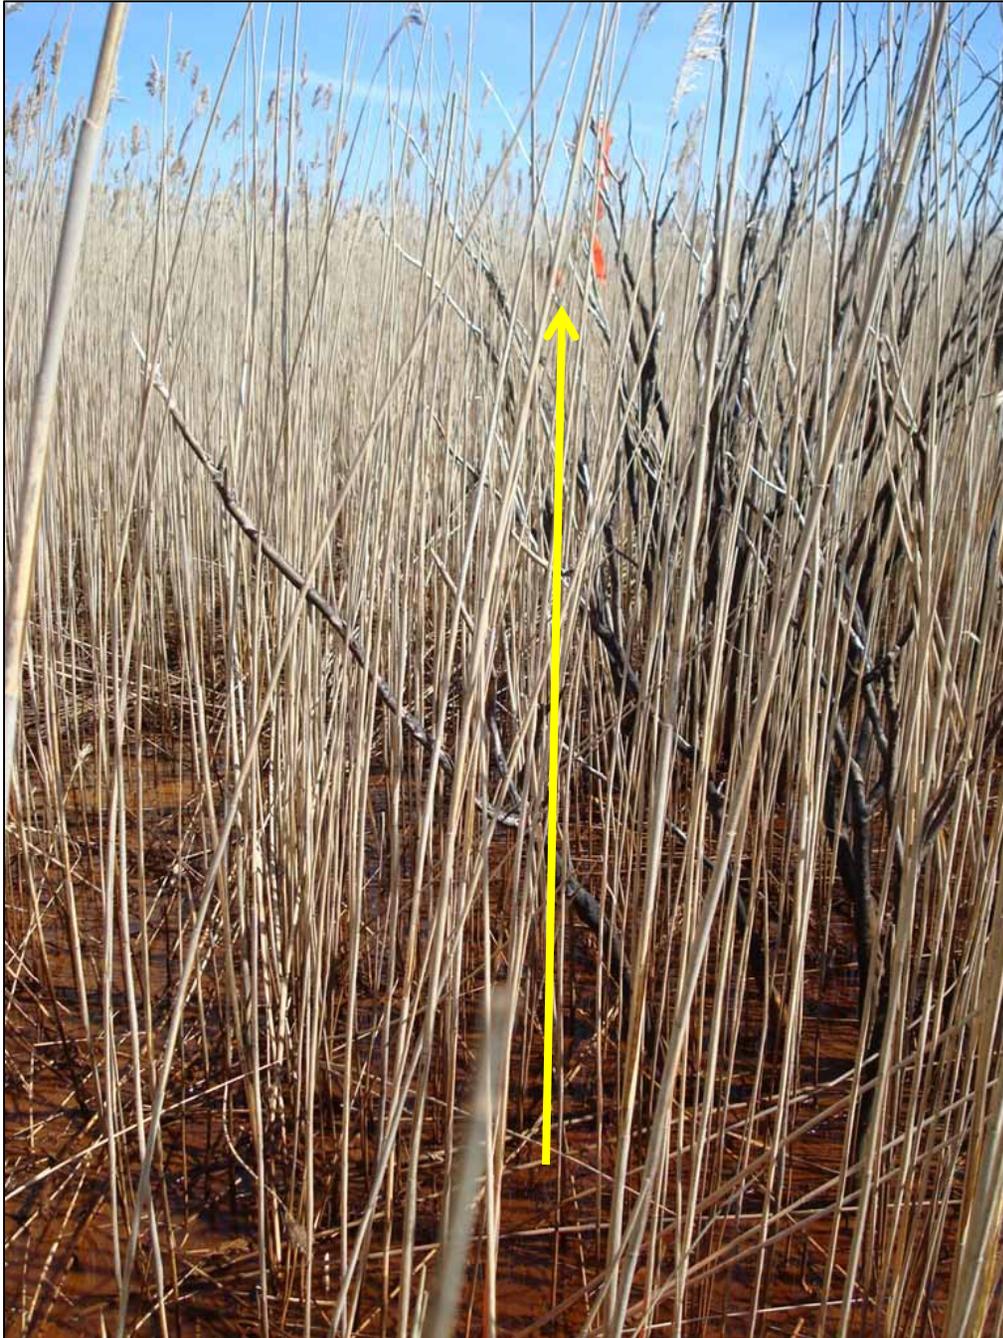
Approximate location of proposed fence alignment near fence stake #1206. Vegetation maintenance will be limited to the cutting of Phragmites and removal of occasional dead shrubs.

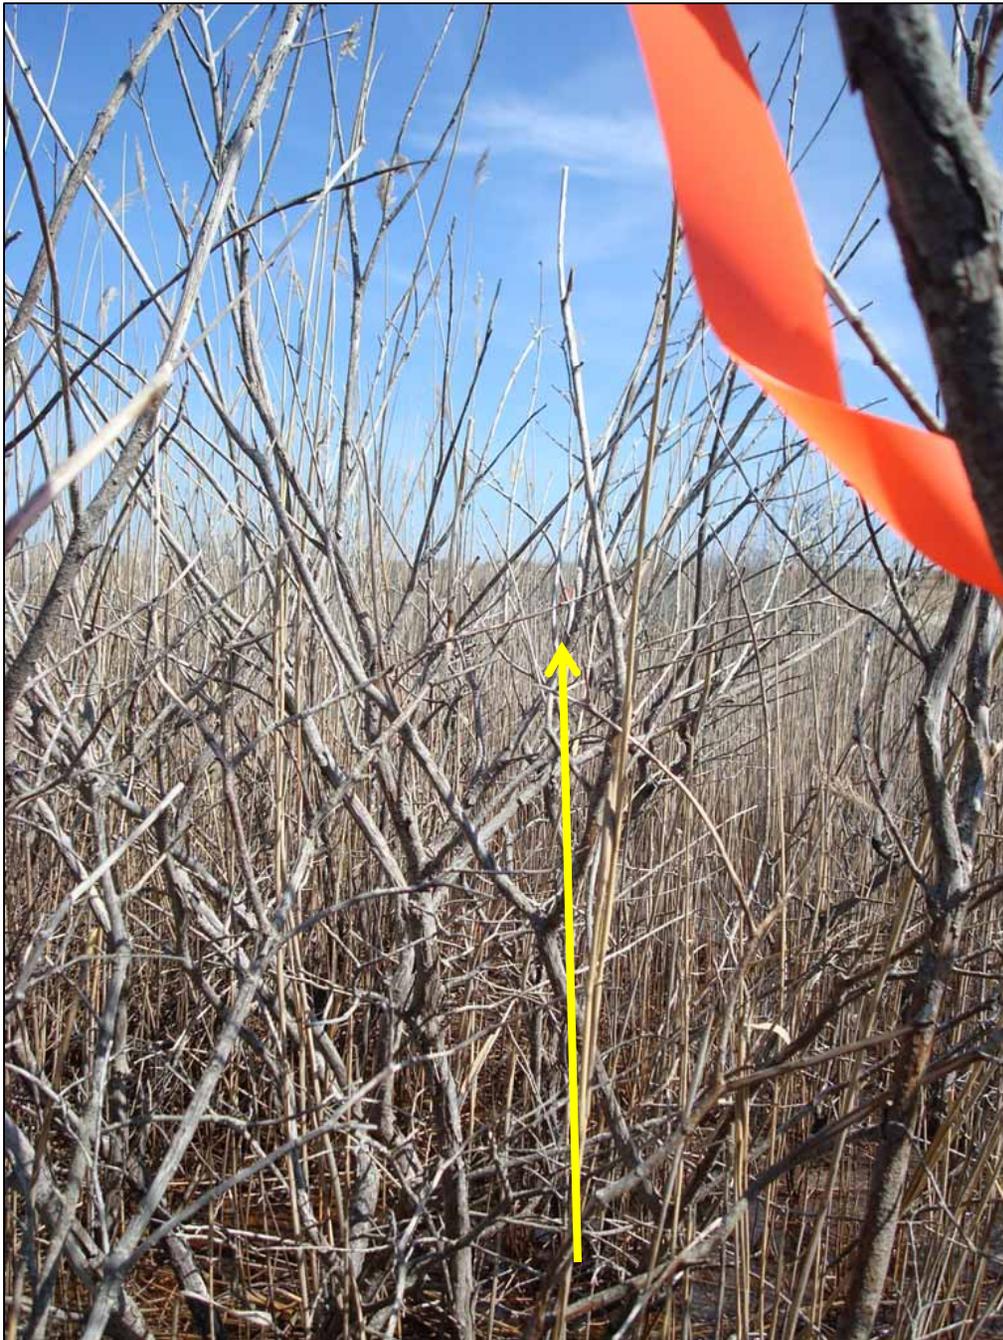
Approximate location of proposed fence alignment near fence stake #1208. Vegetation maintenance will be limited to the cutting of Phragmites and removal of occasional dead or dying shrubs.

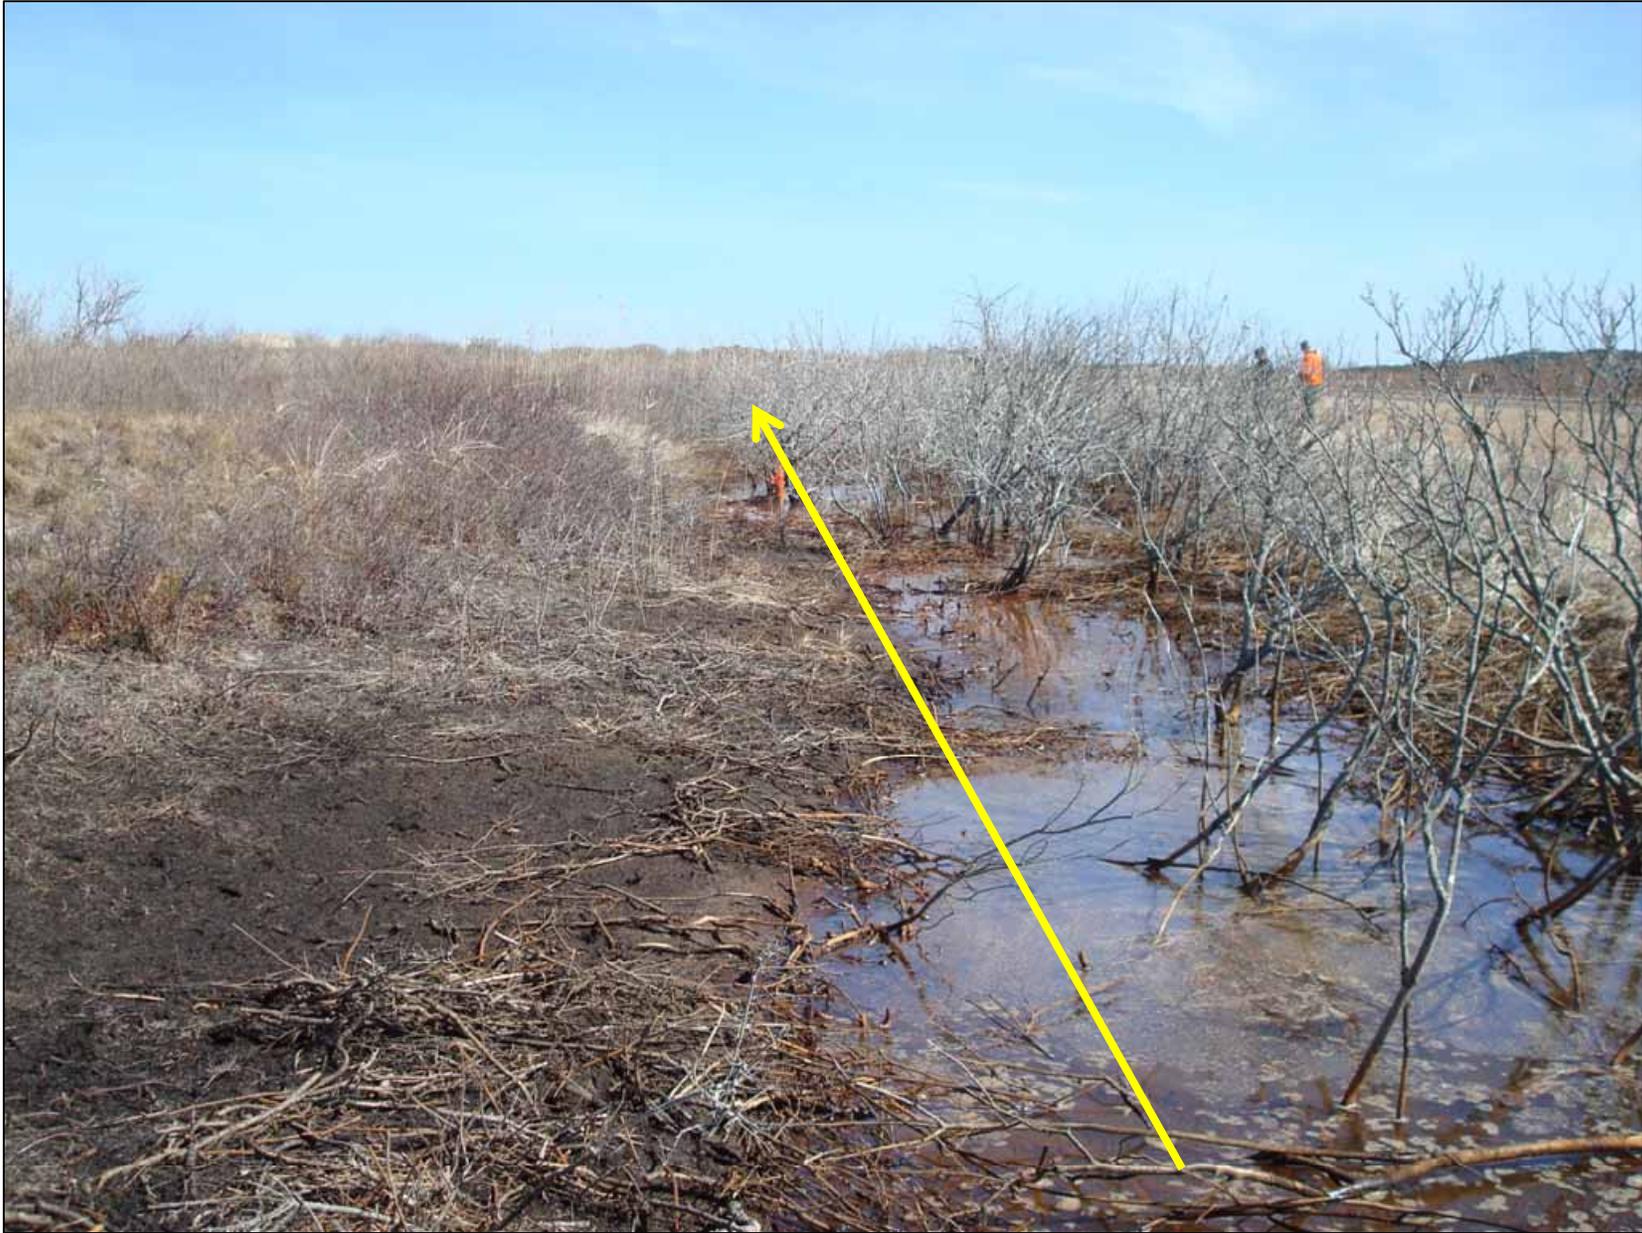
Approximate location of proposed fence alignment near fence stake #1211. Vegetation maintenance will be limited to the cutting of occasional shrubs and dead shrubs.

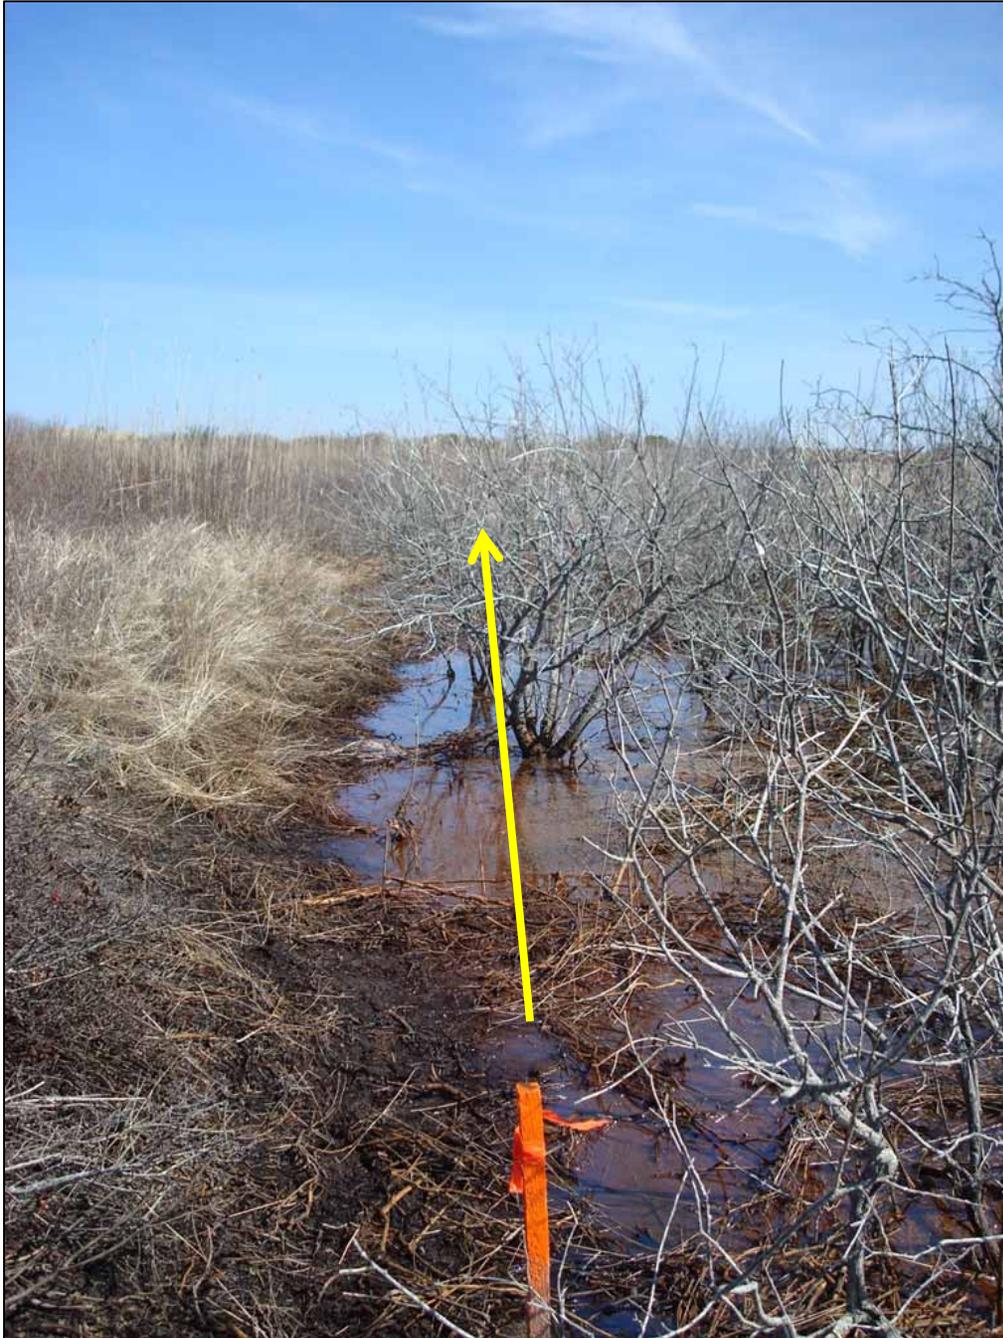
Approximate location of proposed fence alignment near fence stake #1211. Vegetation maintenance will be limited to the cutting of occasional dead shrubs.

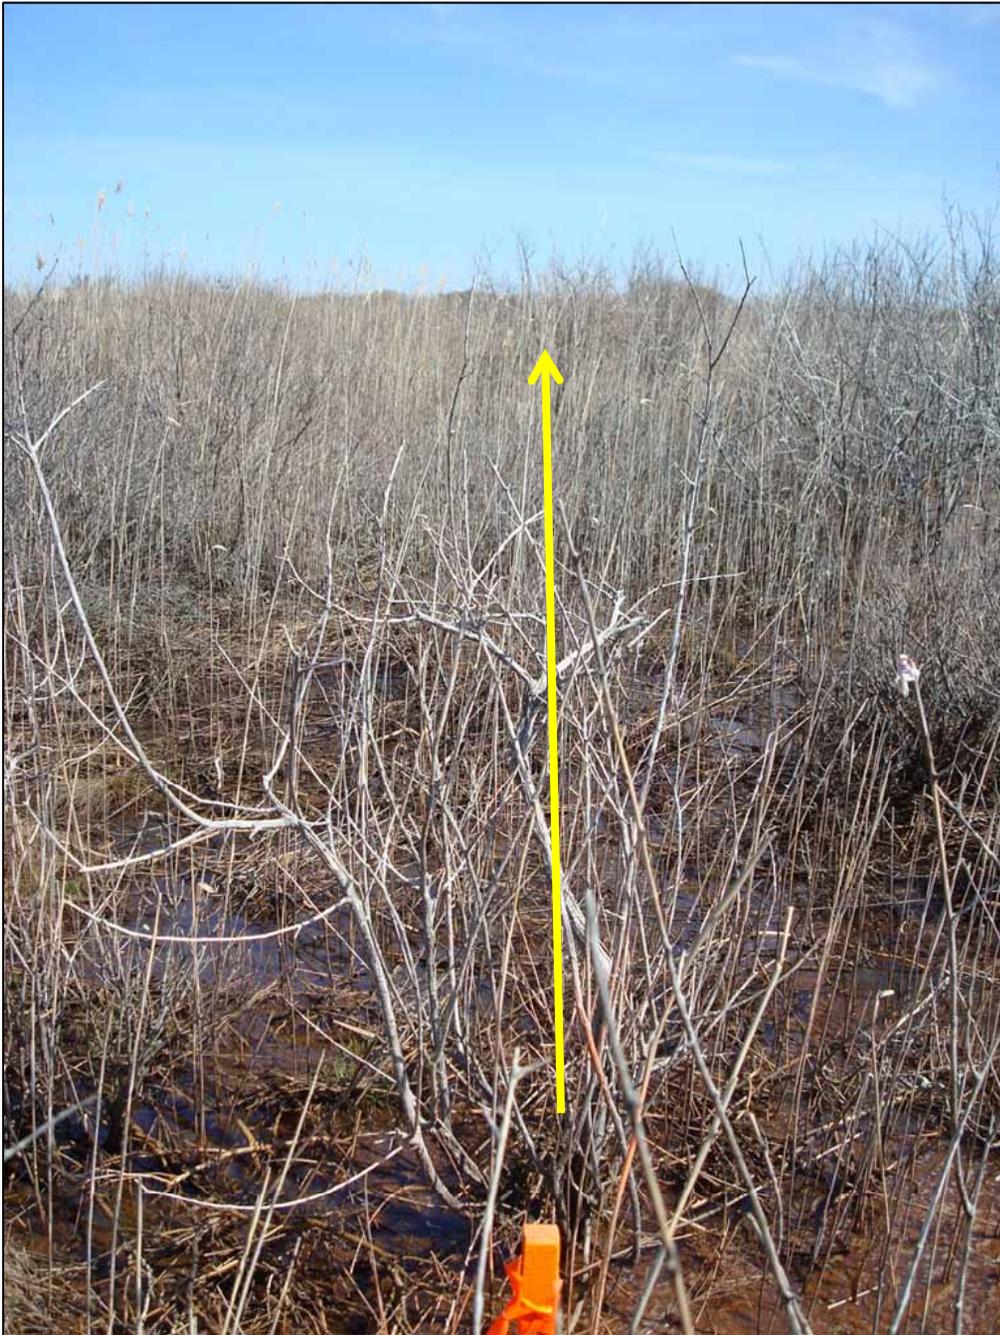
Approximate location of proposed fence alignment near fence stake #1212. Vegetation maintenance will be limited to the cutting of occasional dead shrubs.

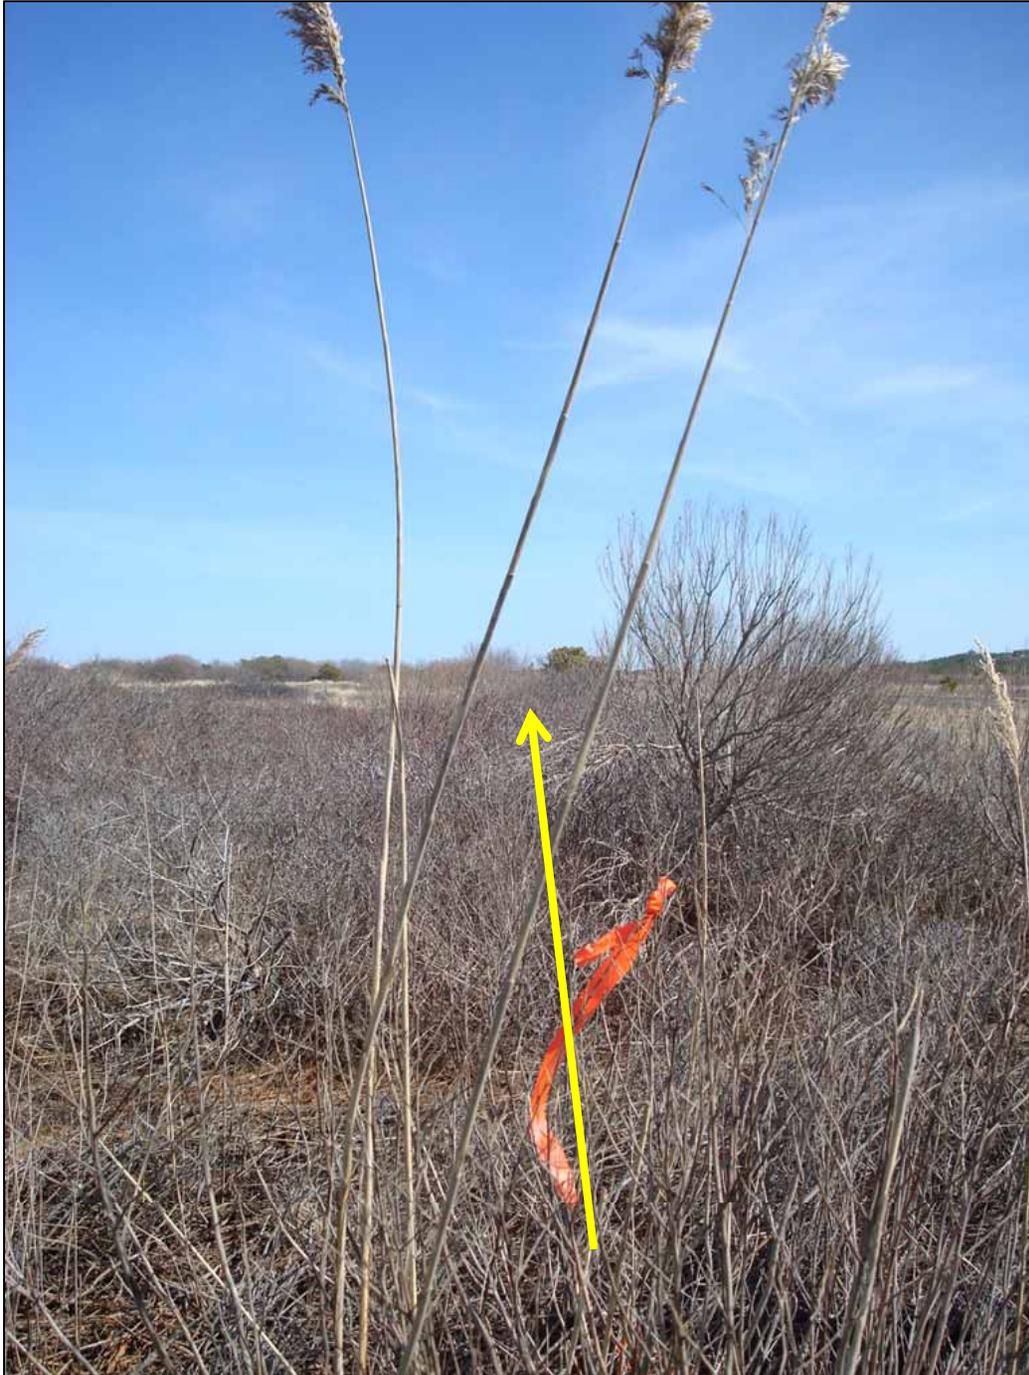
View of approximate location of proposed fence alignment near fence stake #1214. Vegetation maintenance will consist of the removal and pruning of shrubs.

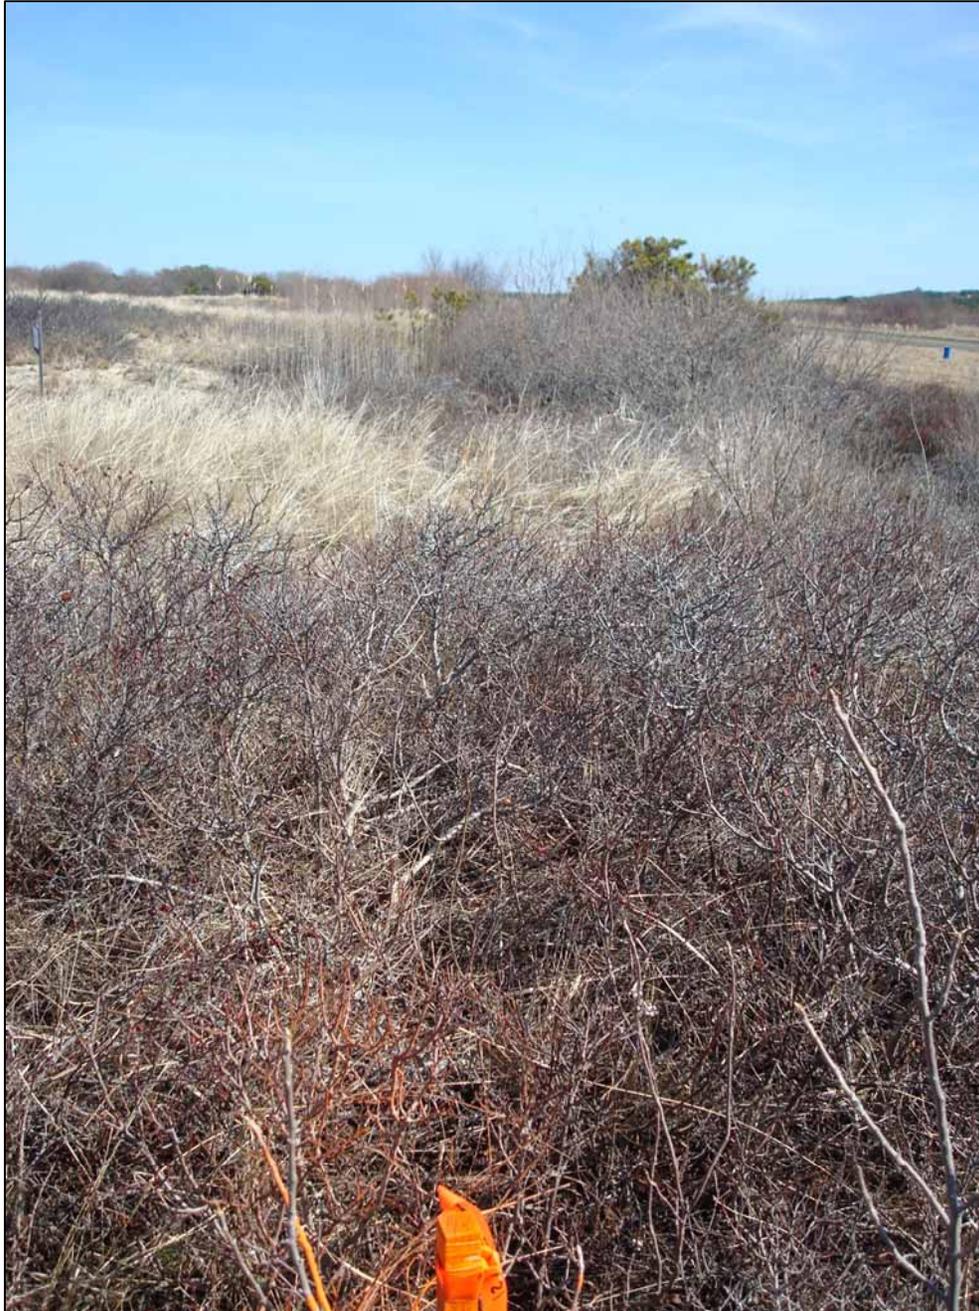
View of approximate location of proposed fence alignment near fence stake #1216. Vegetation maintenance will consist of the removal and pruning of larger shrubs, where necessary.

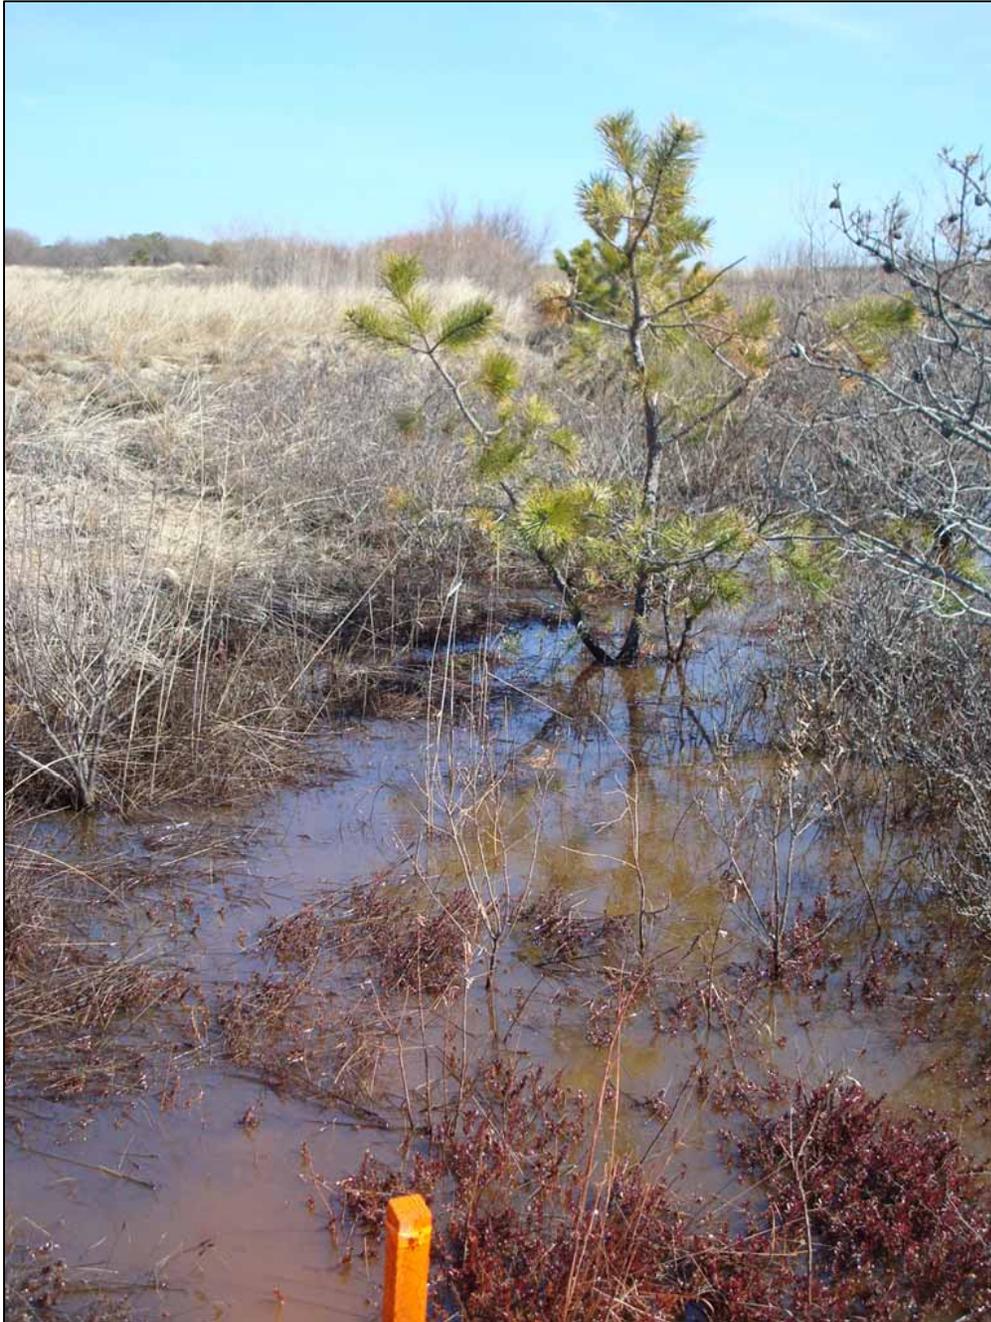
View of approximate location of proposed fence alignment near fence stake #1220. Vegetation maintenance will consist of the removal and pruning of shrubs and pitch pine seedlings, where necessary.

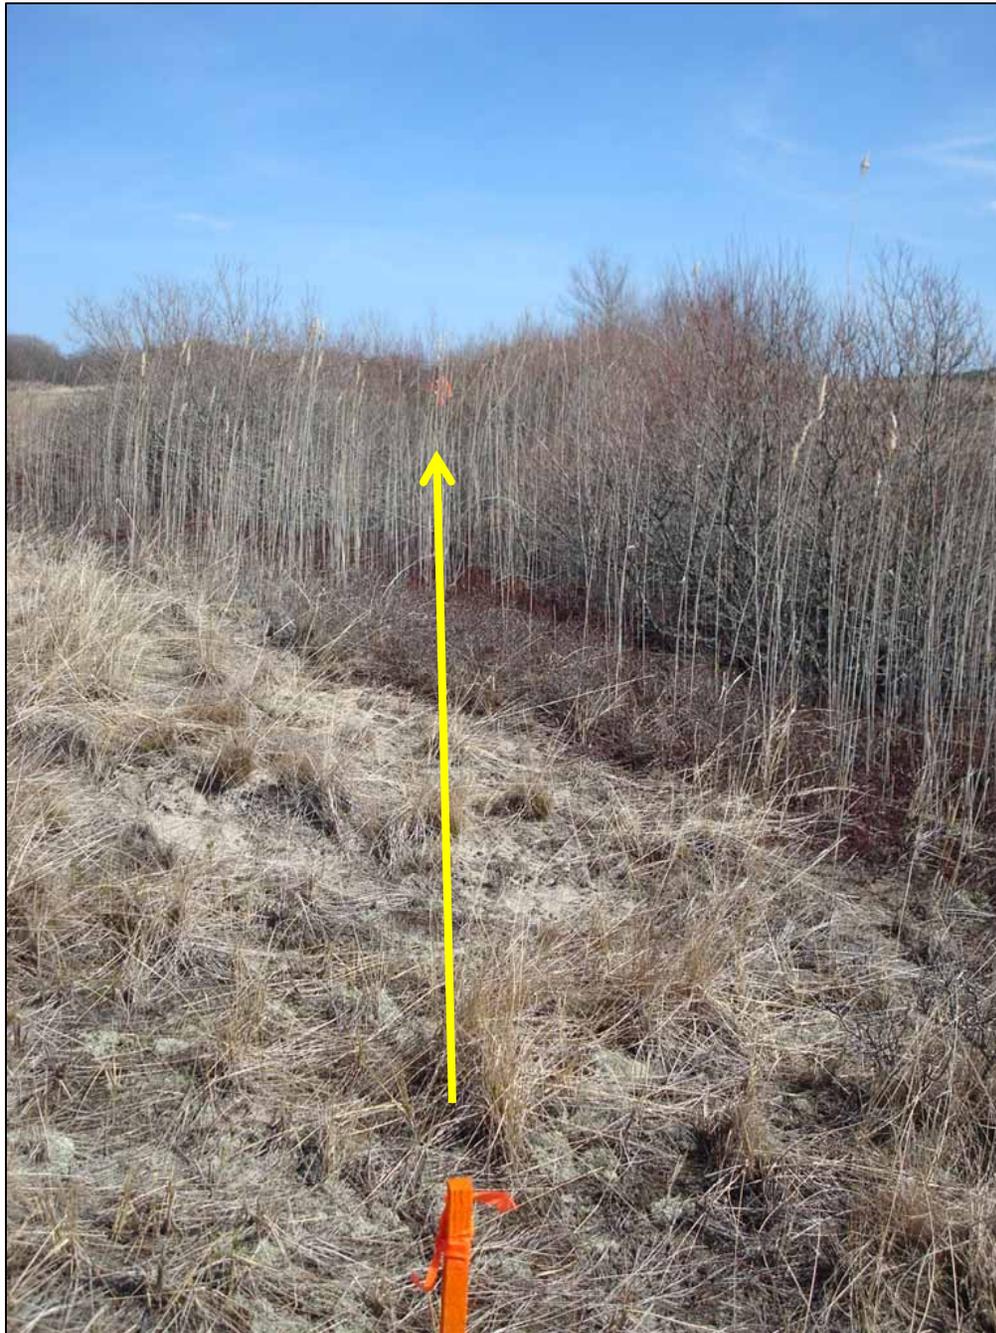
View of approximate location of proposed fence alignment near fence stake #1222. Vegetation maintenance will consist of the removal and pruning of larger shrubs. Shifting the fence alignment to the north 10-15 feet would reduce or eliminate the need for cutting of vegetation.

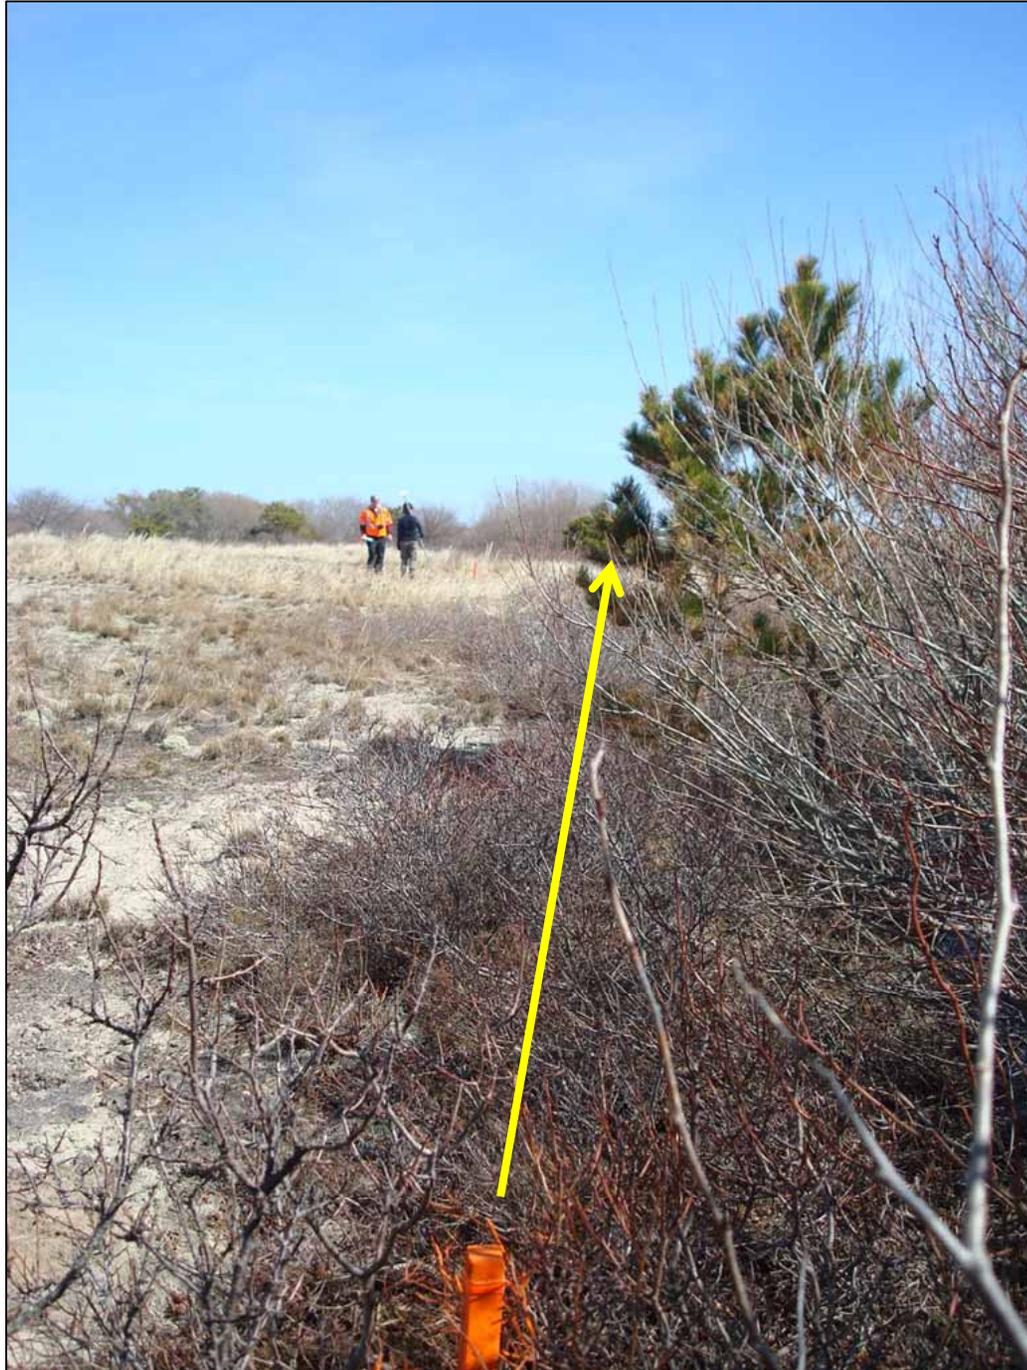
View of approximate location of proposed fence alignment near fence stake #1224 and #1226. Vegetation maintenance will consist of the removal and pruning of larger shrubs and occasional pitch pine. Shifting the fence alignment to the north 10-15 feet would reduce or eliminate the need for cutting of vegetation.

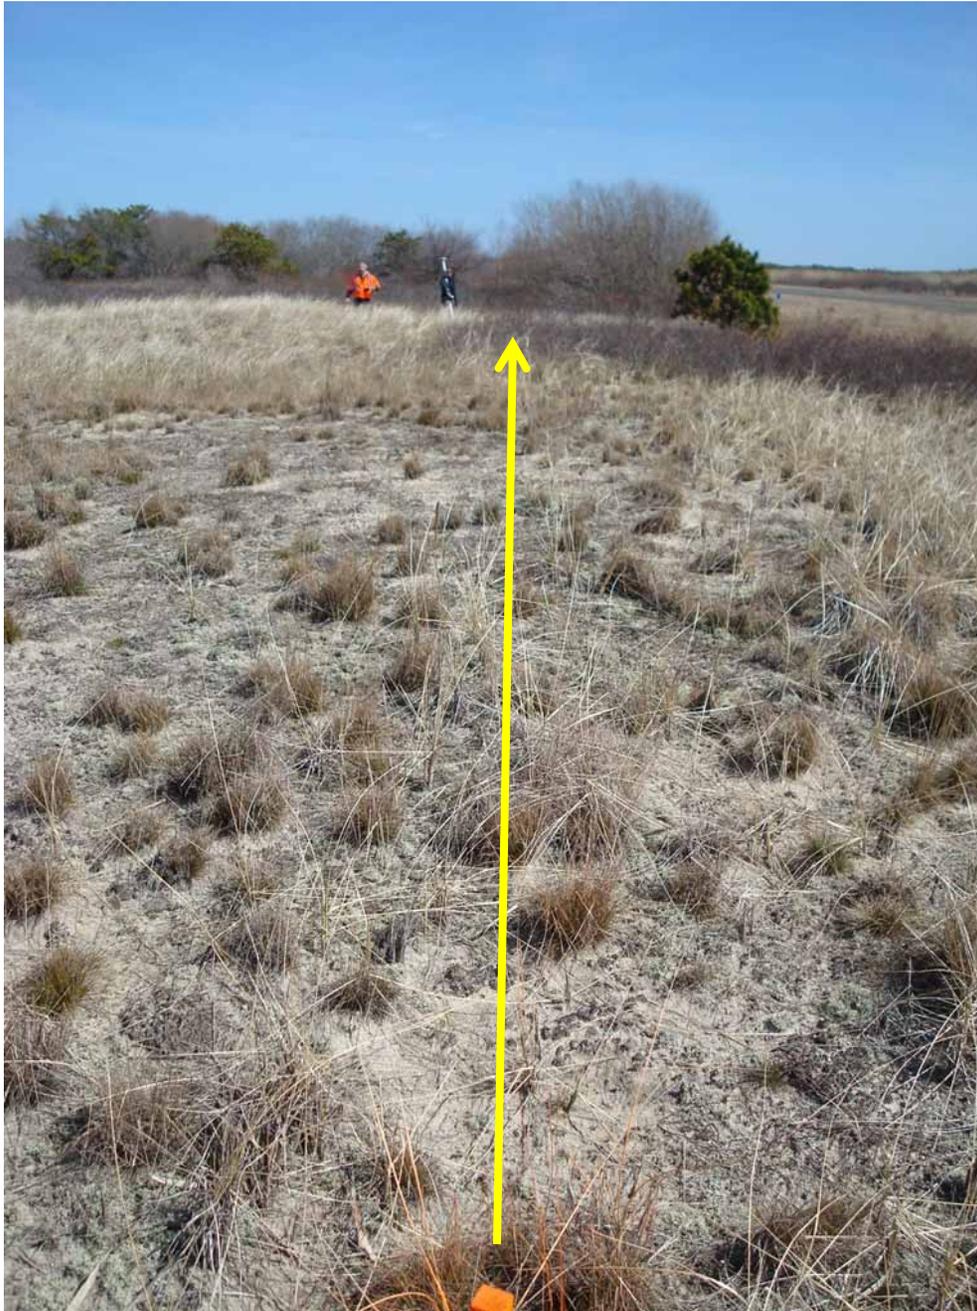
View of approximate location of proposed fence alignment near fence stake #1227 and #1228. Vegetation maintenance will consist of the removal and pruning of larger shrubs, where necessary.

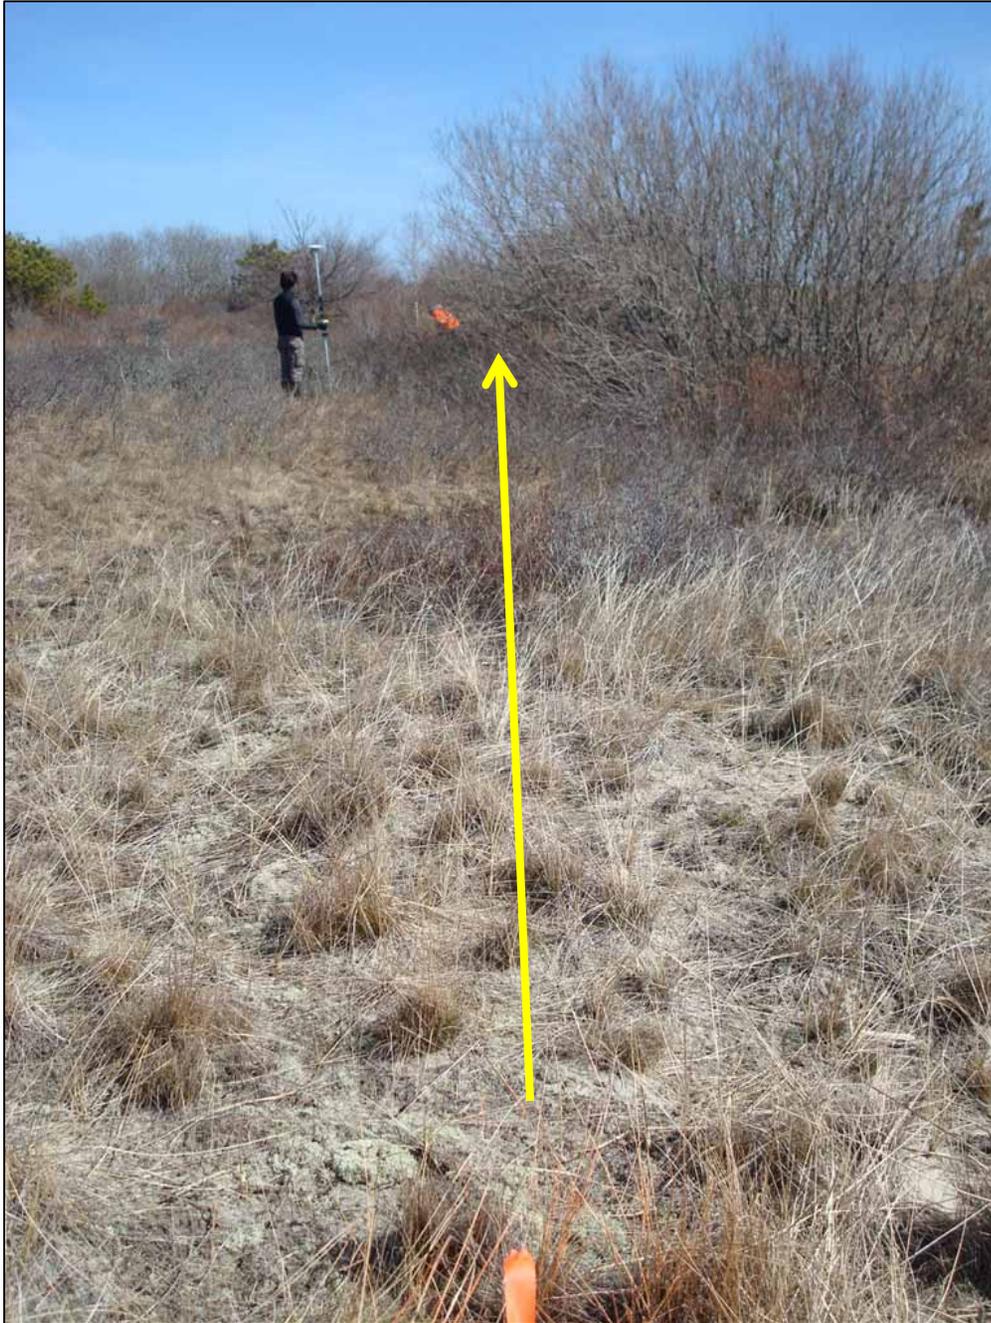
View of approximate location of proposed fence alignment near fence stake #1228. Vegetation maintenance will consist of the removal and pruning of larger shrubs. Shifting the fence alignment to the north 10-15 feet may reduce or eliminate the need for cutting of vegetation in this area.

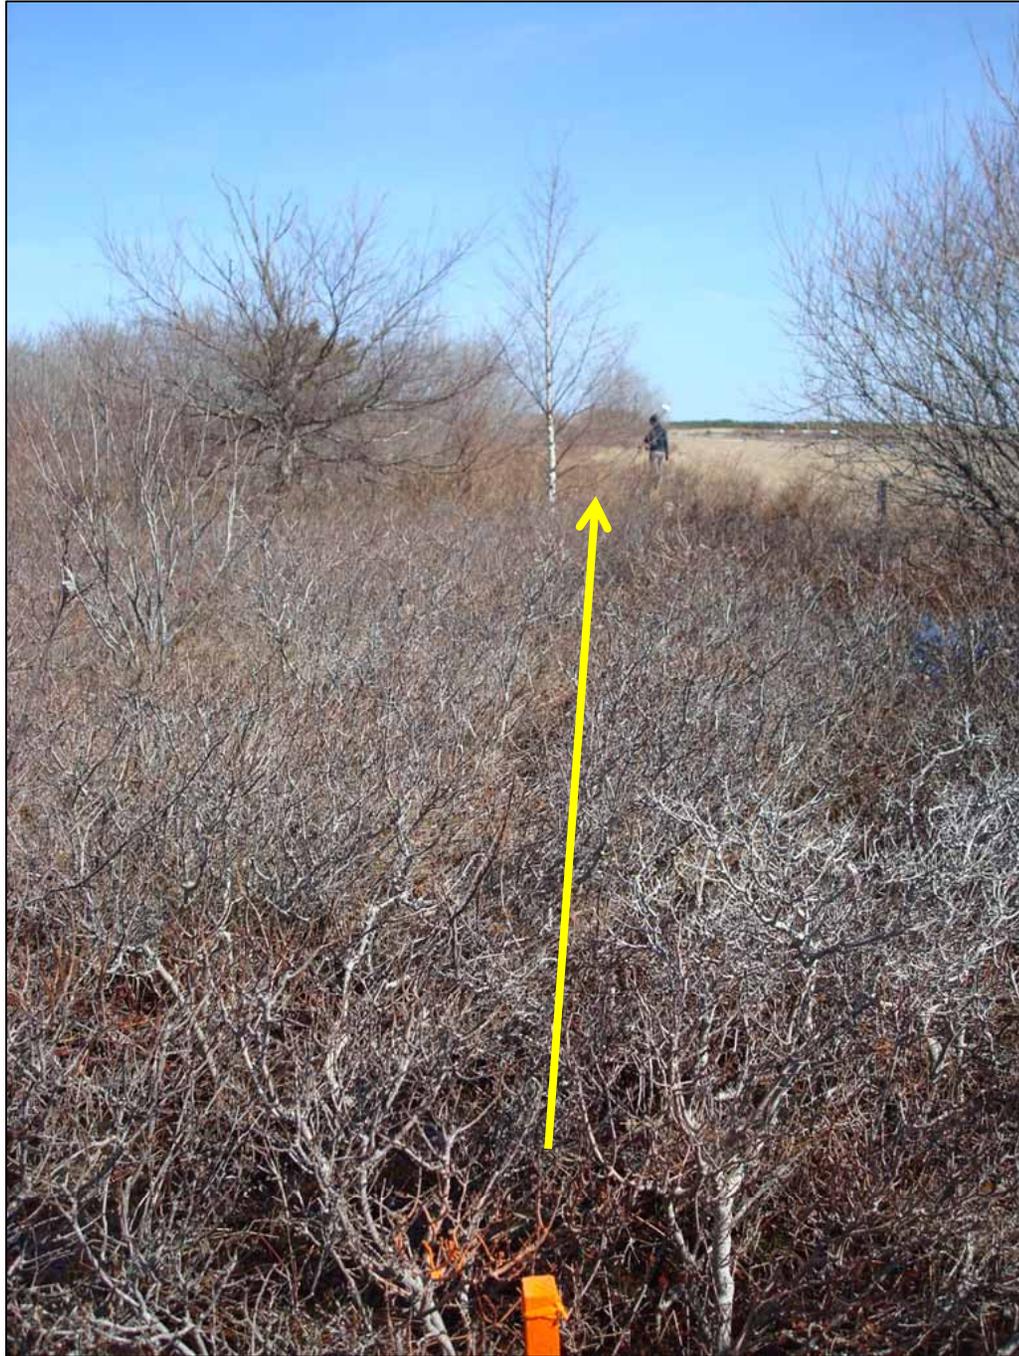
View of approximate location of proposed fence alignment near fence stake #1230. Vegetation maintenance will consist of the removal and pruning of shrubs.

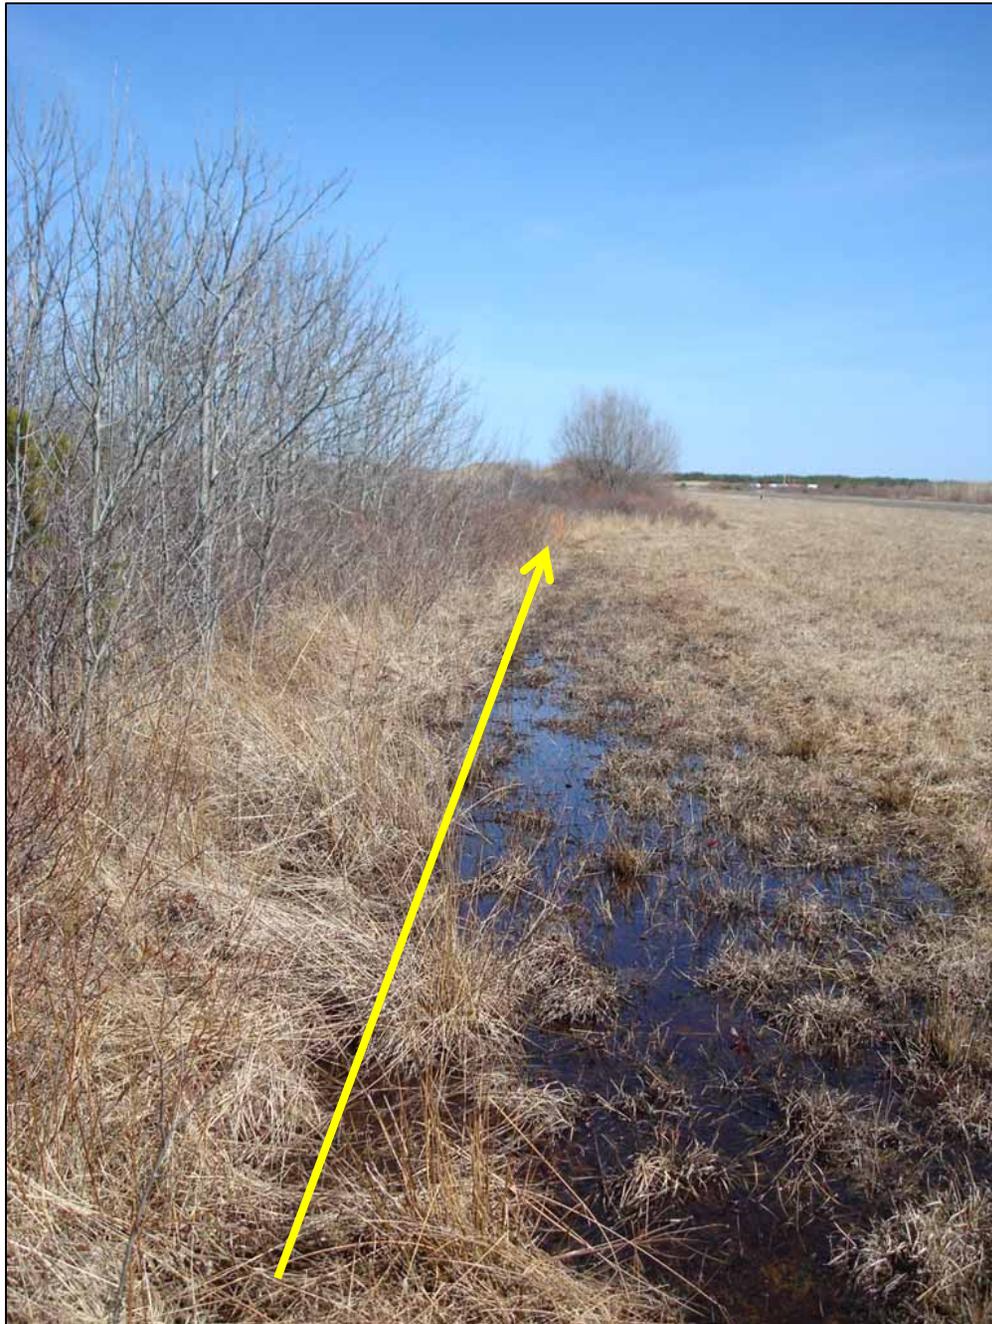
View of approximate location of proposed fence alignment near fence stake #1232. Vegetation maintenance will consist of the removal and pruning of shrubs and saplings along the north (left) side of the proposed fence.
