Proposed Fence Alignment “Concept 6”

Provincetown Municipal Airport
Provincetown, MA

Northern Section

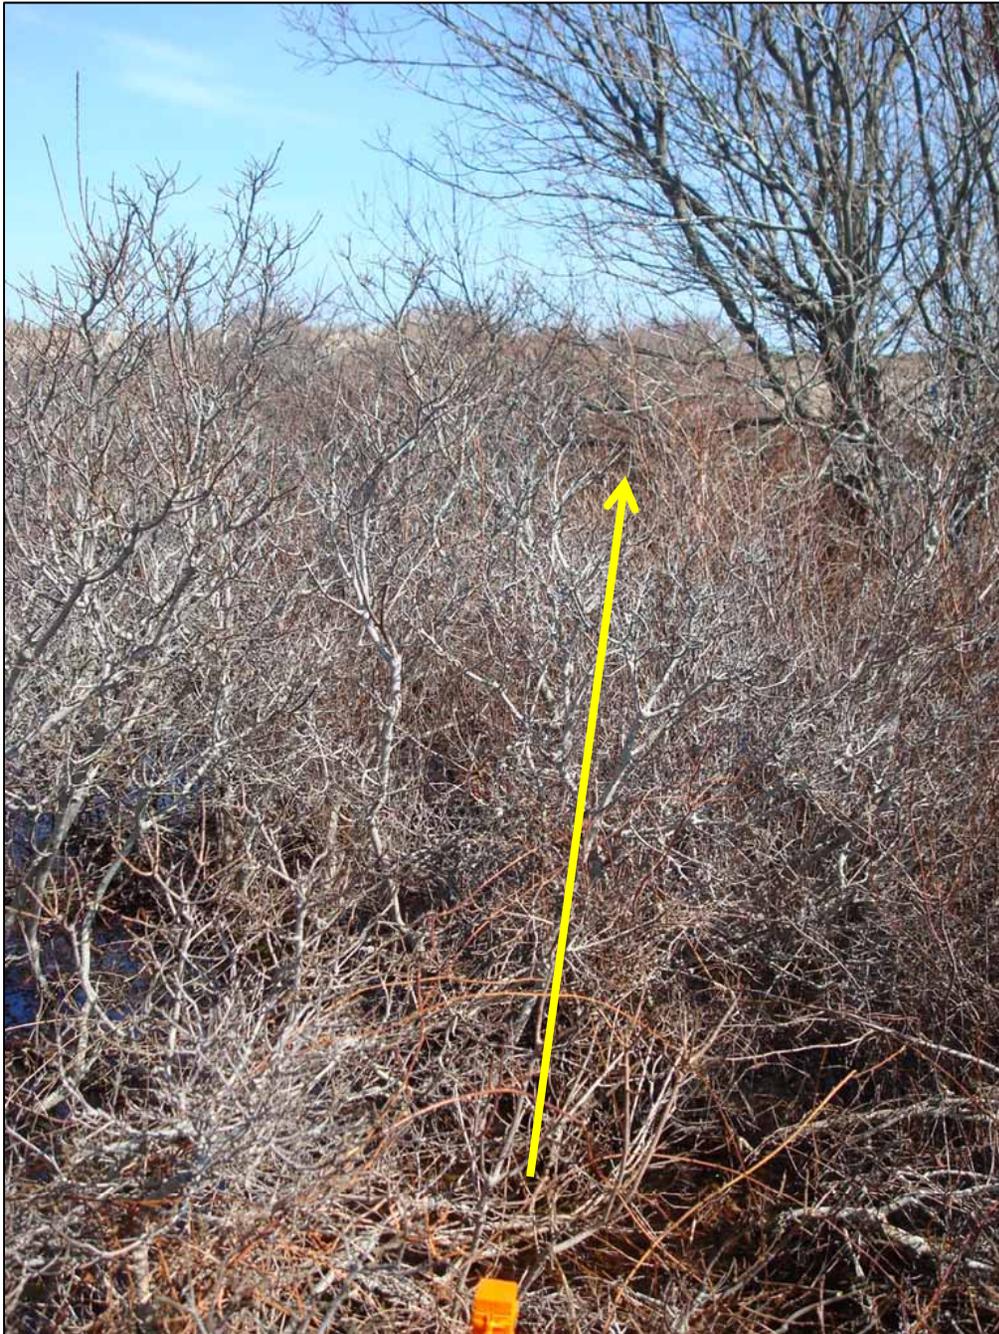
View of approximate location of proposed fence alignment near fence stake #1236. Vegetation maintenance will consist of the removal and pruning of shrubs and saplings.

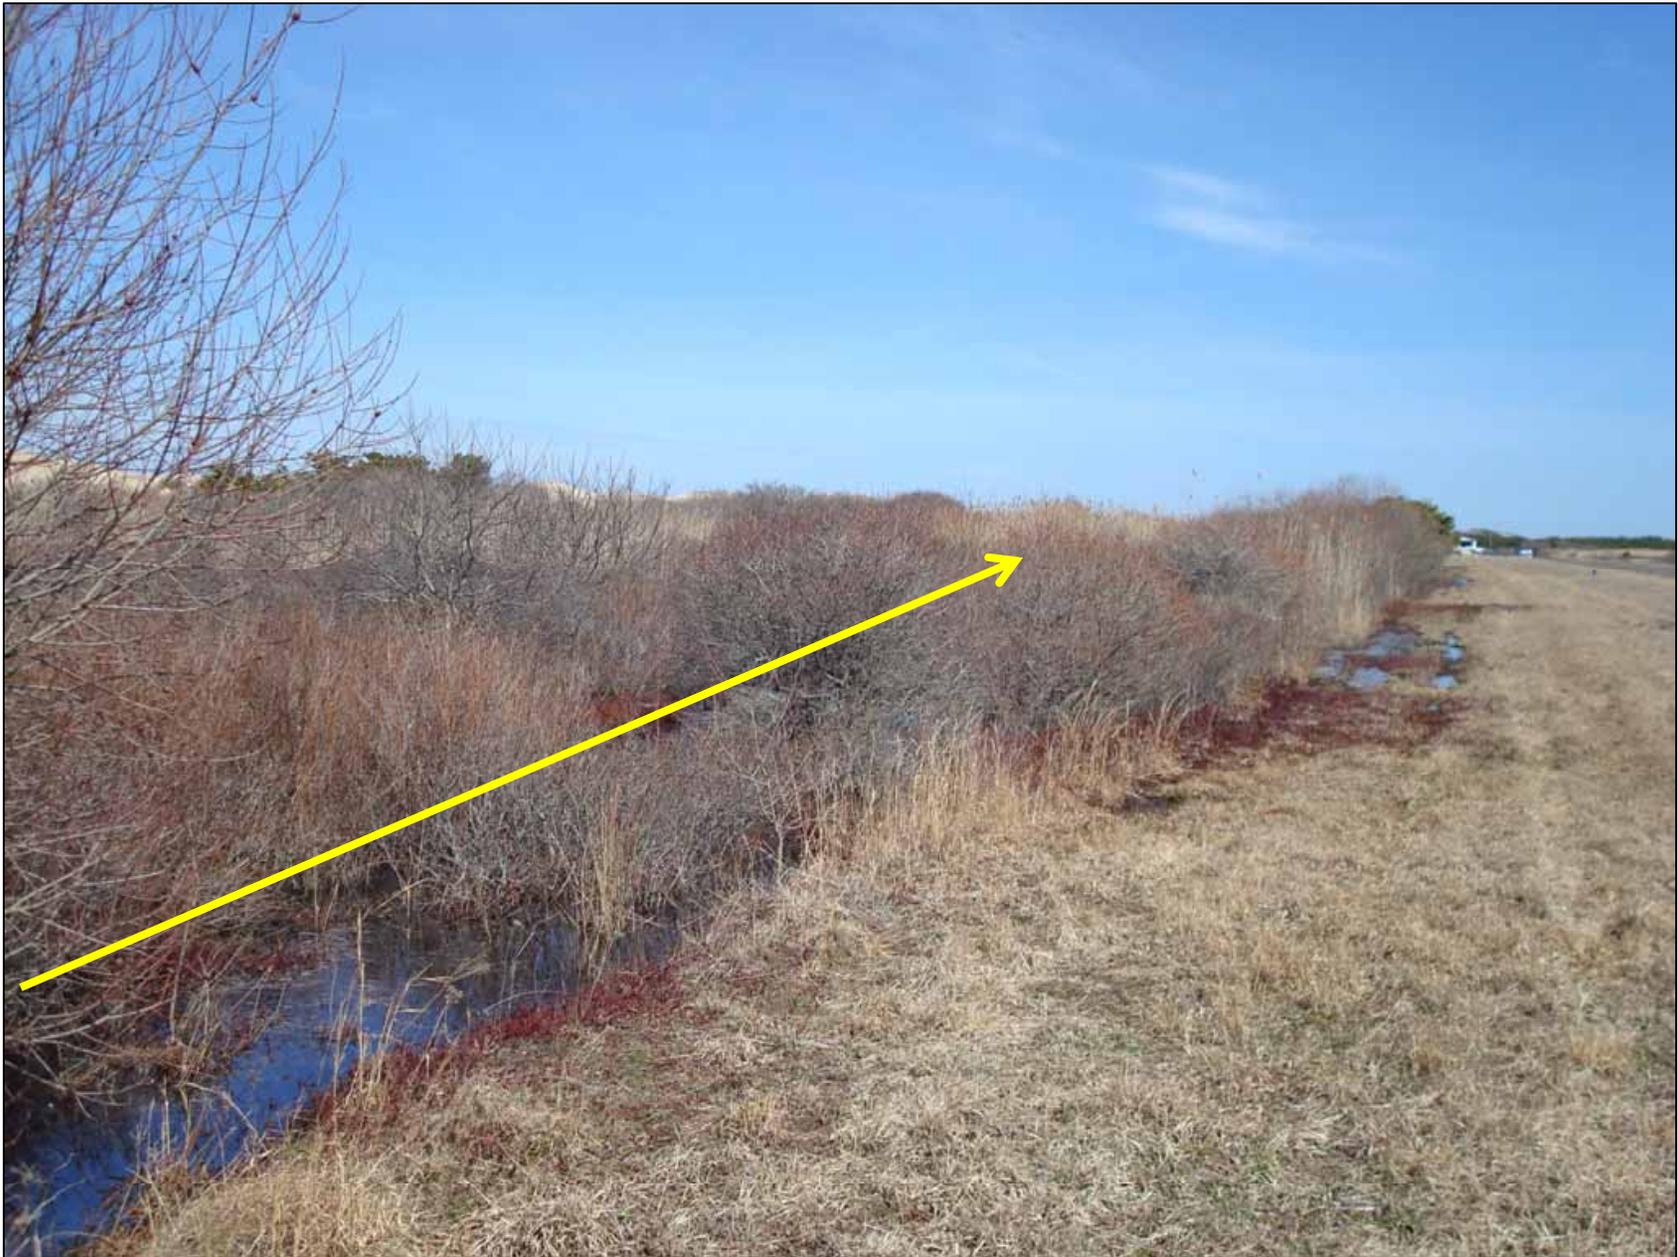
Alternate view of approximate location of proposed fence alignment near fence stake #1236 and #1238 (yellow arrow).
Vegetation maintenance will consist of the removal and pruning of shrubs and saplings.

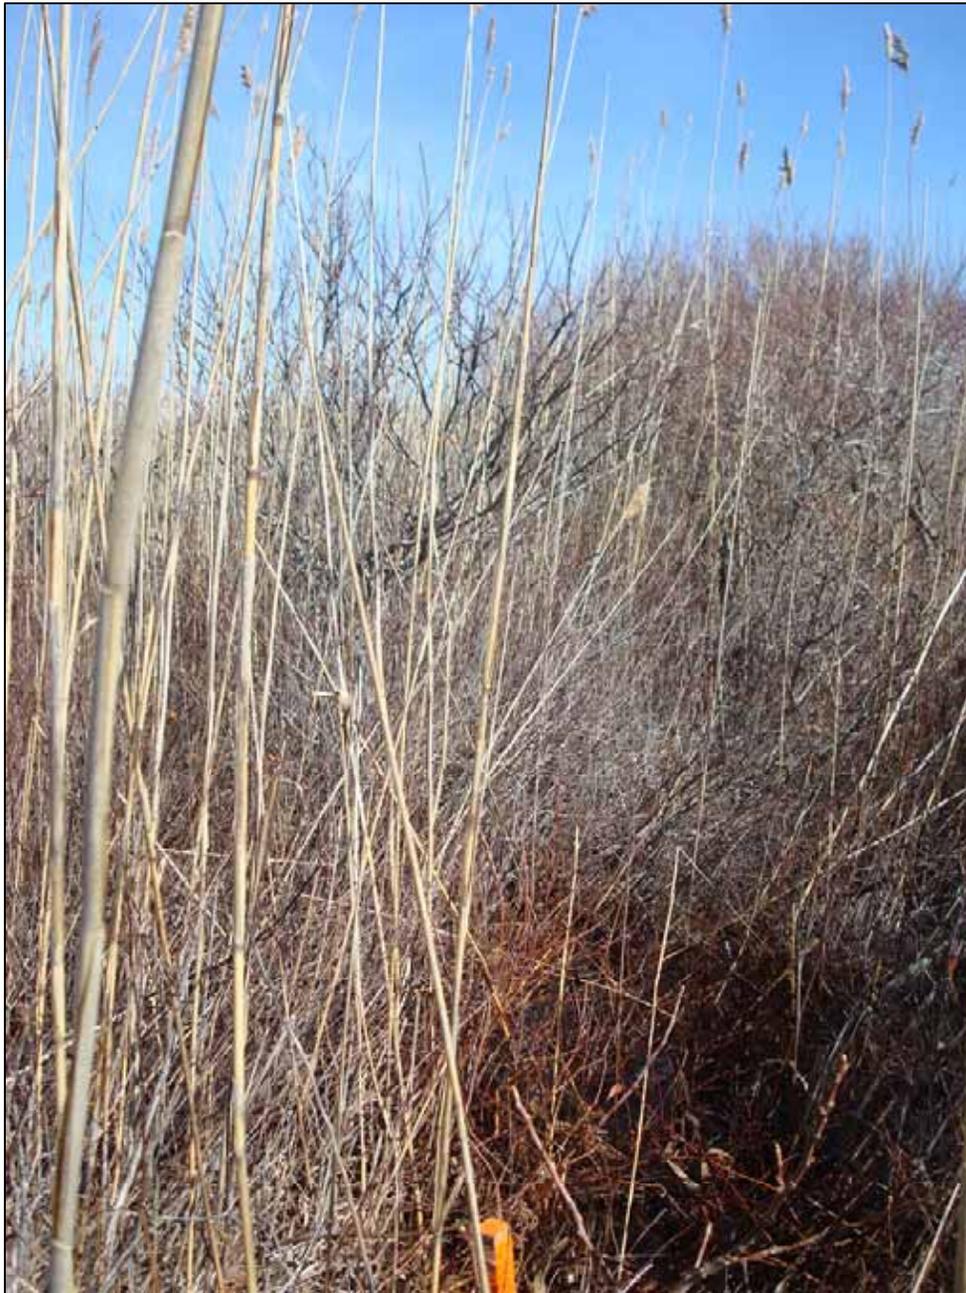
View of approximate location of proposed fence alignment near fence stake #1147. Vegetation maintenance will consist of the removal and pruning of shrubs and saplings. The vegetation in this photo is representative of the vegetation encountered along the alignment up to stake #1160 at the corner of the G/A Apron.

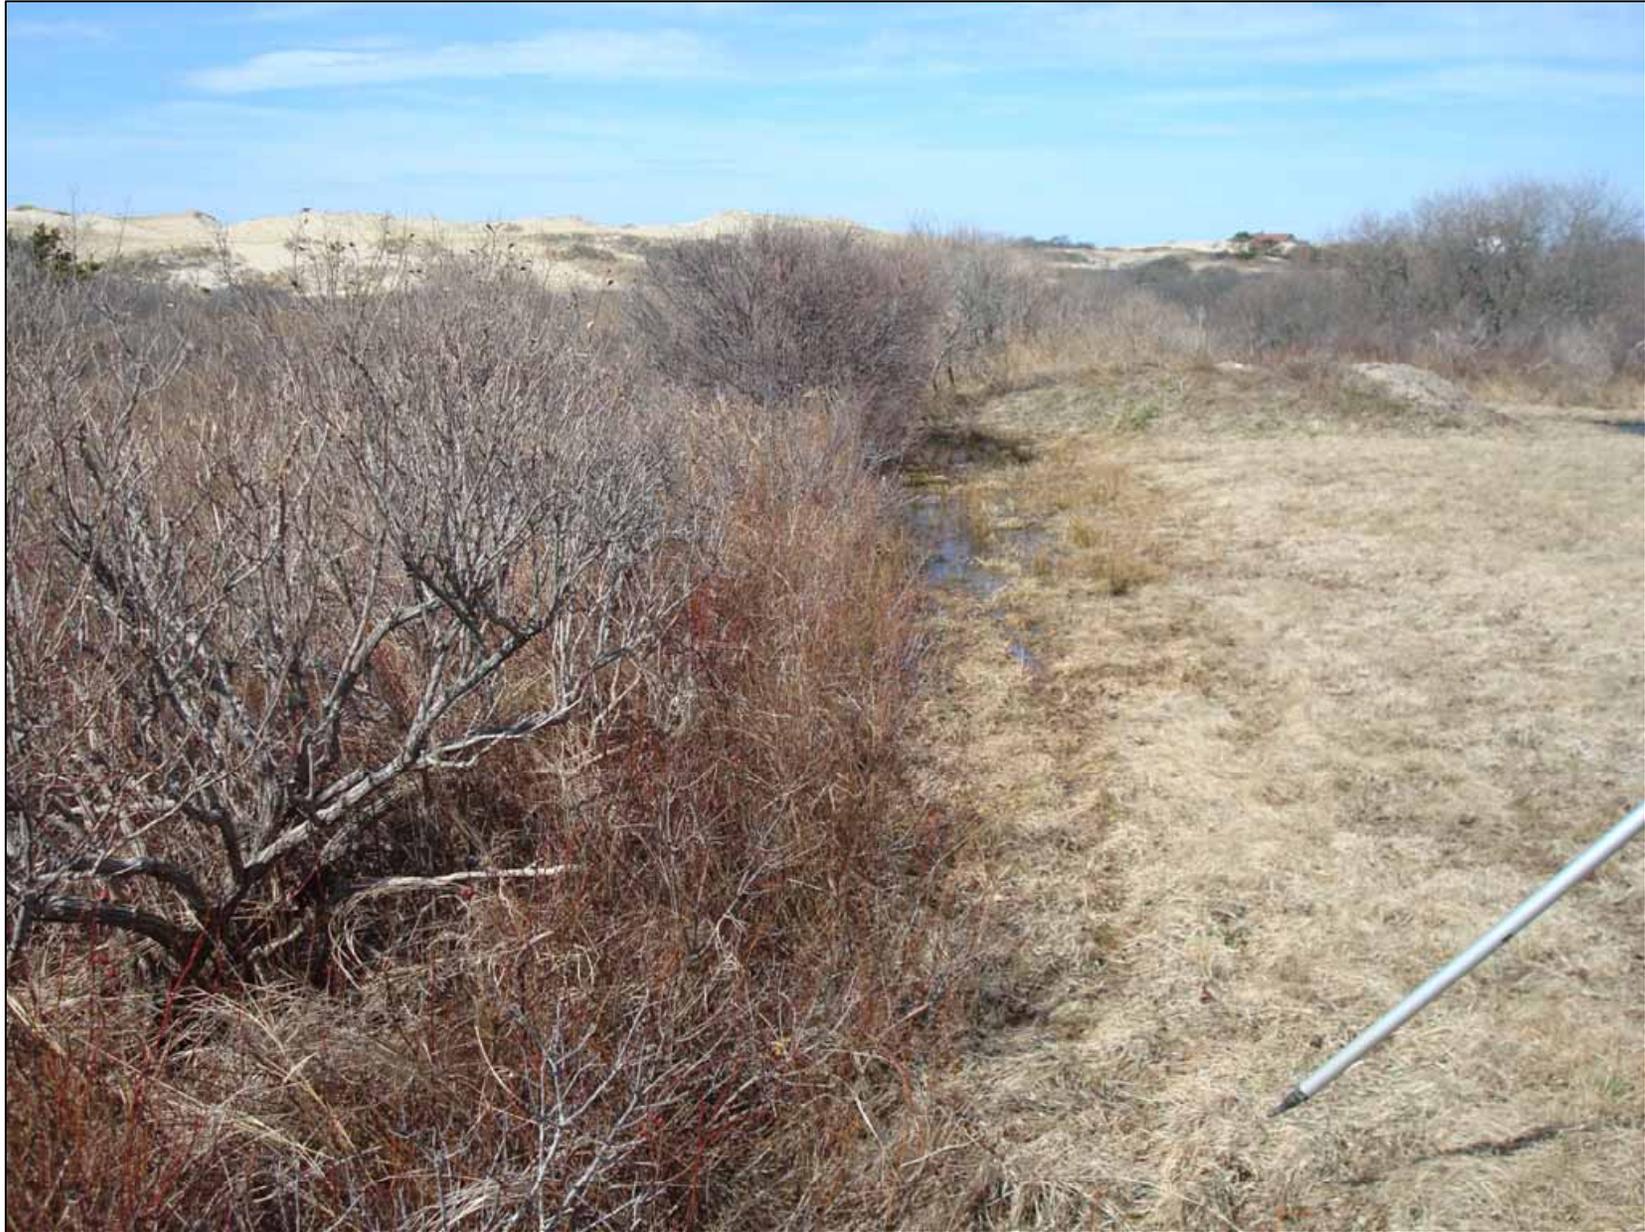
View of approximate location of proposed fence alignment near fence stake #1160 (note orientation is to the north in this photo). Vegetation maintenance will consist of the removal and pruning of shrubs and saplings along the west (left) side of the proposed fence.

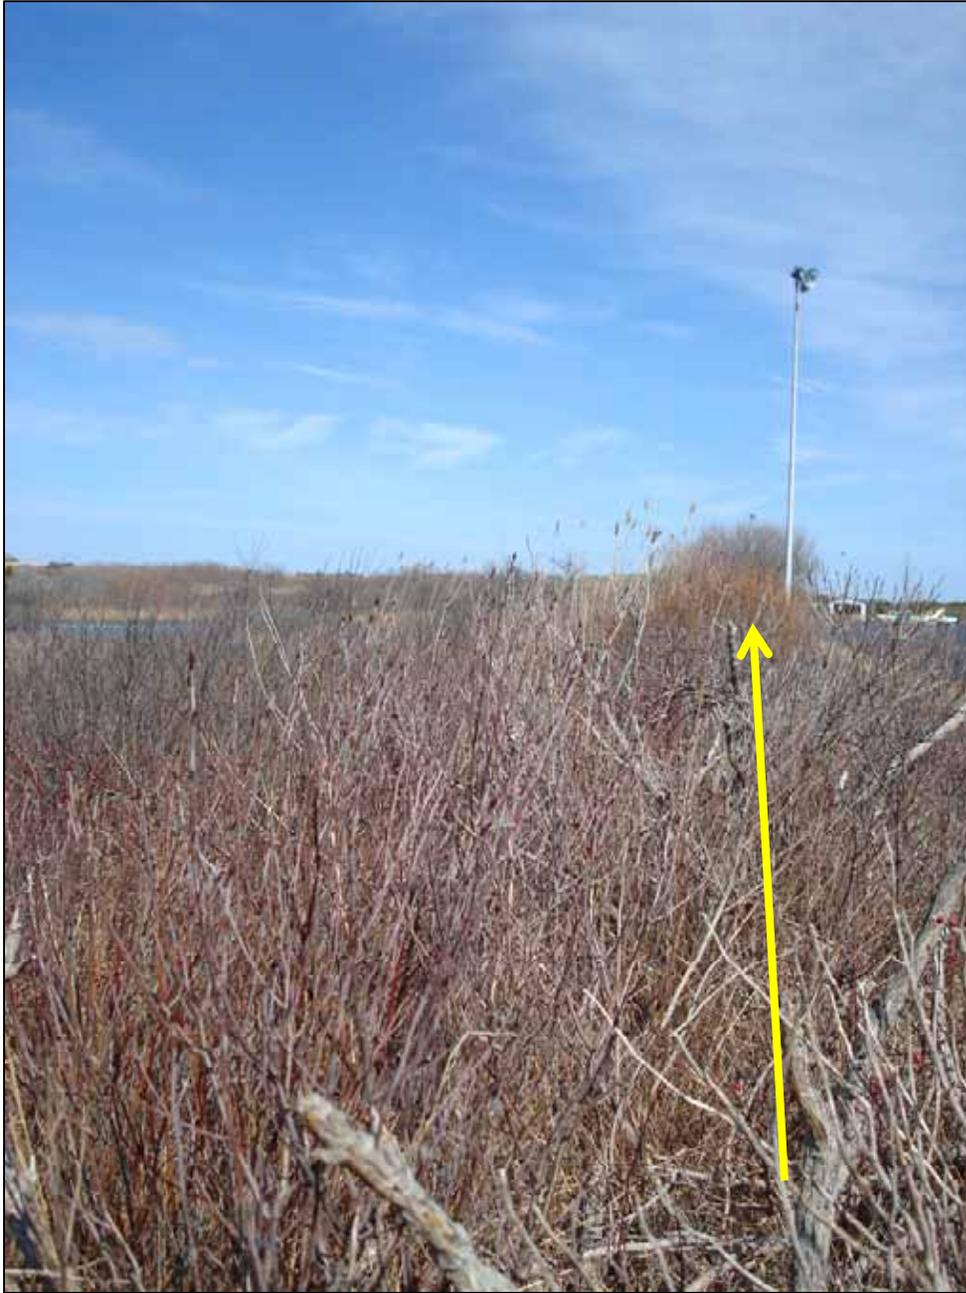
View of approximate location of proposed fence alignment between fence stakes #1162 to #1309 to the rear of the GA Apron. Vegetation maintenance will consist of the removal and pruning of shrubs and saplings along the north (left) side of the proposed fence.

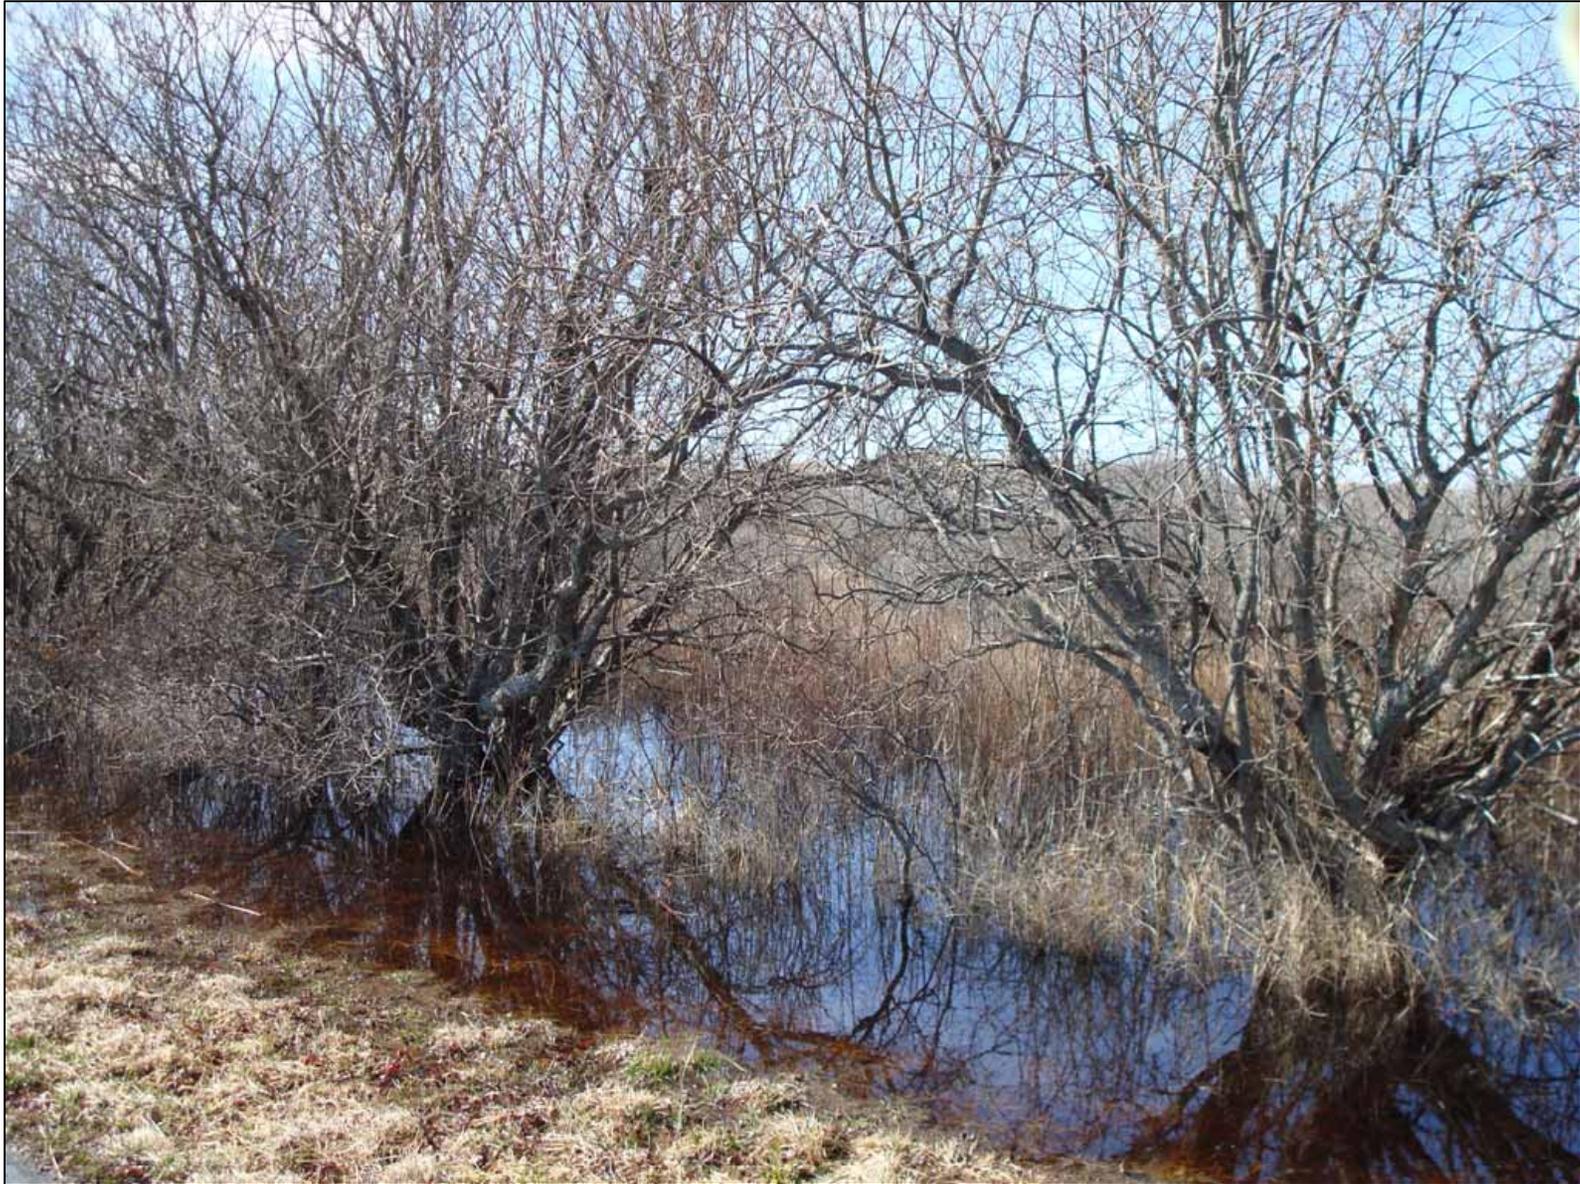
Vegetation along the proposed fence alignment, immediately behind the G/A apron. The fence will run behind the willow shrubs and pruning and selective cutting will be required for fence maintenance. A shift to the north may reduce or eliminate the need for cutting in this location.
