Proposed Fence Alignment “Concept 6”

Provincetown Municipal Airport
Provincetown, MA

“Southern Section”

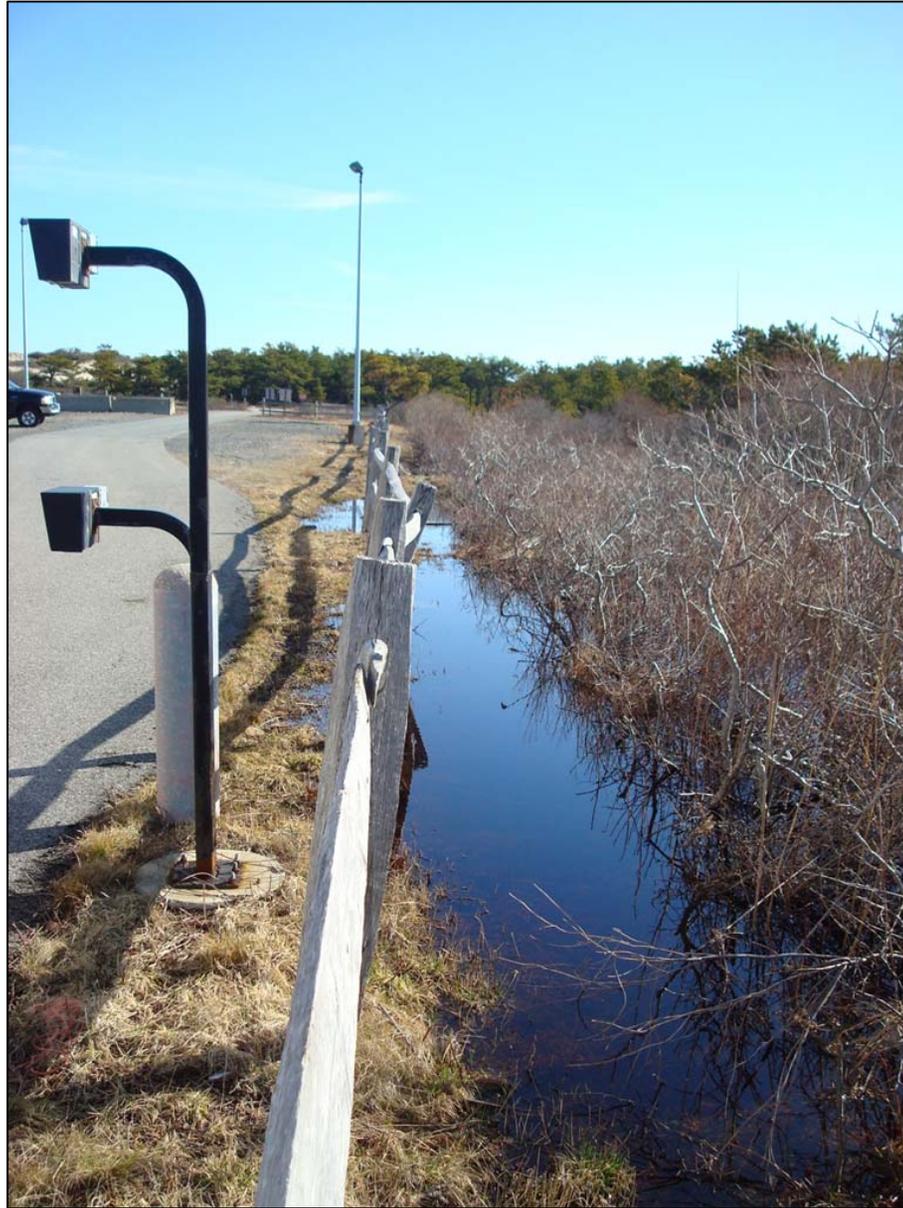
Wetland Area B, looking east. Photo taken at security gate adjacent to hangar building. The proposed fence alignment will coincide with the existing split rail fence. Vegetation removal in this area will not be required.

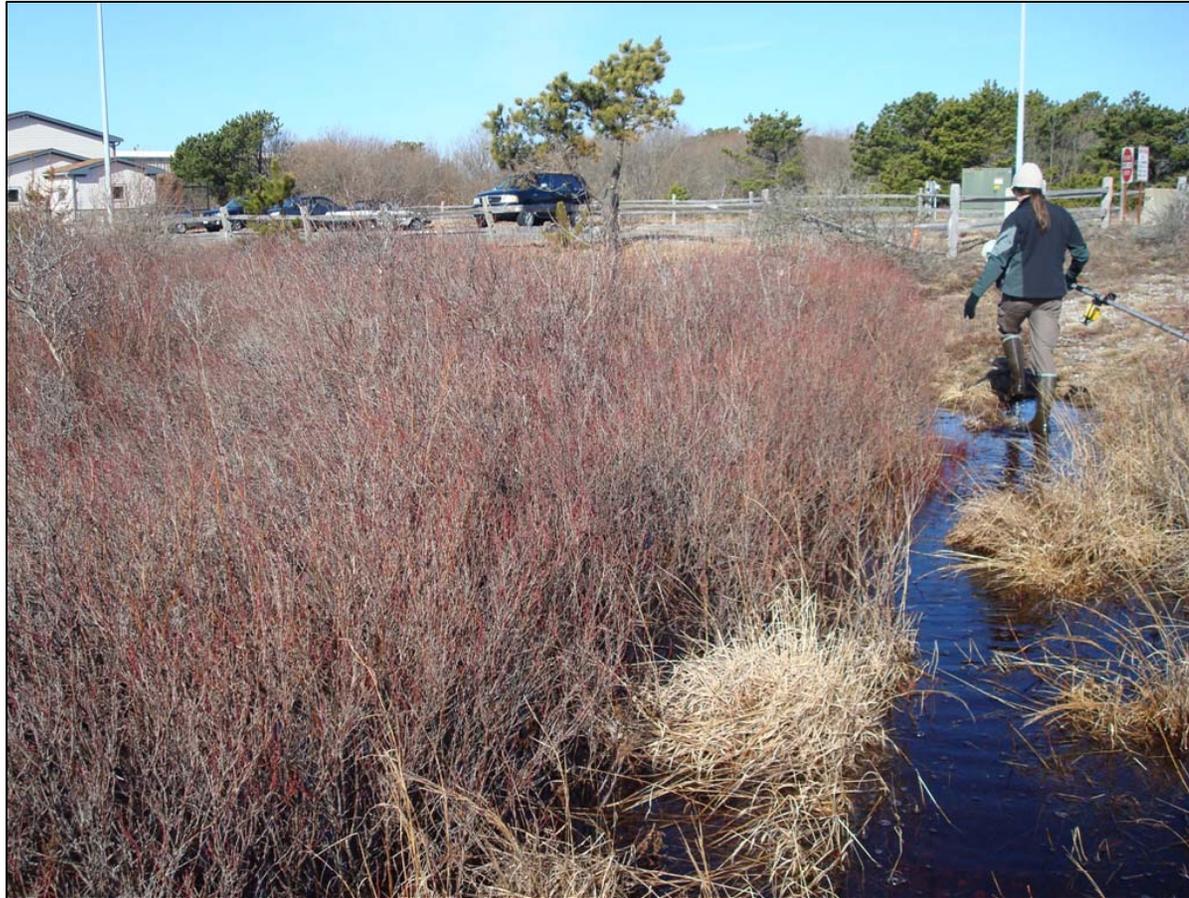
Dense shrub community in Wetland B. The fence will be located along the edge of the shrub line. Looking north. Vegetation cutting will be limited to selective pruning and shrub removal along the south side (left) of the fence.

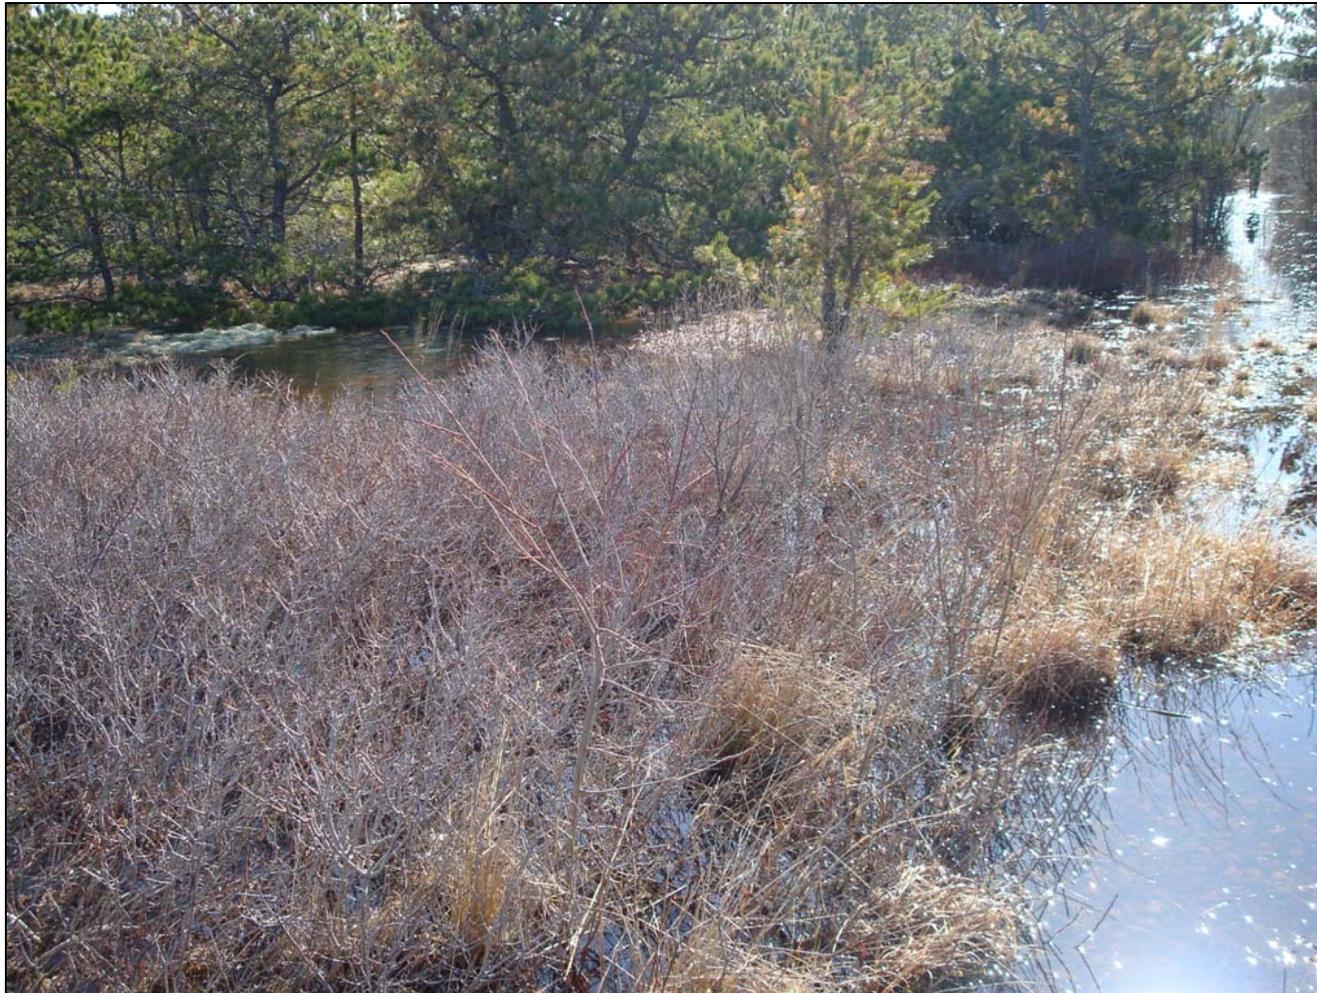
Gravel pathway (submerged) that traverses Wetland B, looking southeast. The fence will be located within the existing pathway and vegetation maintenance will be limited to existing clear areas along the pathway, requiring minimal vegetation removal.

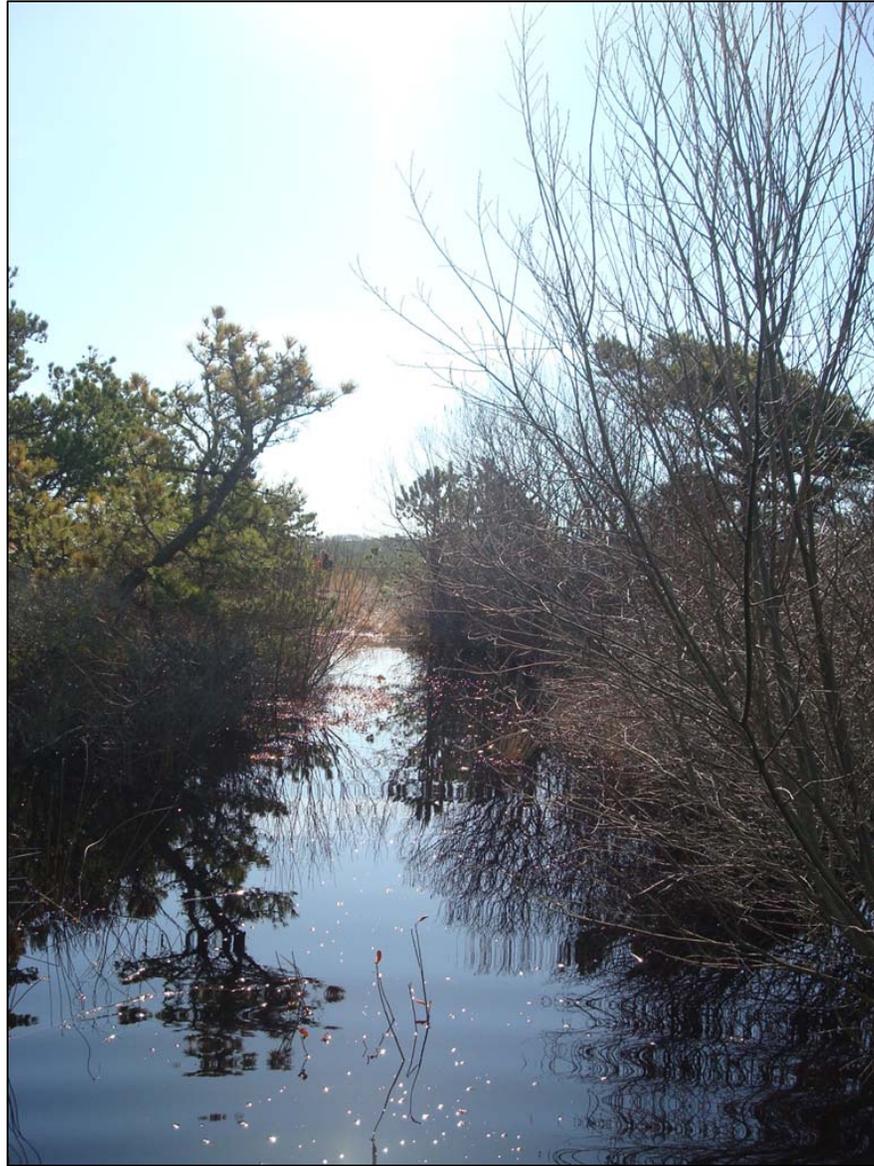
Gravel pathway (submerged) that traverses Wetland B, looking southeast. The fence will be located within the existing pathway and vegetation maintenance will be limited to existing clear areas along the pathway, requiring no vegetation removal. Select branches may need to be trimmed.

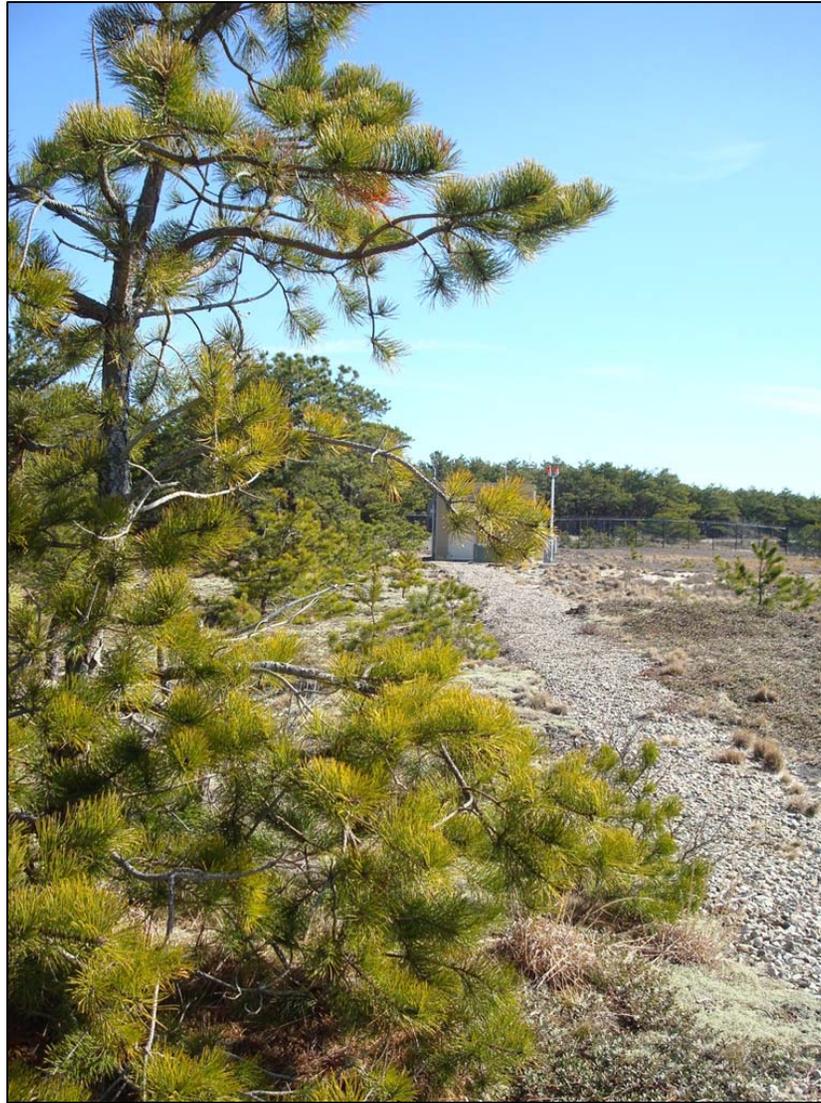
View corridor of proposed fence location, looking northeast. Vegetation removal and long-term maintenance will be limited to pruning of scattered pitch pine within the footprint of the fence. Vegetation is limited to scattered individual pitch pine trees atop open sandy dunes.

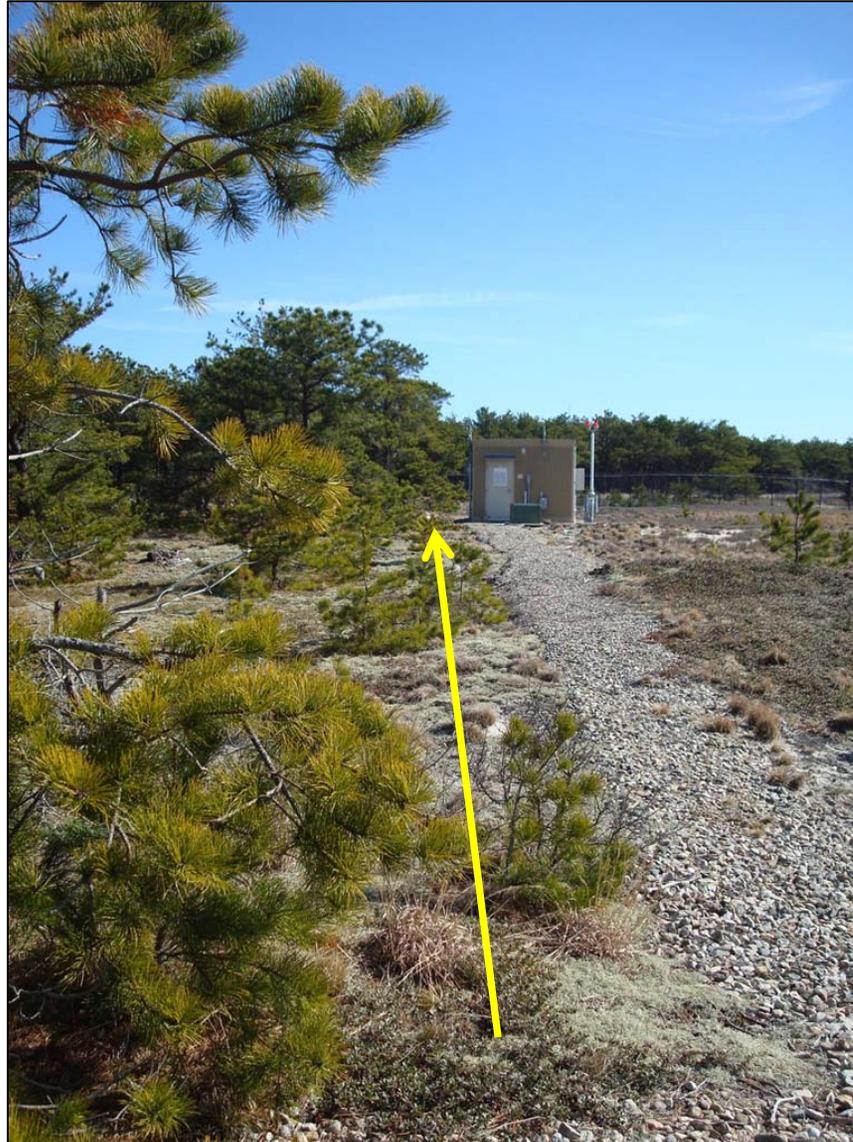
Additional view of proposed fence location (yellow line) between the southern reaches of Wetland B and the airfield, looking northeast. Vegetation removal and long-term maintenance will be limited to pruning of scattered pitch pine within the footprint of the fence. Vegetation is limited to scattered individual pitch pine trees atop open sandy dunes.

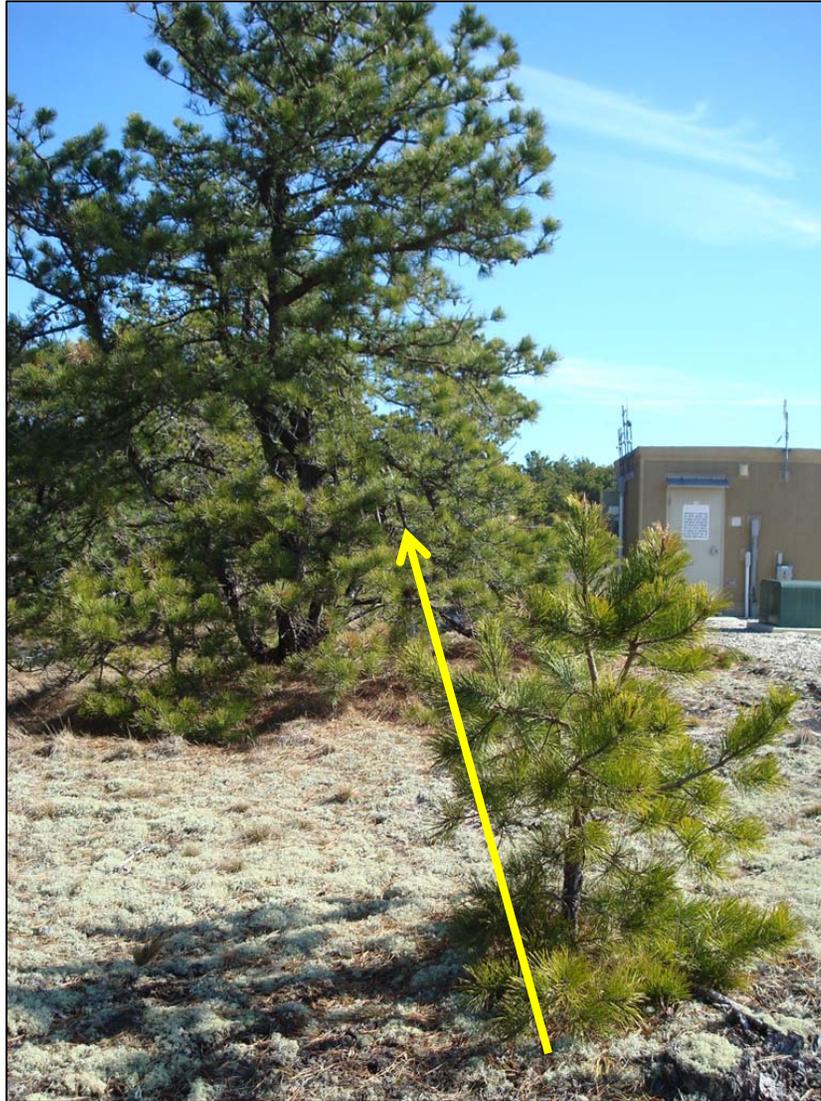
View of proposed fence location (yellow arrow) between the southern reaches of Wetland B and the airfield, looking northeast. Vegetation removal and long-term maintenance will be limited to pruning limbs of scattered pitch pine and removal of pitch pine seedlings within the footprint of the fence. Vegetation is limited to scattered individual pitch pine atop open sandy dunes in this area.

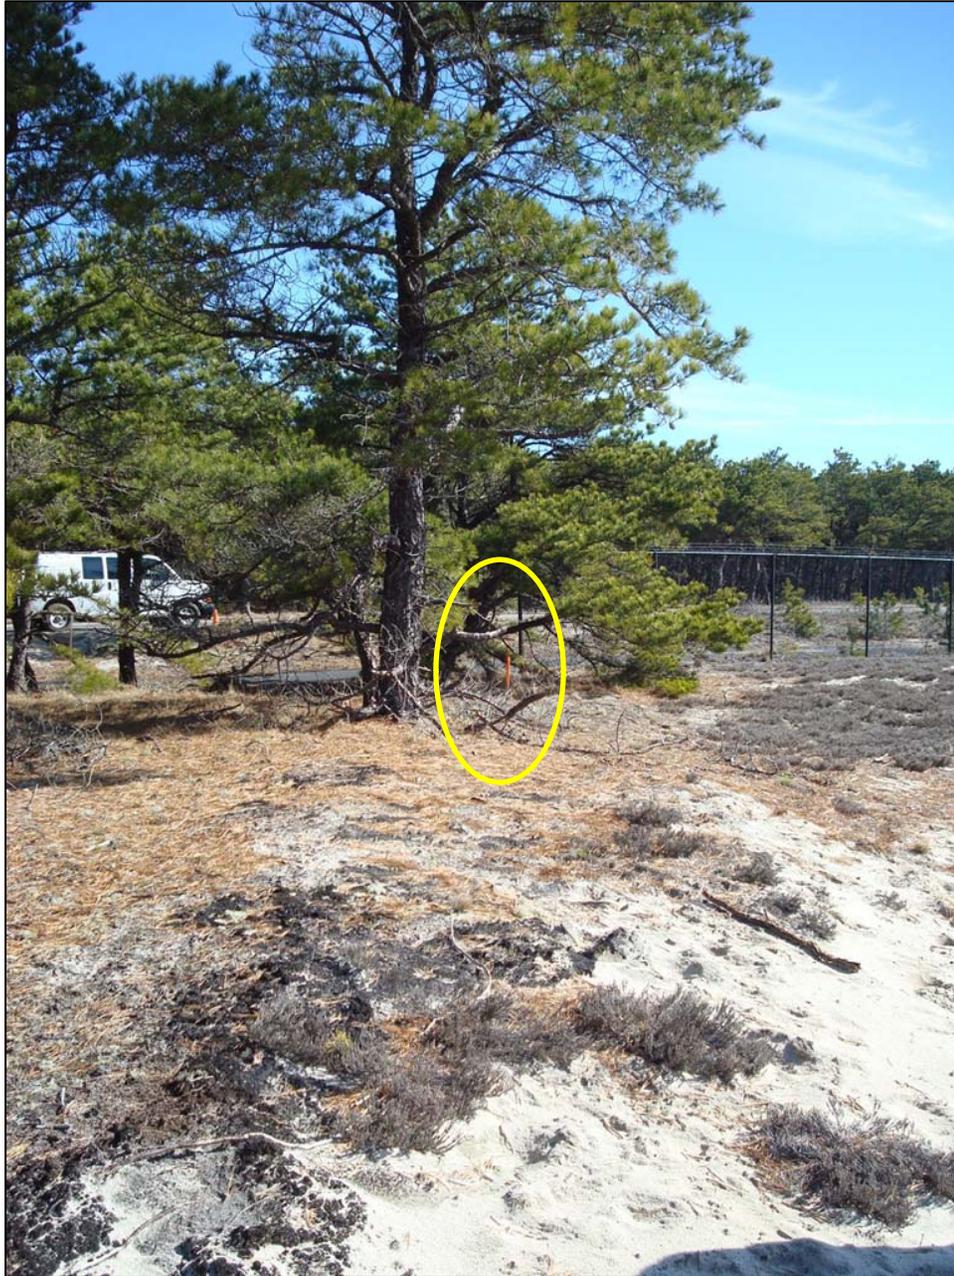
View of proposed fence location south of Wetland B and perpendicular to the bike path and existing fence segment (looking northeast). Note orange survey stake demarcating location of fence line where fence will connect to existing fence segment. Vegetation removal and long-term maintenance will be limited to pruning limbs of the pitch pine adjacent to the stake, so as to prevent the tree from growing into the fence.

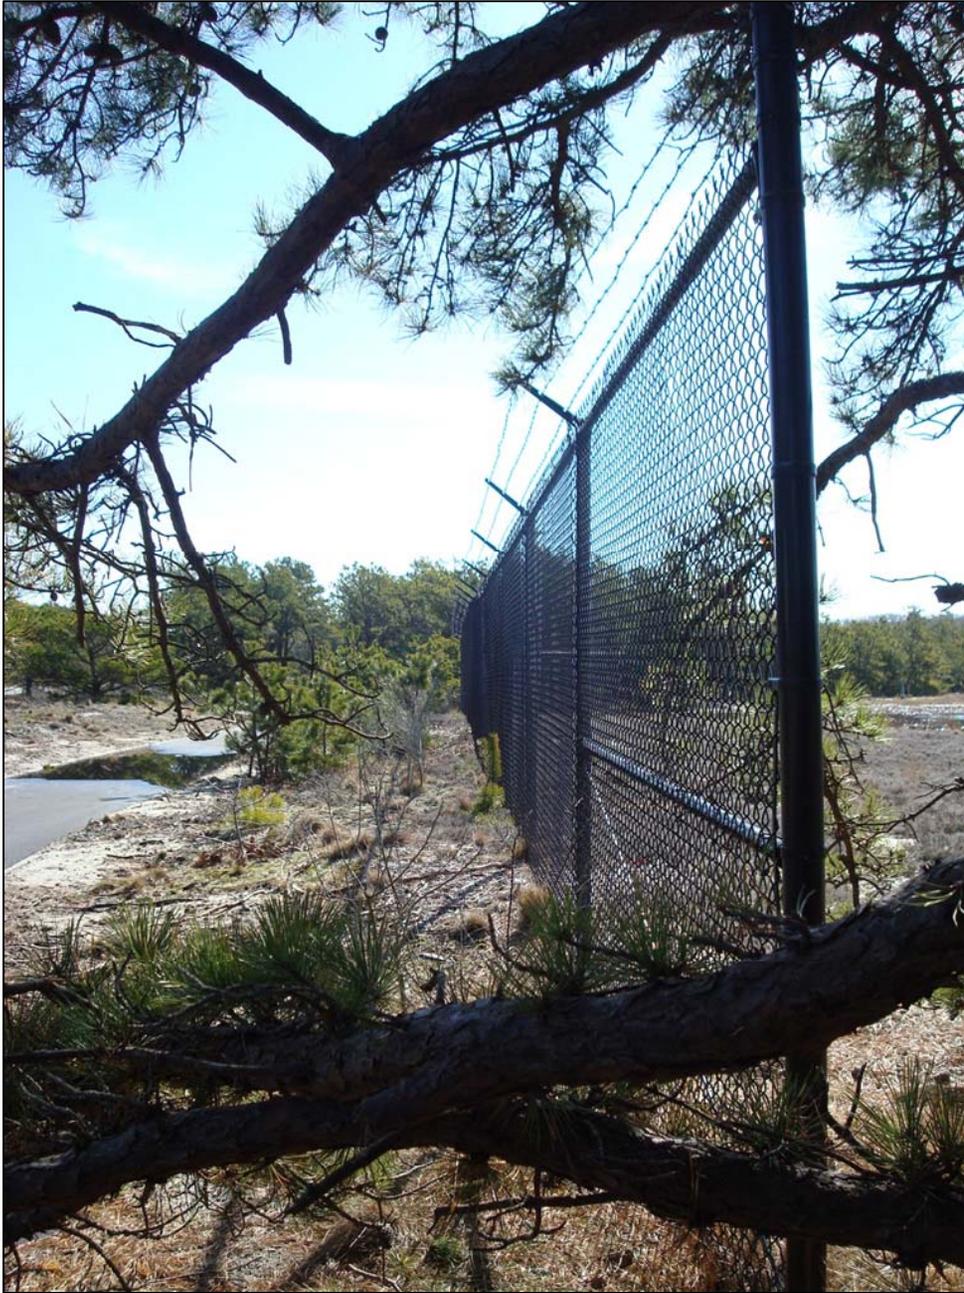
Segment of existing fence segment north of localizer antenna and airfield. The bike path is visible to the left of the fence. The proposed fence will join the existing fence pole in the foreground.

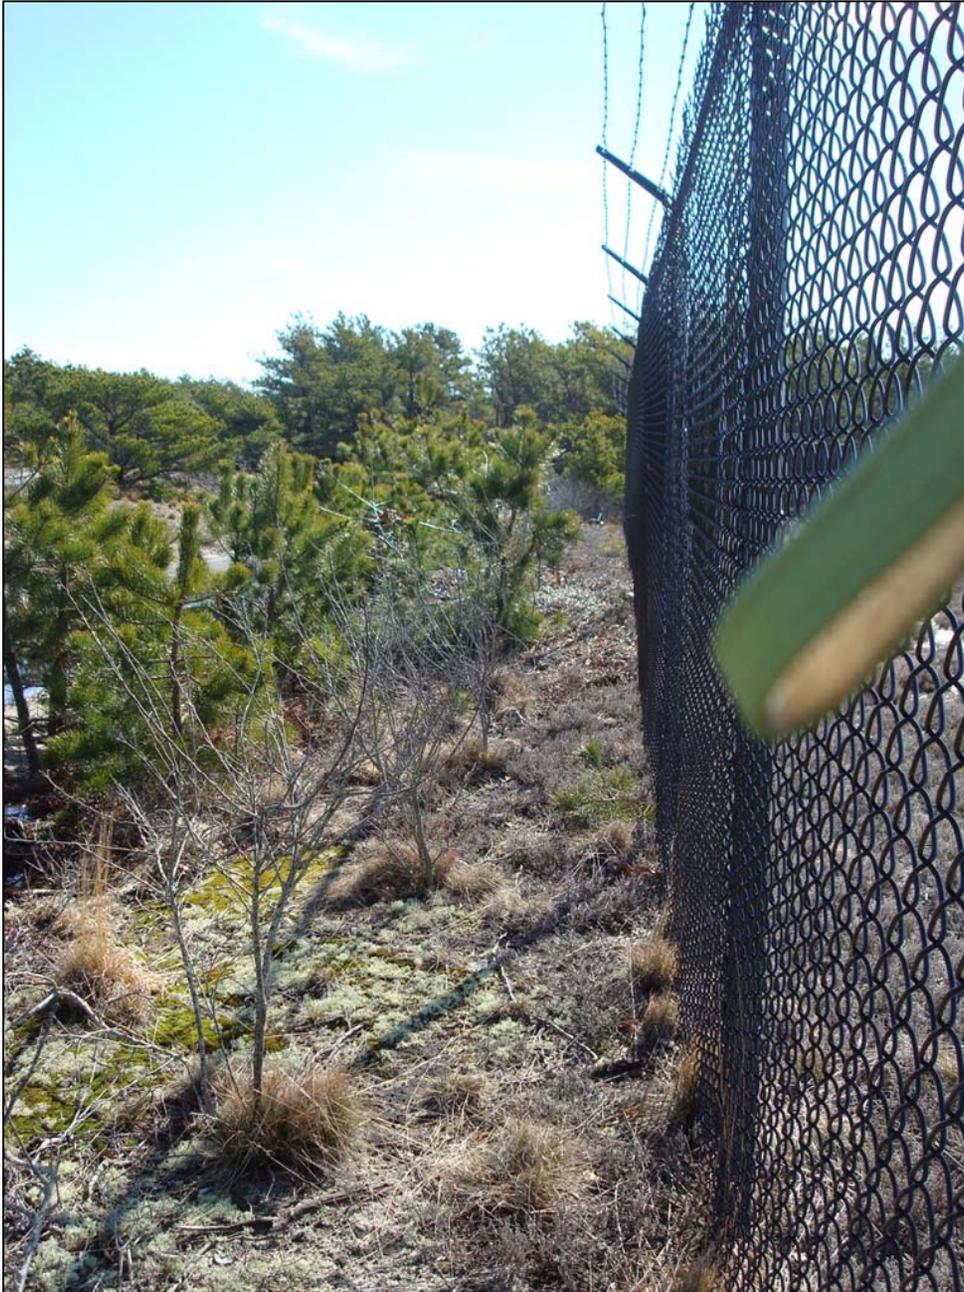
Existing fence segment along bike path to the north of the airfield and localizer antenna, looking southeast. Note existing managed vegetation.

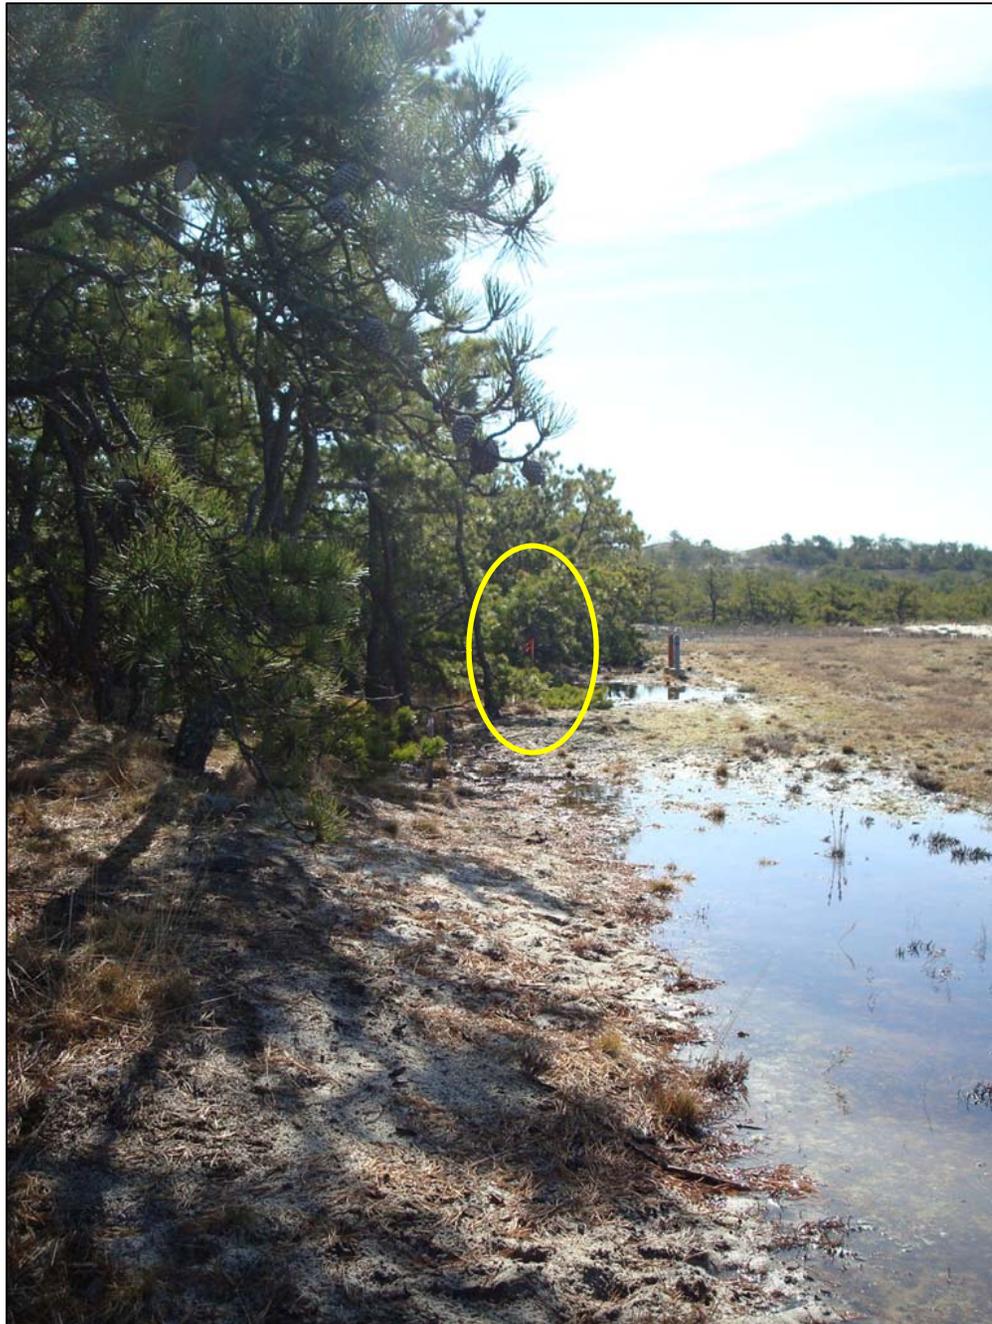
Additional view of existing fence segment.
Proposed fence will join the end of this fence
section at the treeline inside the airfield.

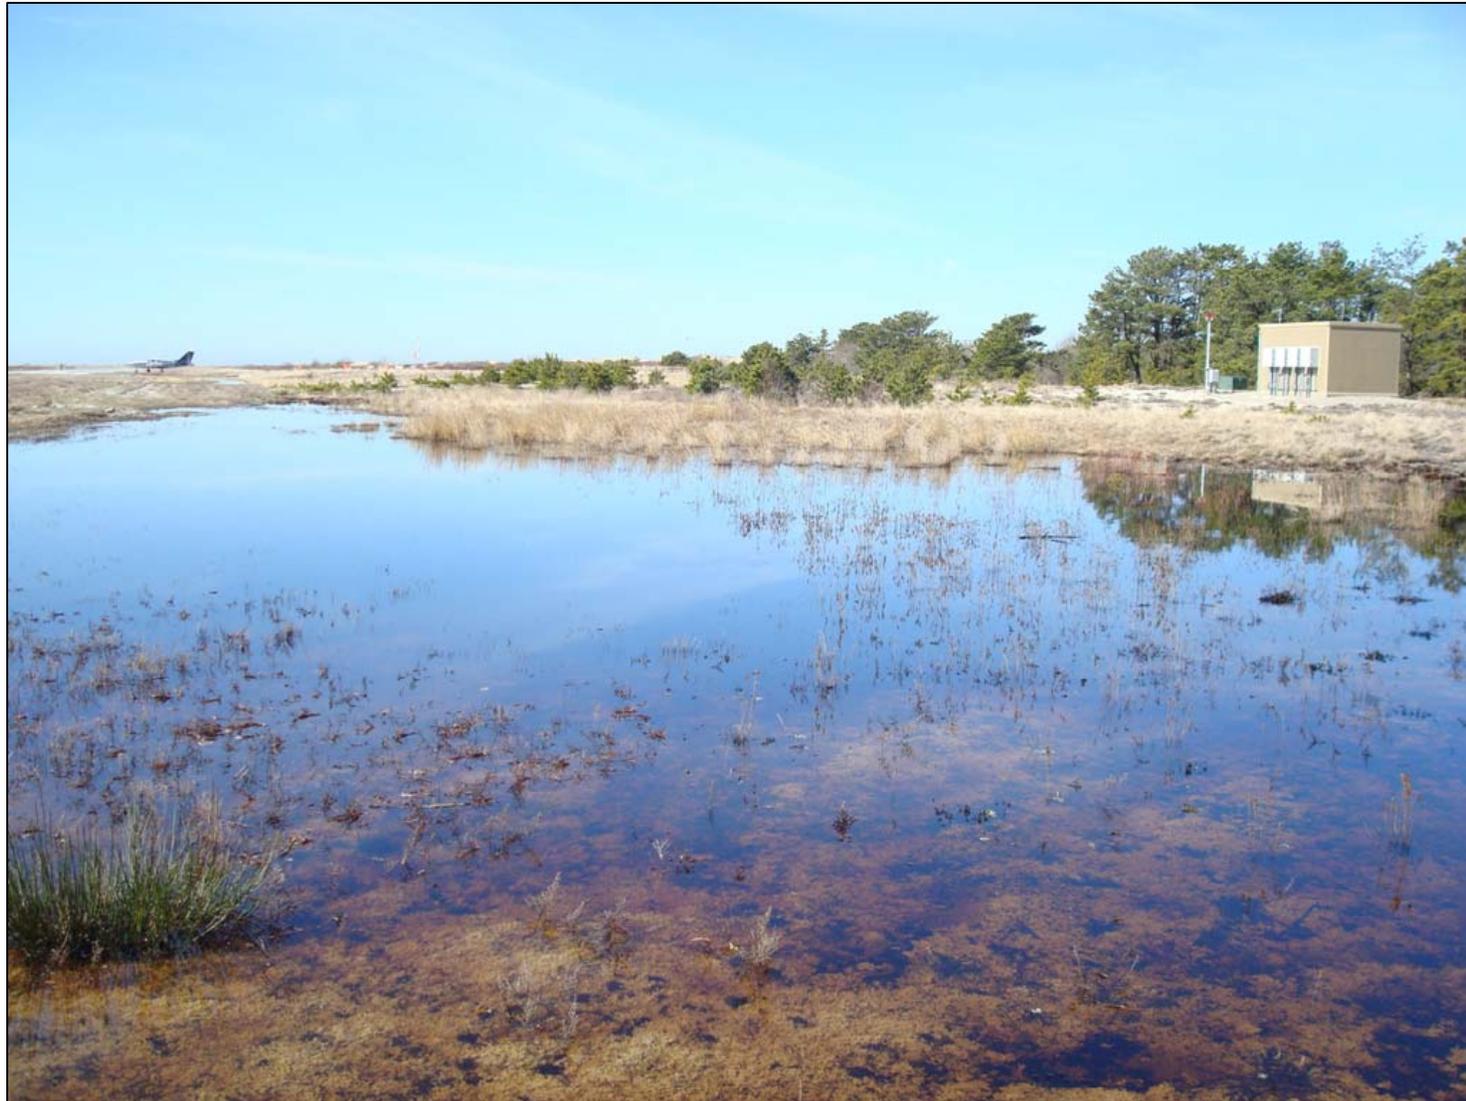
Proposed location for Fence Concept 6. Photo taken from the end of the existing fence segment looking southeast. Note orange survey stake marking fence alignment that will generally follow the sandy area outside the treeline. Vegetation maintenance will be limited to pruning of pitch pine limbs and selective removal of individual trees on the north (forested) side of the fence only. Vegetation removal will not be necessary along the airfield side of the fence.

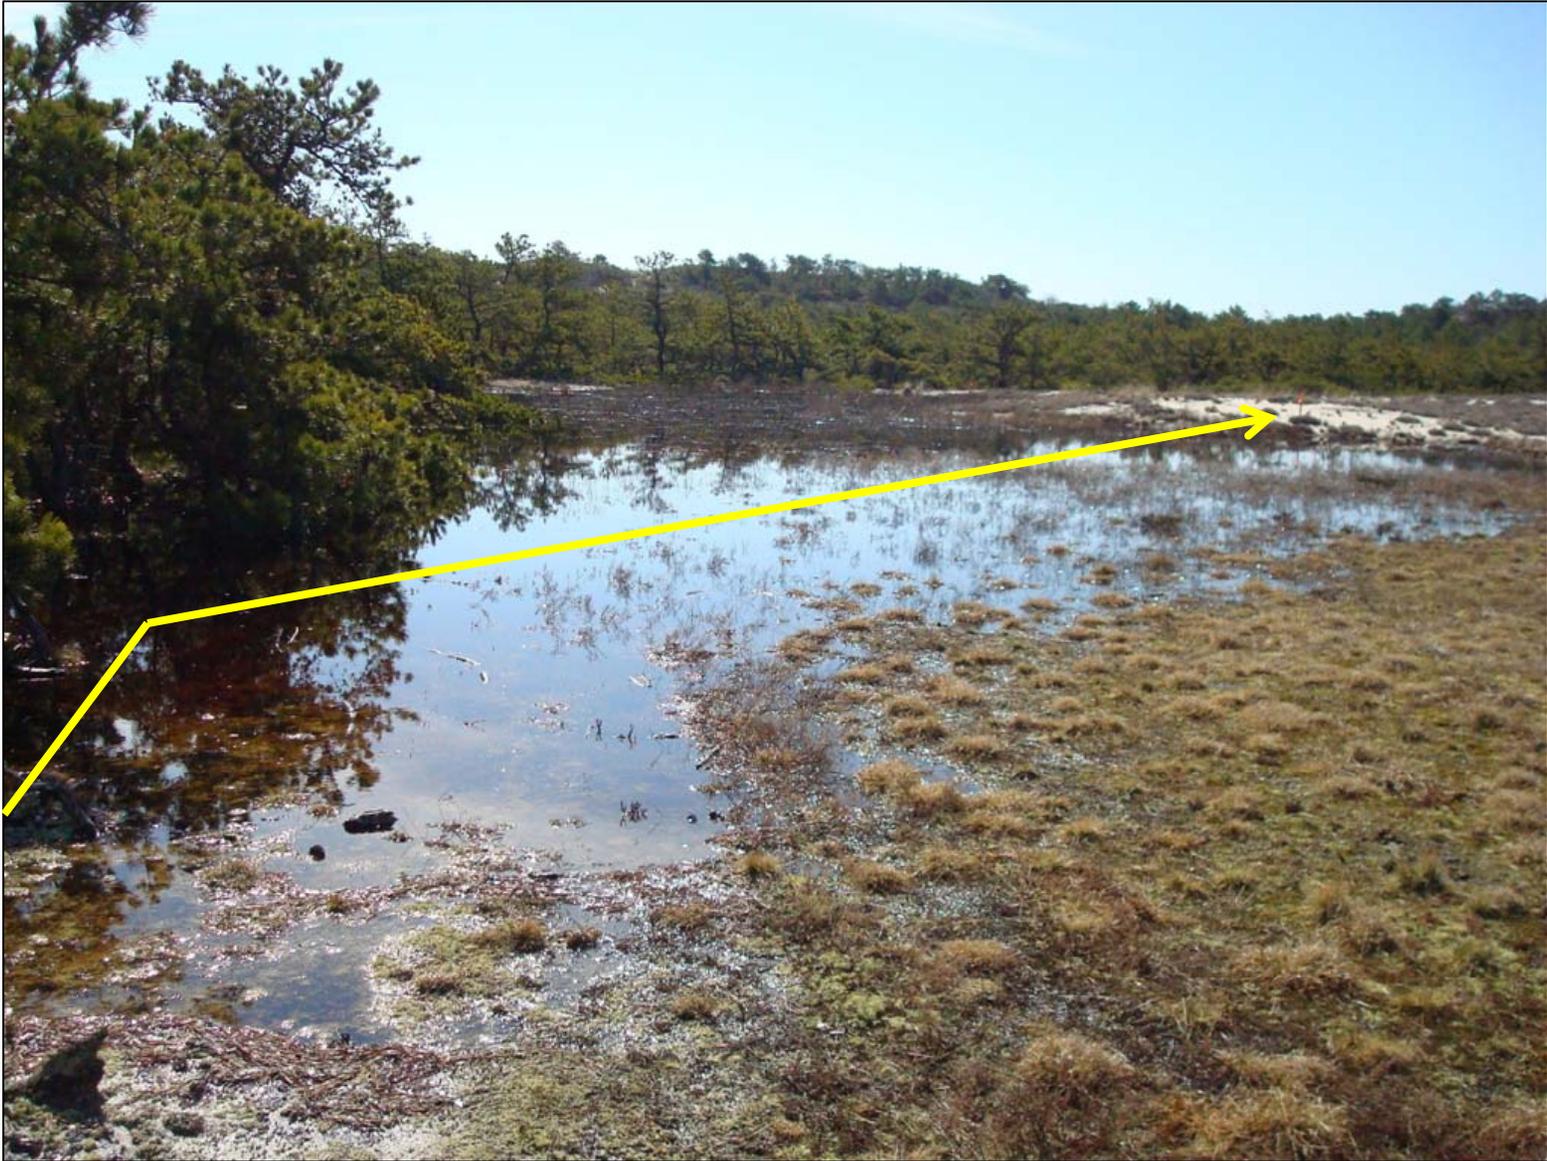
Water levels observed during the site visits on March 17th and 18th, 2010. Large amounts of precipitation were received, in excess of 7 inches. Groundwater is also at a seasonal high.

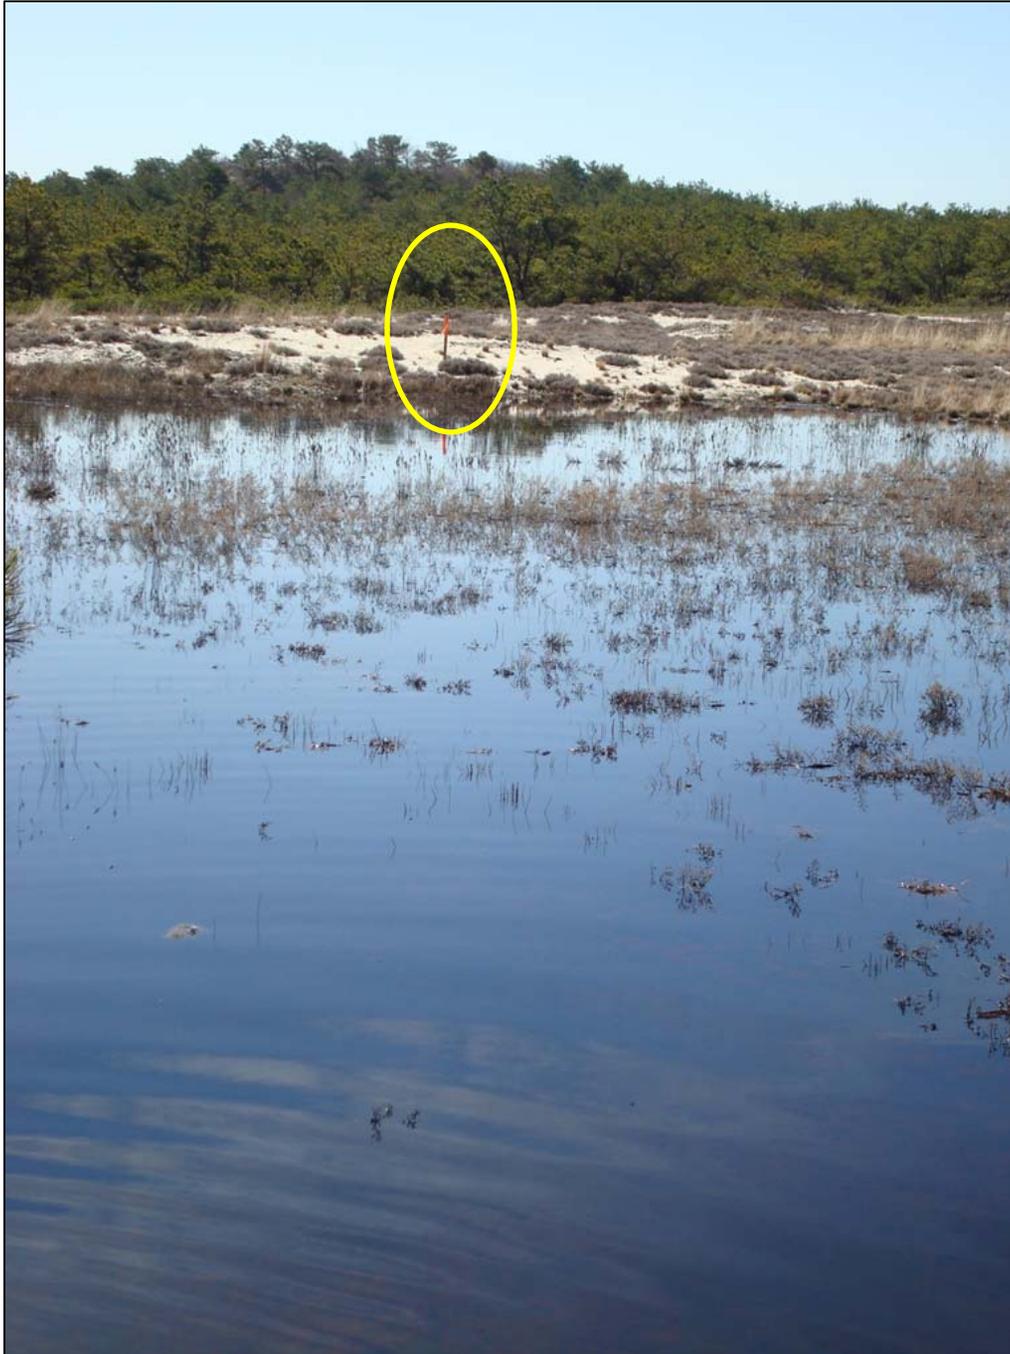
Proposed location for Fence Concept 6. Photo taken from the edge of the treeline along the proposed alignment, looking southeast. The fence will roughly coincide with the location of the yellow arrow. The fence will run from the tree line to the open area of dune at the end of the arrow. Note orange survey stake (#1121) marking fence alignment. Vegetation removal and maintenance will not be required in this area, as it is open grassland and dune.

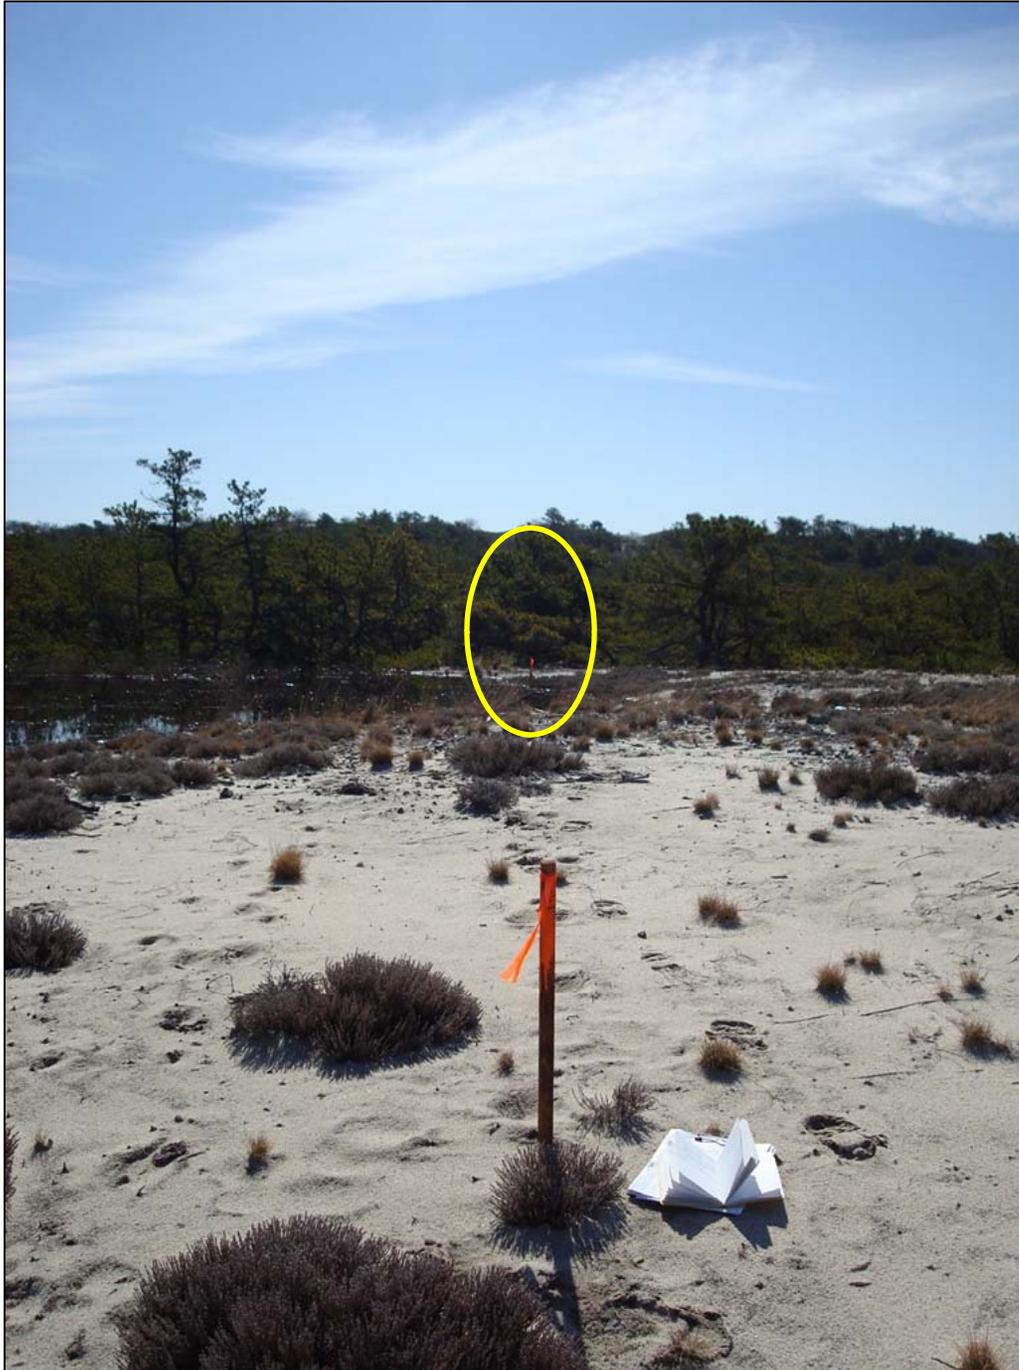
Additional view of fence stake #1121 depicted in previous photo. Cutting of vegetation for fence maintenance will not be required in this area.

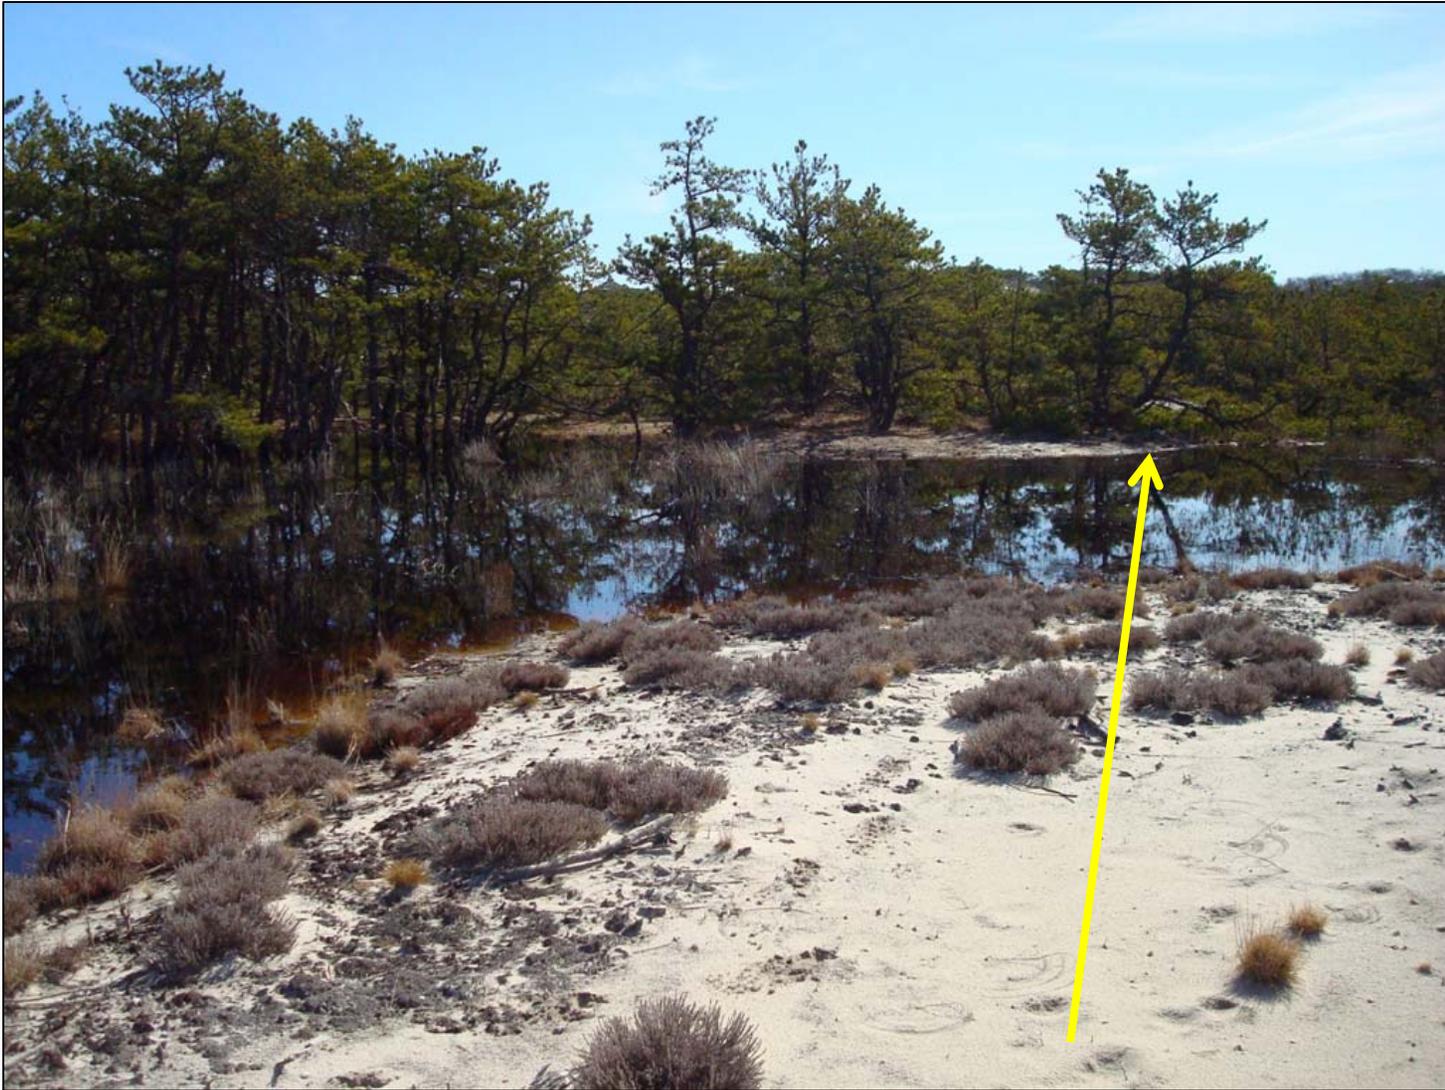
Proposed alignment for Fence Concept 6.
Photo taken from survey stake #1121.
Note stake #1119 in the background.
Vegetation maintenance will not be
required in this area, as it is comprised of
open dunes and wetland with low
growing groundcover.

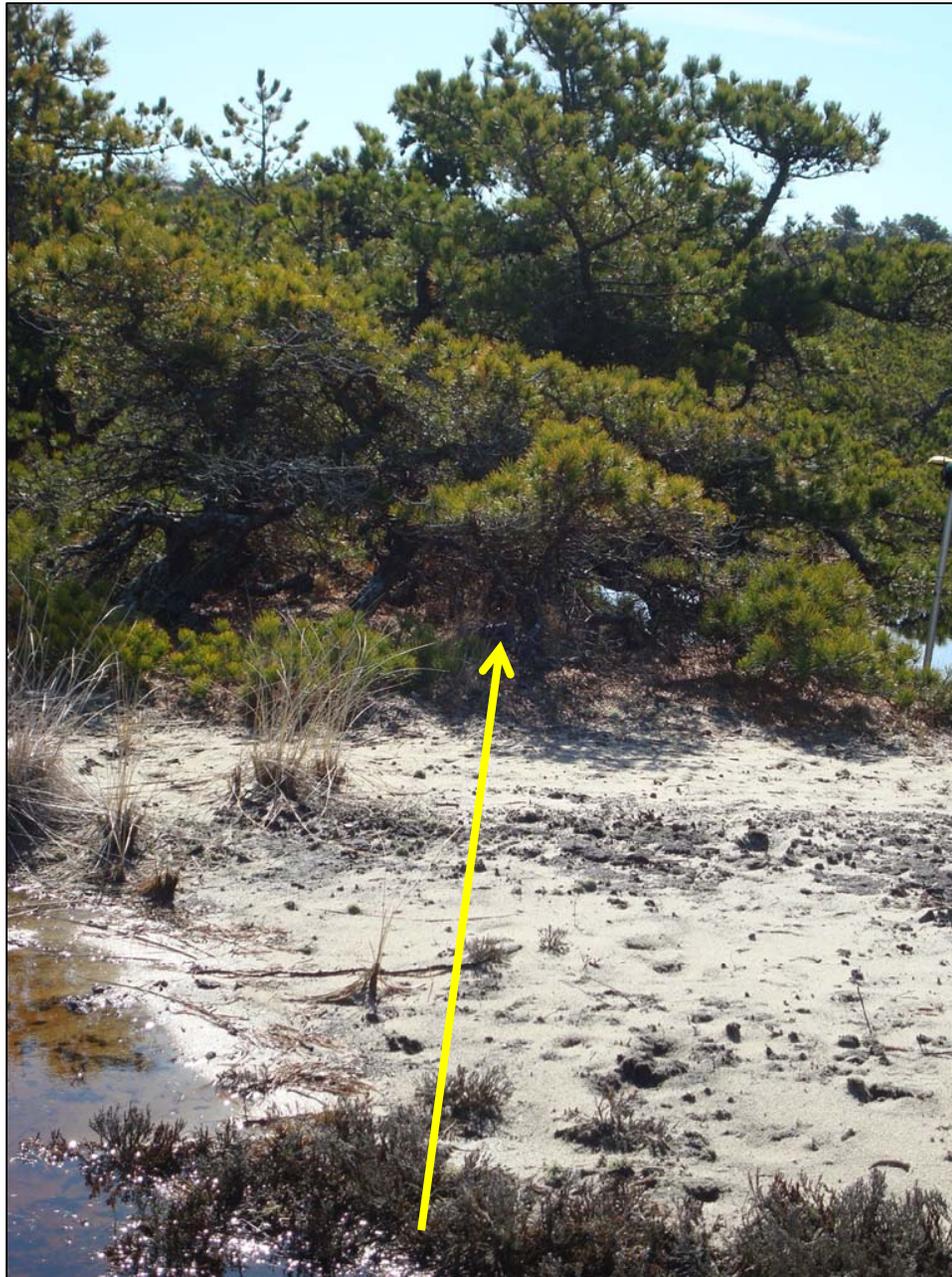
Proposed alignment for Fence Concept 6. Photo taken between survey stake #1119 and #1117. Vegetation maintenance will consist of selective removal of pitch pine and pitch pine limb removal only. This forested area is comprised of pitch pine with an open understory.
