Proposed Fence Alignment “Concept 6”

Provincetown Municipal Airport
Provincetown, MA

“Southern Section”

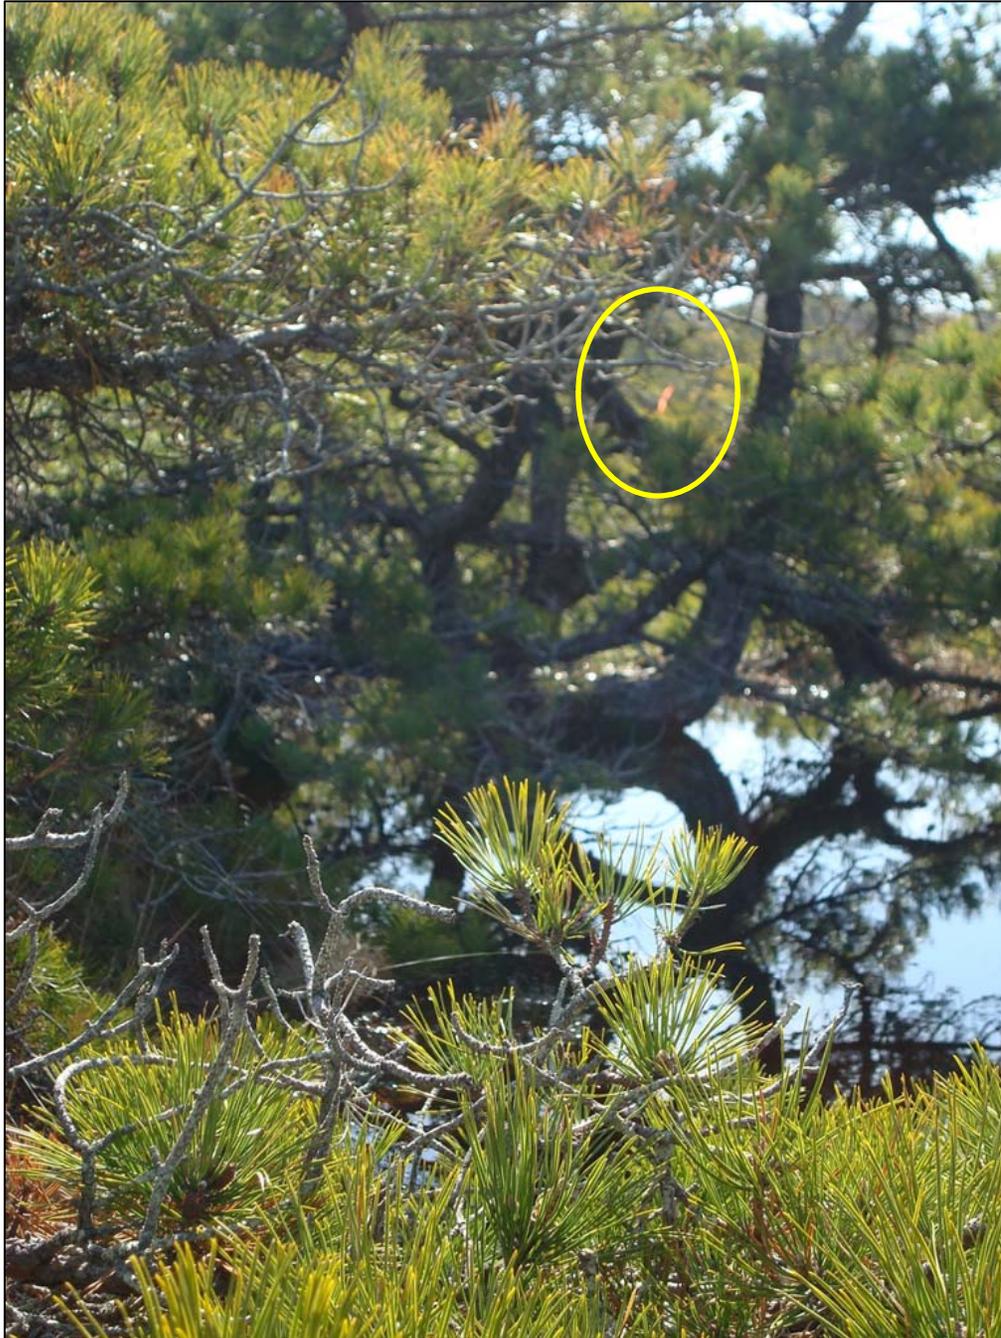
Proposed alignment for Fence Concept 6. Photo taken between survey stake #1119 and #1117. Vegetation maintenance will consist of selective removal of pitch pine and pitch pine limb removal only. This forested area is comprised of pitch pine with an open understory.

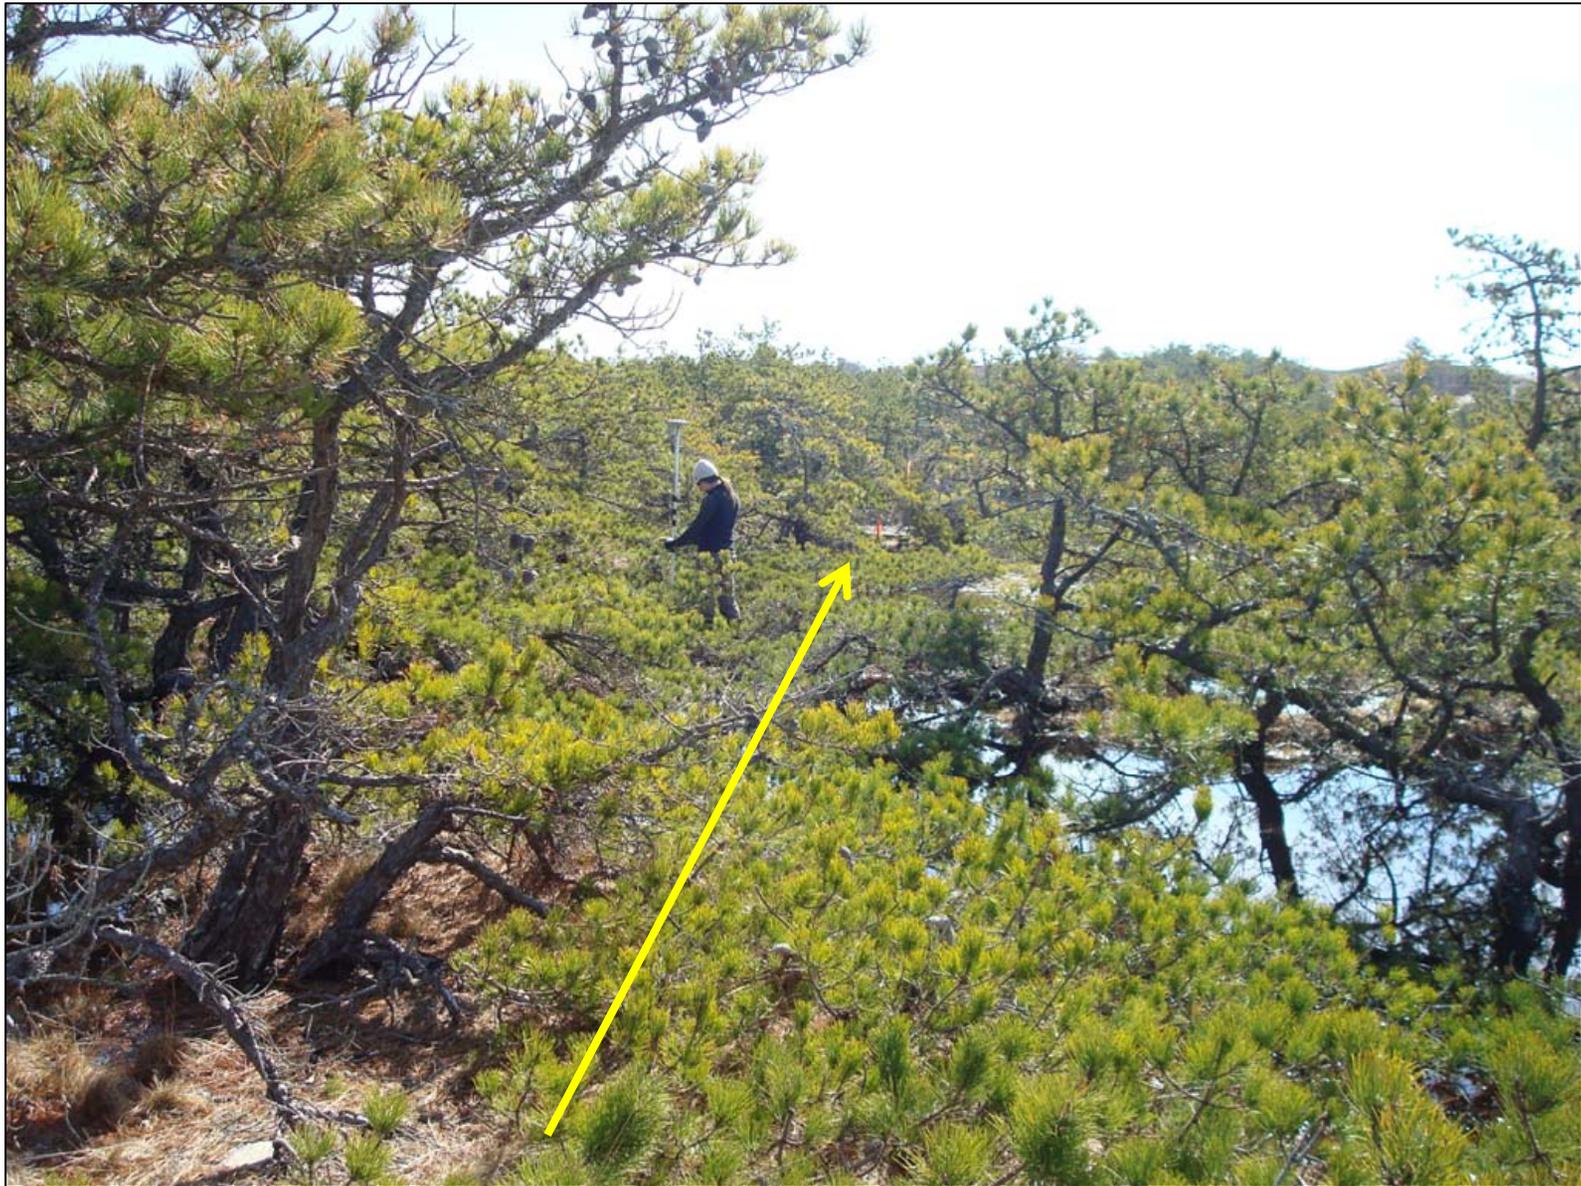
Proposed alignment for Fence Concept 6. Orange flagging marking survey stake #1117 is visible (inside yellow oval). Vegetation maintenance will consist of selective removal of pitch pine and pitch pine limb removal only. This forested area is comprised of pitch pine with an open understory. The area to the immediate right of the photo is an open section of unforested dune.

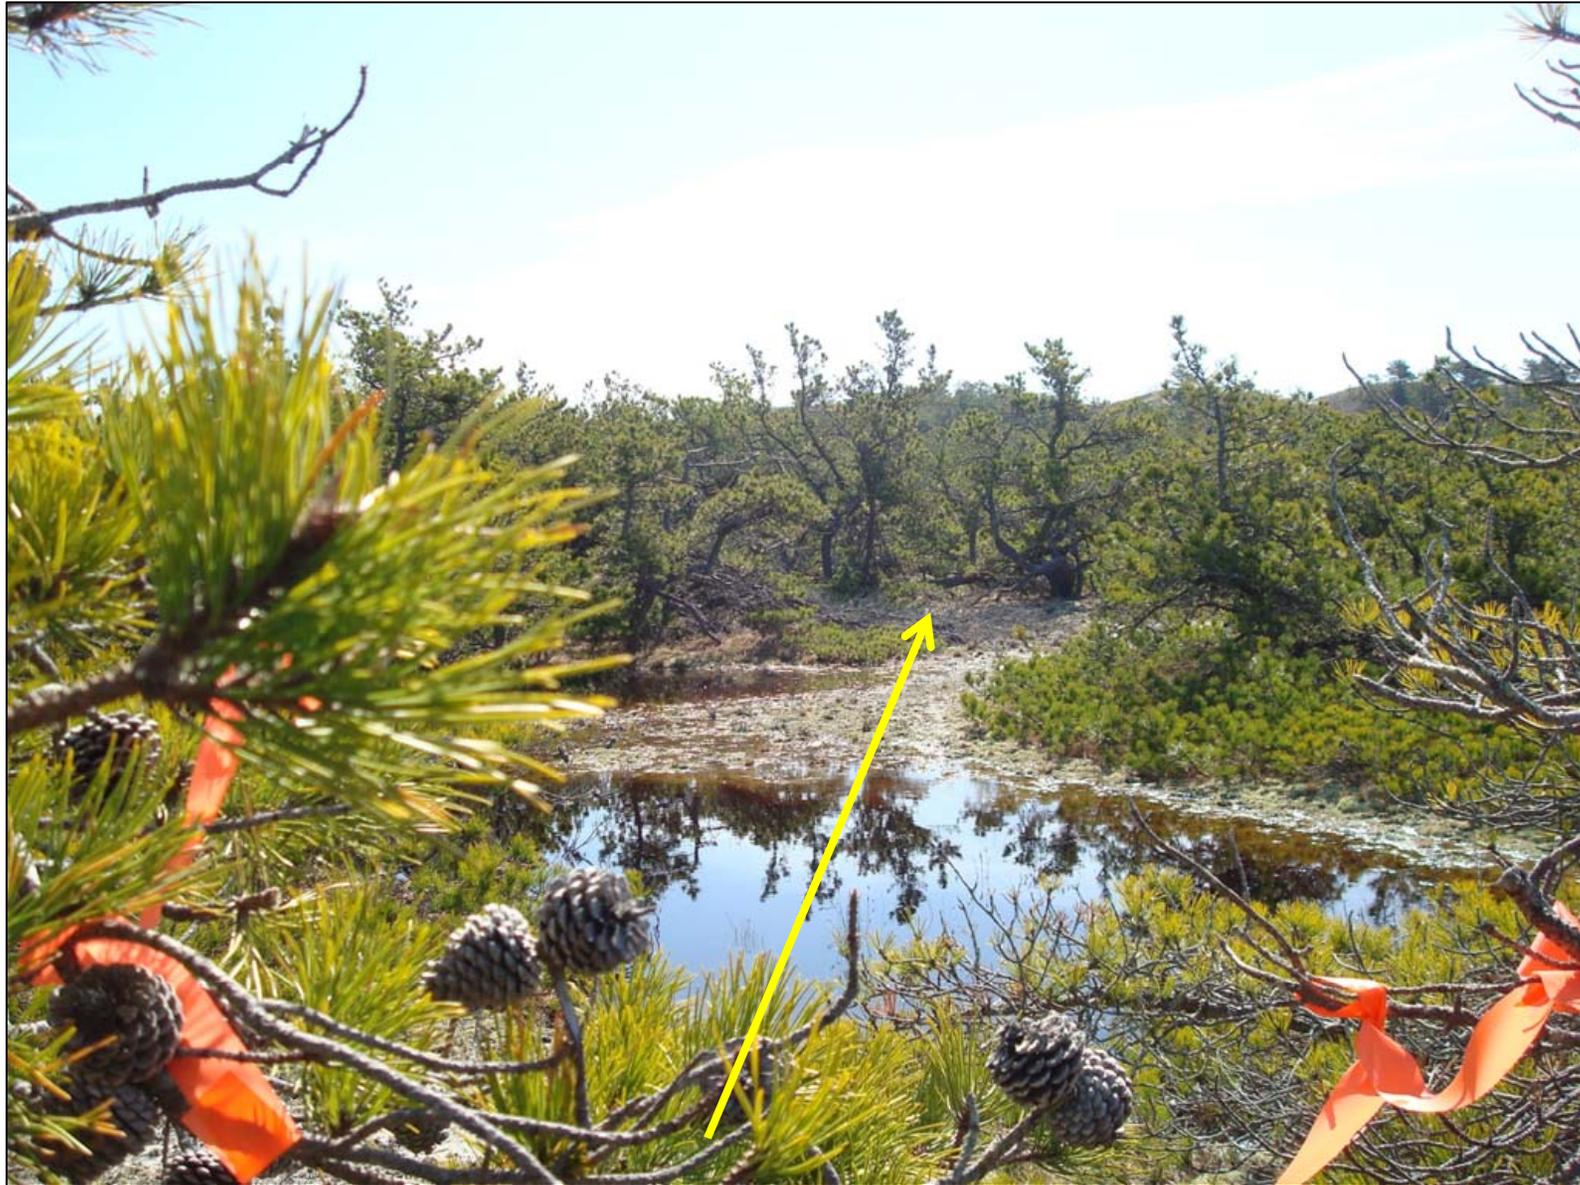
Proposed alignment for Fence Concept 6. Note orange survey stake #1117 at the end of the yellow arrow. The arrow depicts the approximate footprint of the fence. Vegetation maintenance will consist of selective removal of pitch pine and pitch pine limb removal only. This forested area is comprised of pitch pine with an open understory.

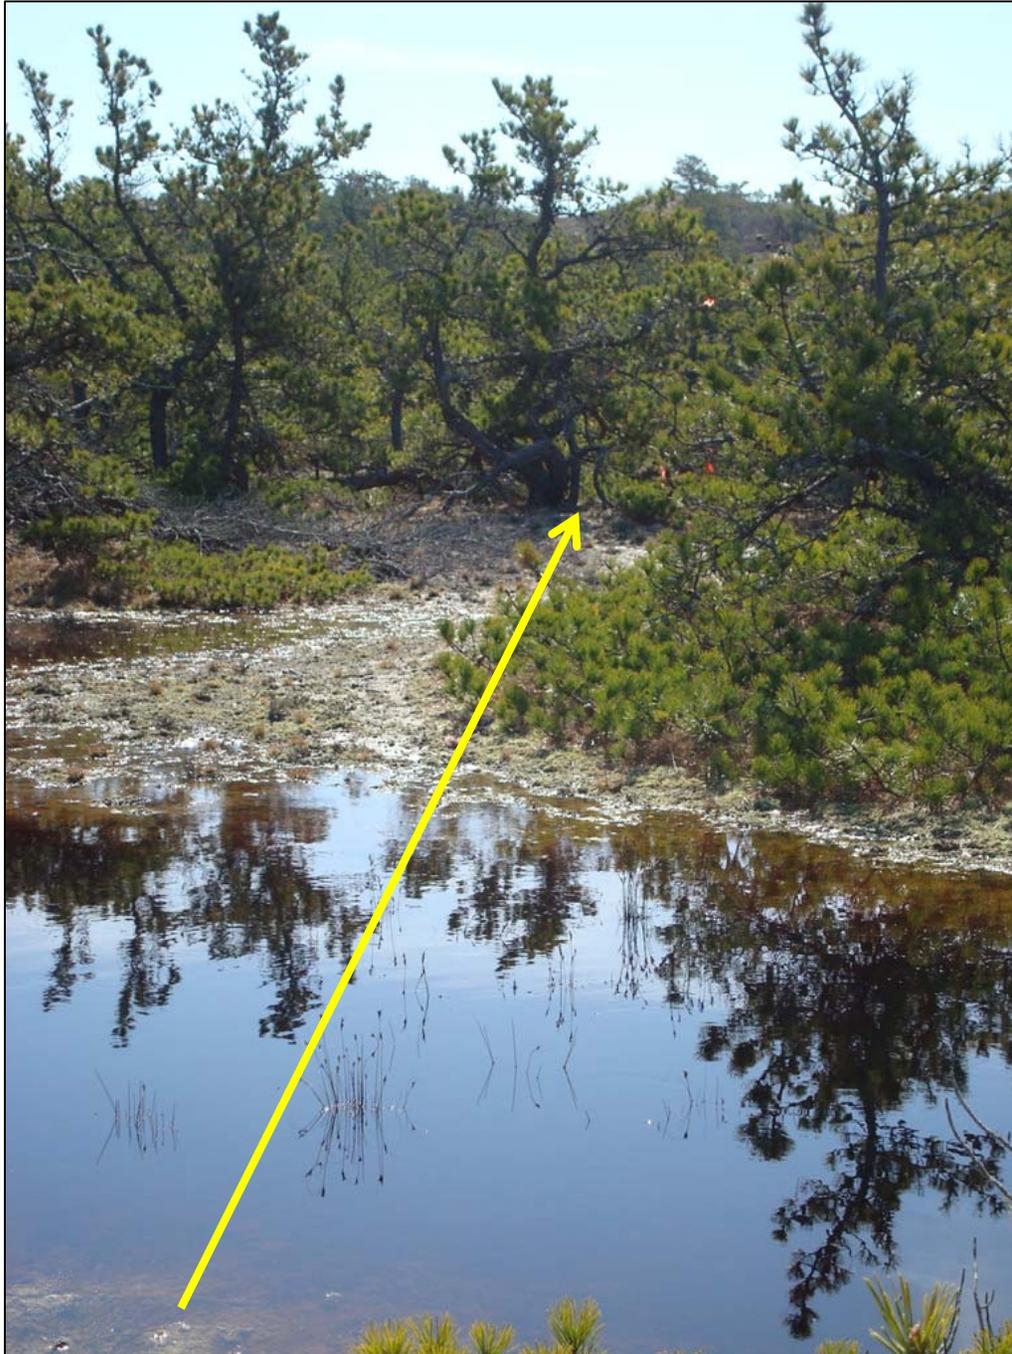
Proposed alignment for Fence Concept 6. Orange flagging is marking survey stake #1117. Vegetation maintenance will consist of limited selective removal of pitch pine and pitch pine limbs only. This forested area is comprised of pitch pine with an open understory. The yellow arrow depicts the approximate path of the fence alignment.

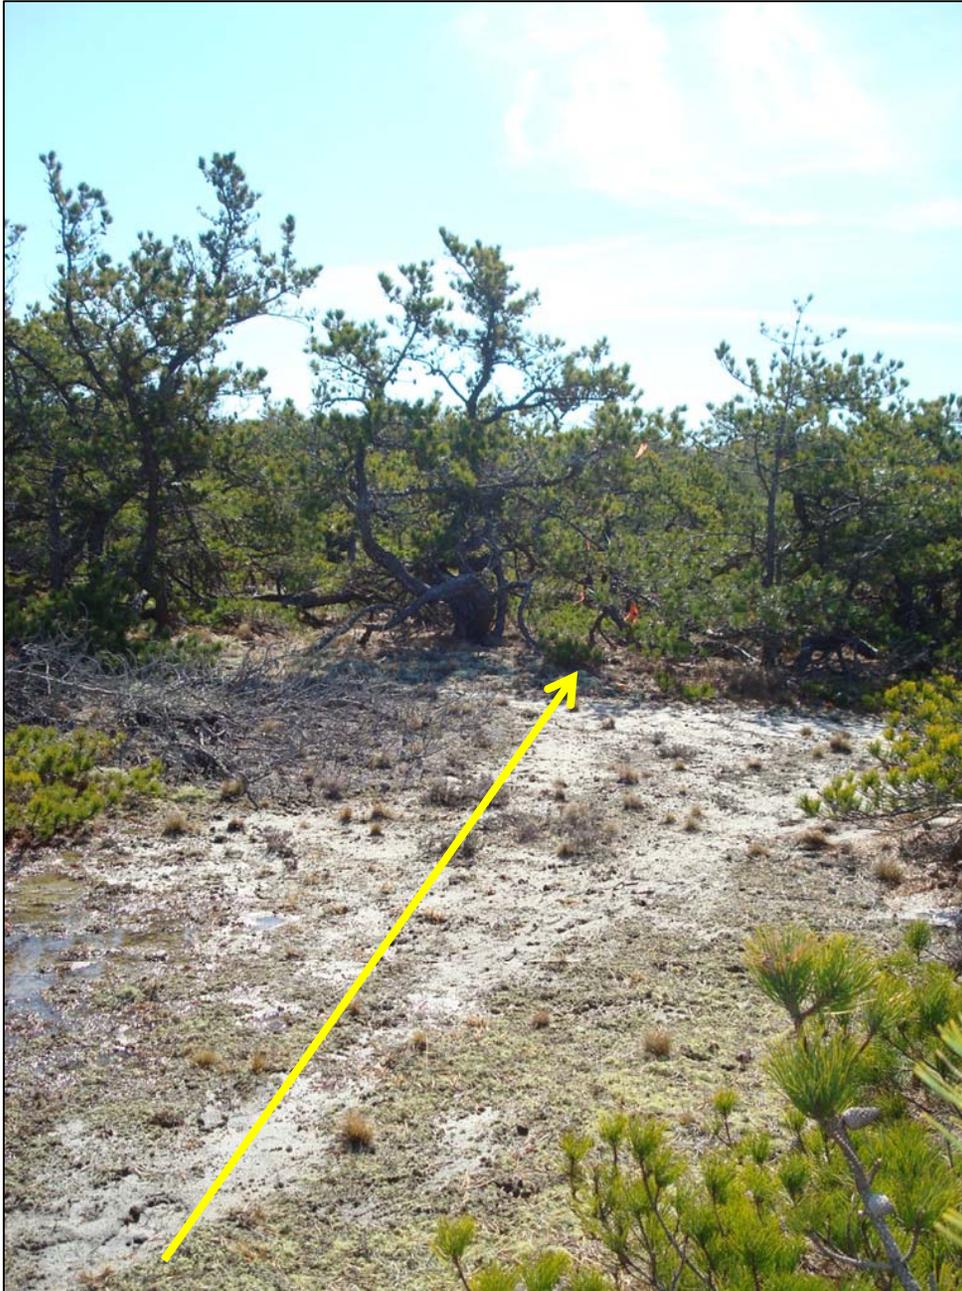
The yellow arrow depicts the approximate footprint of the proposed alignment for Fence Concept 6. Orange flagging marking survey stake #1115 is visible (at end of yellow arrow). Vegetation maintenance will be limited to selective removal of pitch pine limbs only. The majority of this area is open with sparse groundcover (i.e., lichens and *Hudsonia*).

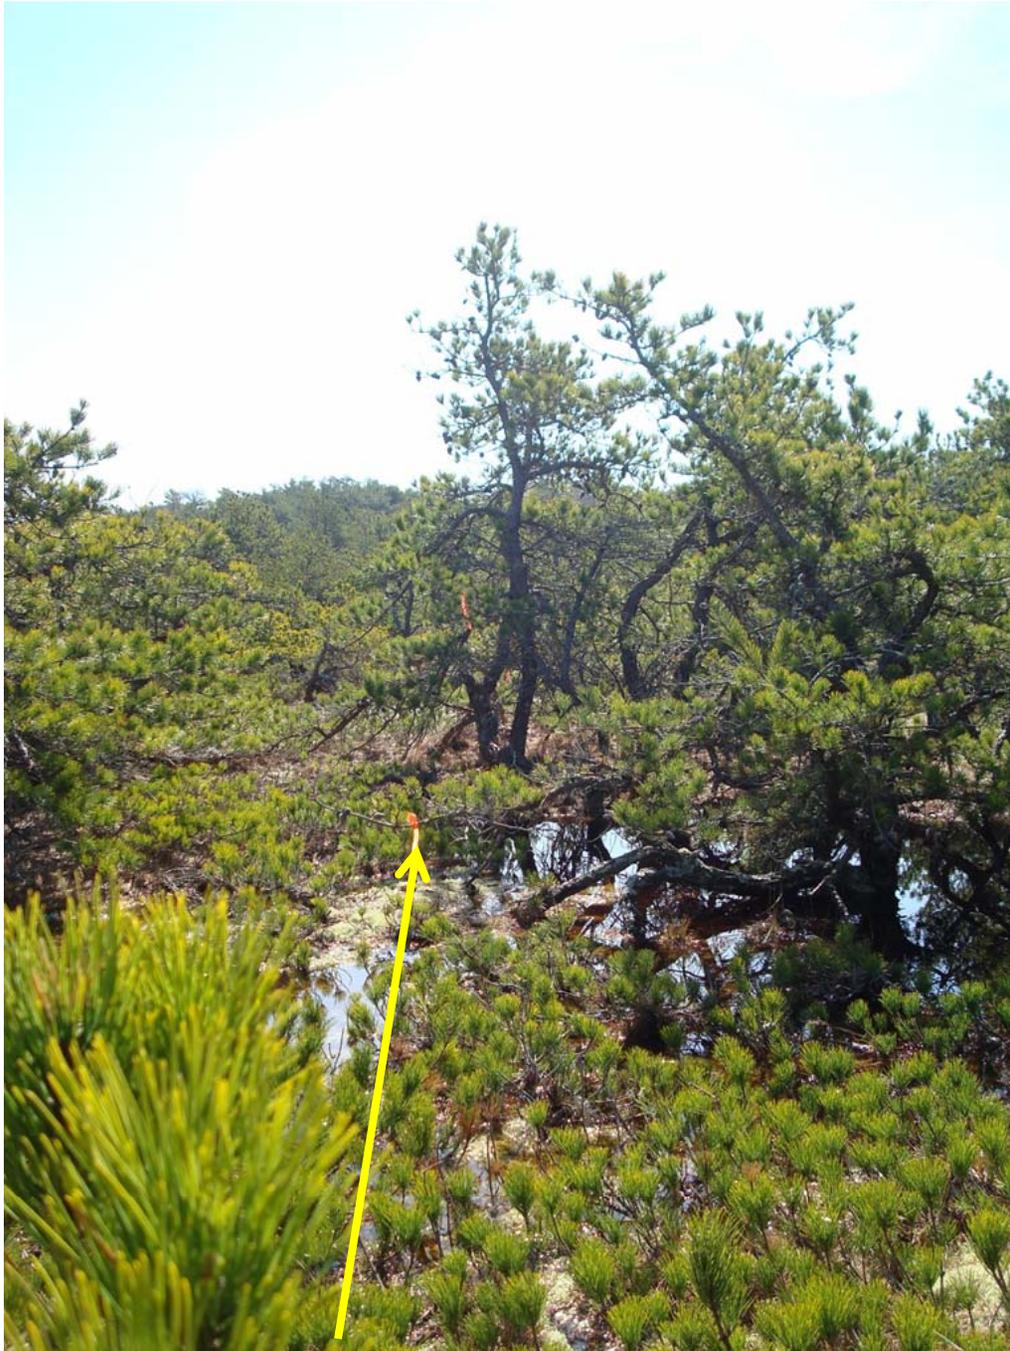
The yellow arrow depicts the approximate footprint of the proposed fence alignment. Orange flagging marking survey stake #1113 is visible (at end of yellow arrow). Photo taken from fence stake #1115. Vegetation maintenance will be limited to selective removal of individual pitch pine trees and pitch pine limbs only. There are several open pockets of dune with sparse groundcover (i.e., lichens and *Hudsonia*) among the trees.

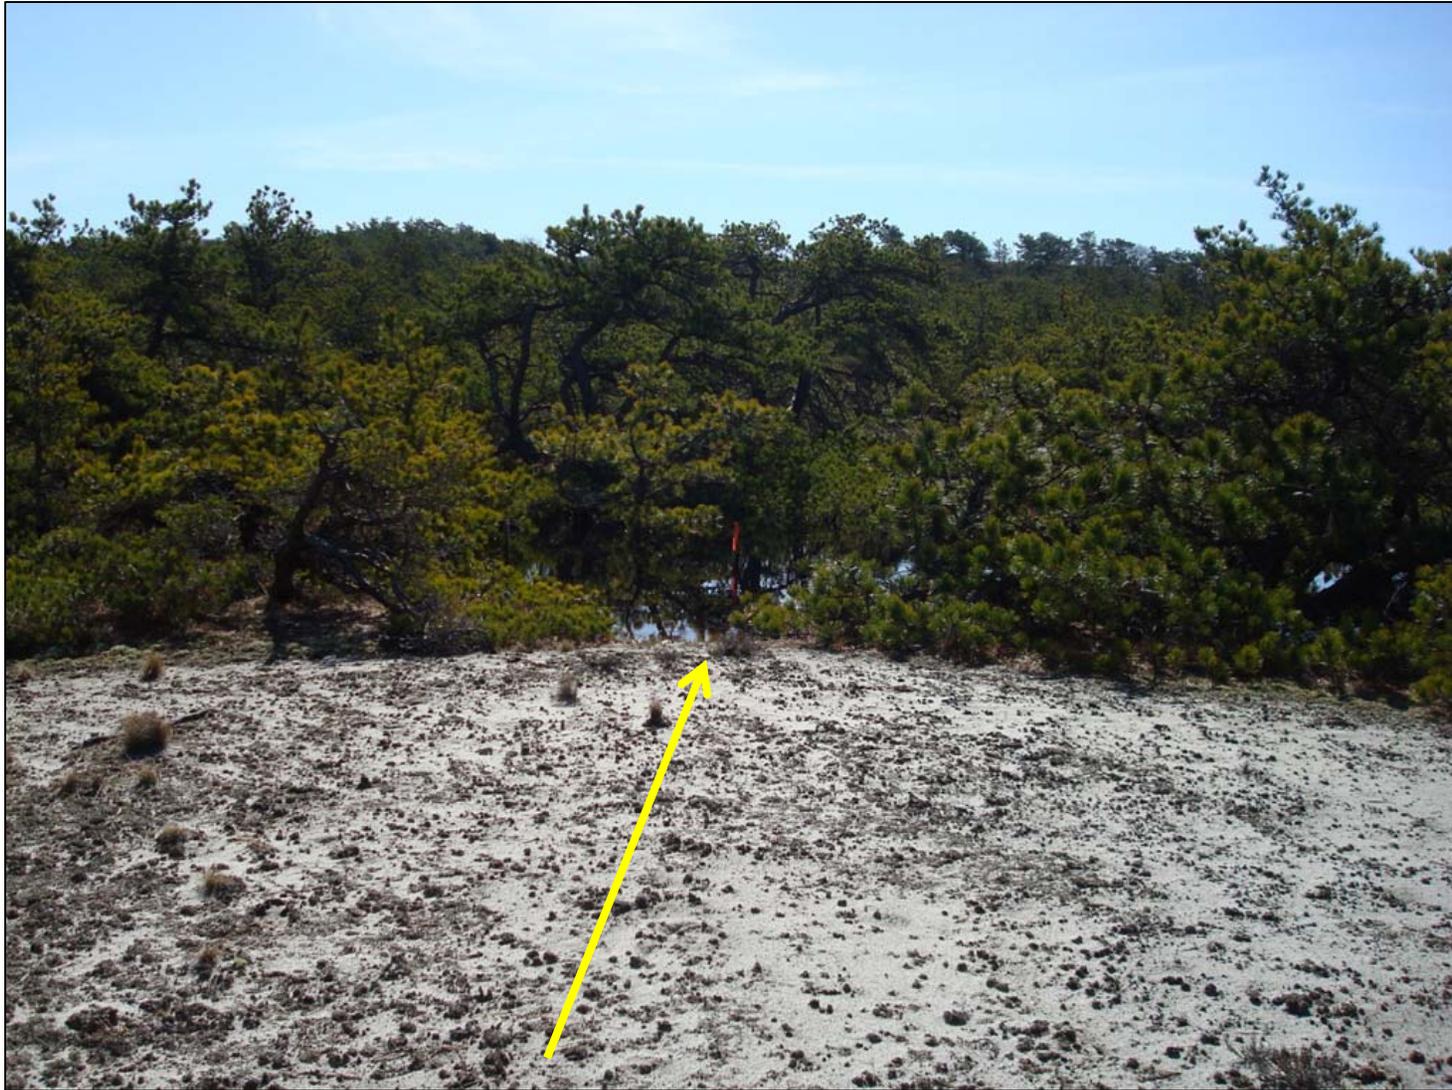
The yellow arrow depicts the approximate footprint of the proposed fence alignment. Orange flagging marking survey stake #1113 is visible (at end of yellow arrow). Vegetation maintenance will be limited to selective removal of individual pitch pine trees and pitch pine limbs only. There are several open pockets of dune with sparse groundcover (i.e., lichens and *Hudsonia*) among the trees. Open dune is present immediately beyond fence stake #1113, as shown in the following photo.

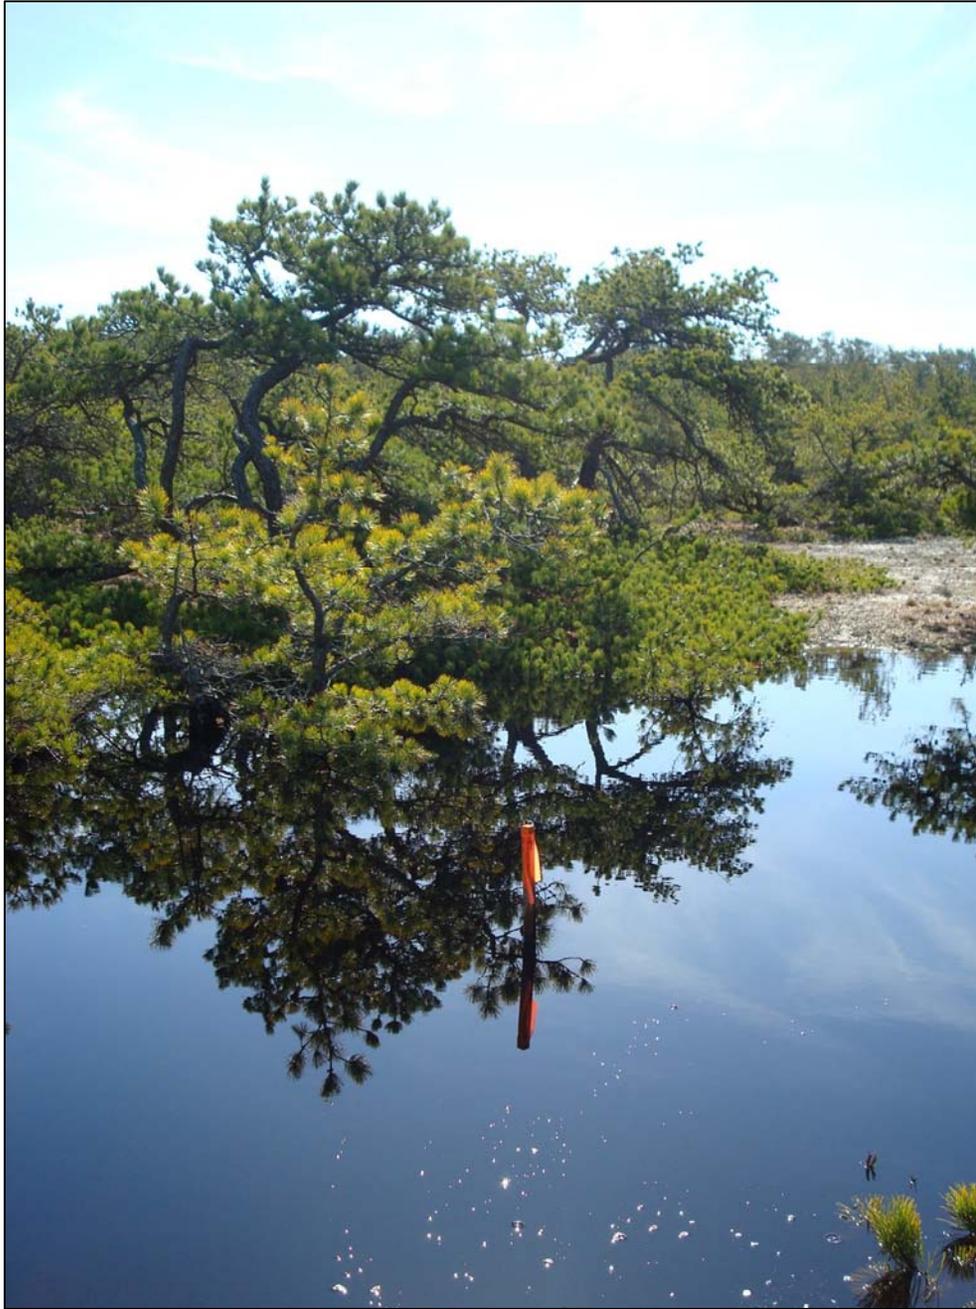
The yellow arrow depicts the approximate footprint of the proposed fence alignment. Note orange survey stake #1111. Vegetation maintenance will be limited to selective removal of individual pitch pine trees and pitch pine limbs only. There are several open pockets with sparse groundcover (i.e., lichens, cranberry, and *Hudsonia*) where vegetation maintenance will not be necessary.

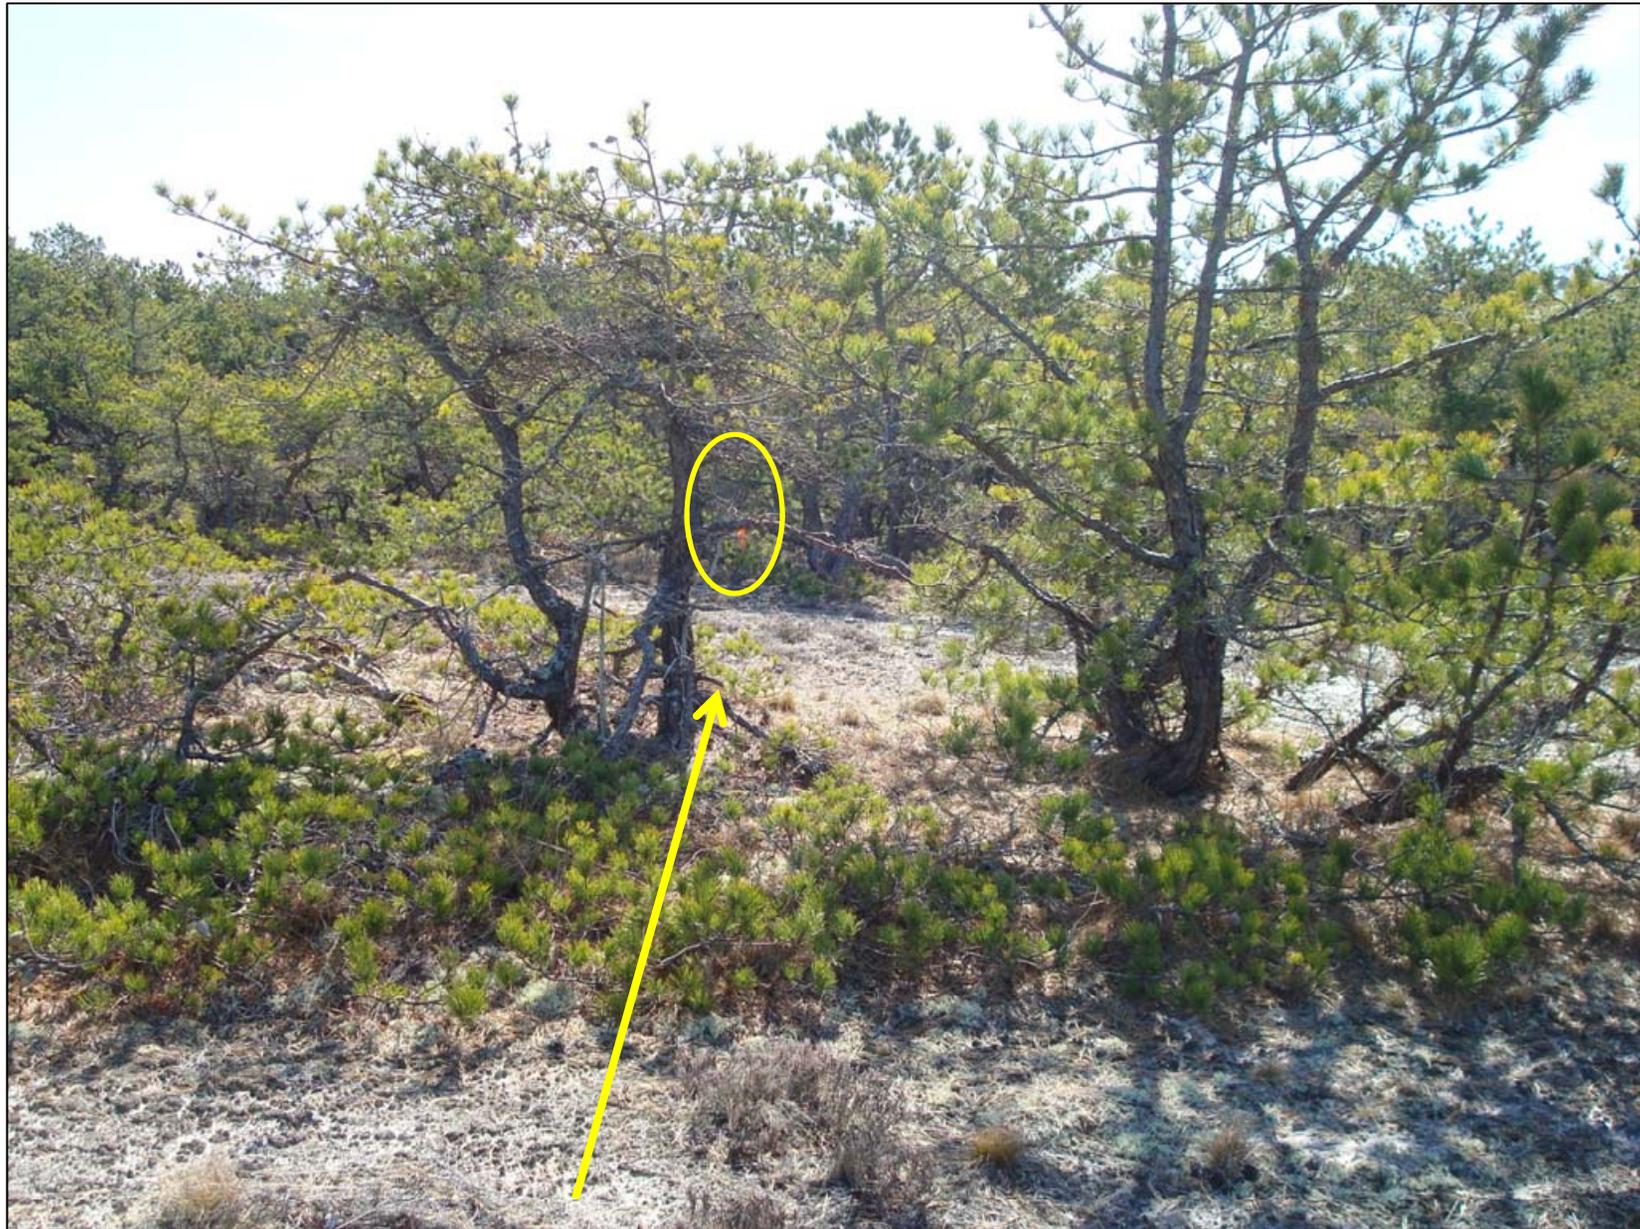
The yellow arrow depicts the approximate footprint of the proposed fence alignment. Photo taken immediately south of fence stake #1111. Vegetation maintenance will be limited to selective removal of individual pitch pine trees and pitch pine limbs only. The majority of this area is occupied by open pockets of dune with sparse groundcover (i.e., lichens and *Hudsonia*) among the trees, where vegetation maintenance will not be necessary. Pitch pines are generally scattered and sparse in this location, as shown in the following photo.

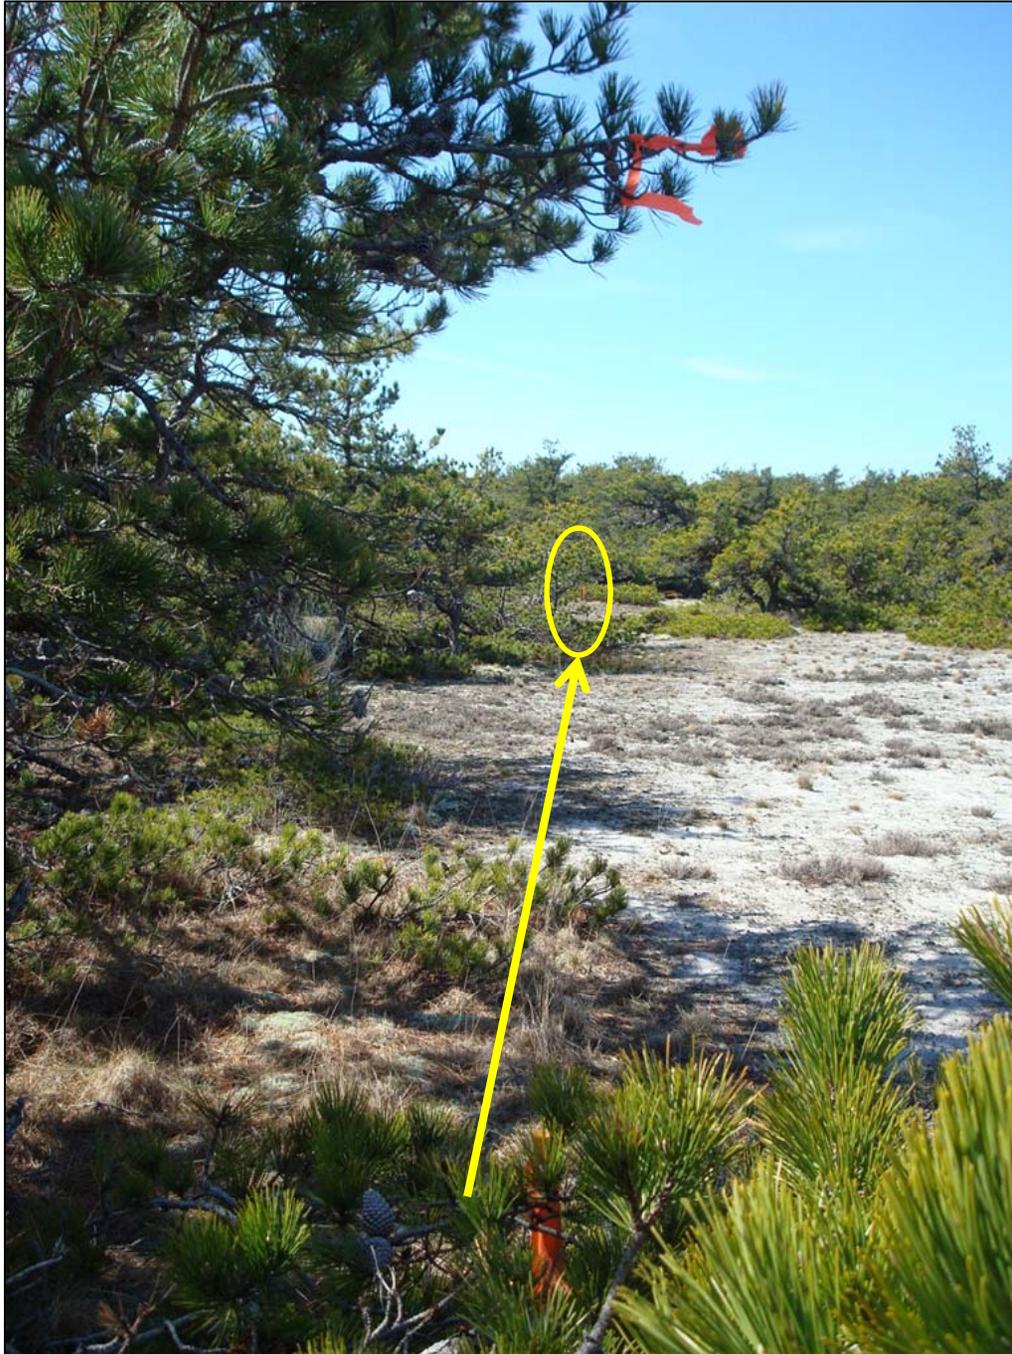
The yellow arrow depicts the approximate footprint of the proposed fence alignment. Orange flagging marking survey stake #1110 is visible (inside circle). Vegetation maintenance will be limited to selective removal of individual pitch pine trees and pitch pine limbs only. The majority of this area consists of open pockets of dune with sparse groundcover (i.e., lichens and *Hudsonia*) among the trees.

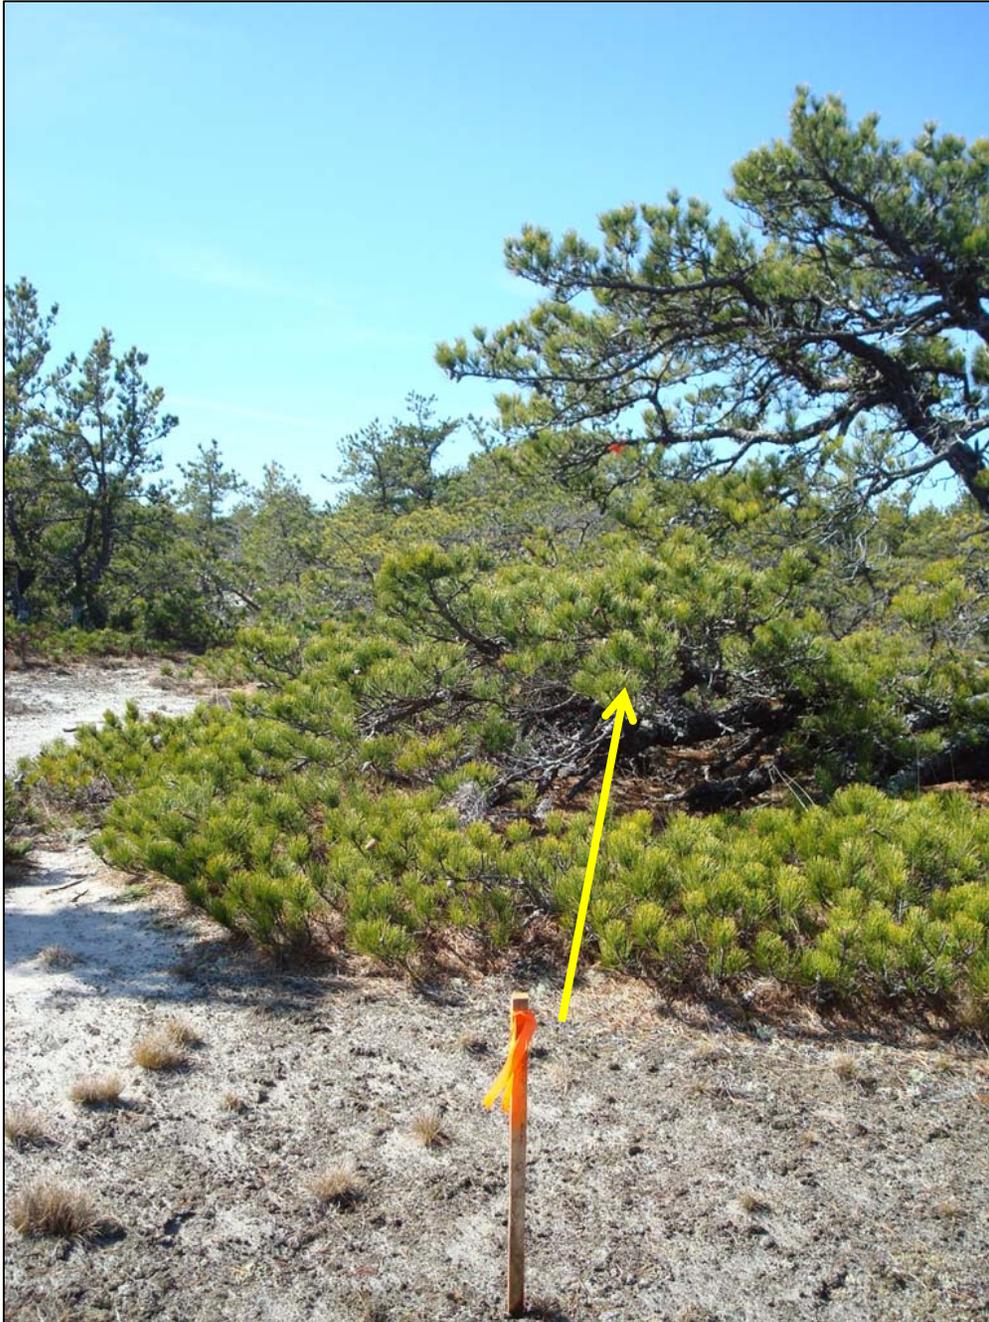
Approximate location of proposed fence alignment. Photo taken at fence stake #1110 (visible). The fence will follow the edge of the treeline. Vegetation maintenance will be limited to selective removal of individual pitch pine trees and pitch pine limbs only. The majority of this area consists of open pockets of dune with sparse groundcover (i.e., lichens and *Hudsonia*) among the trees.

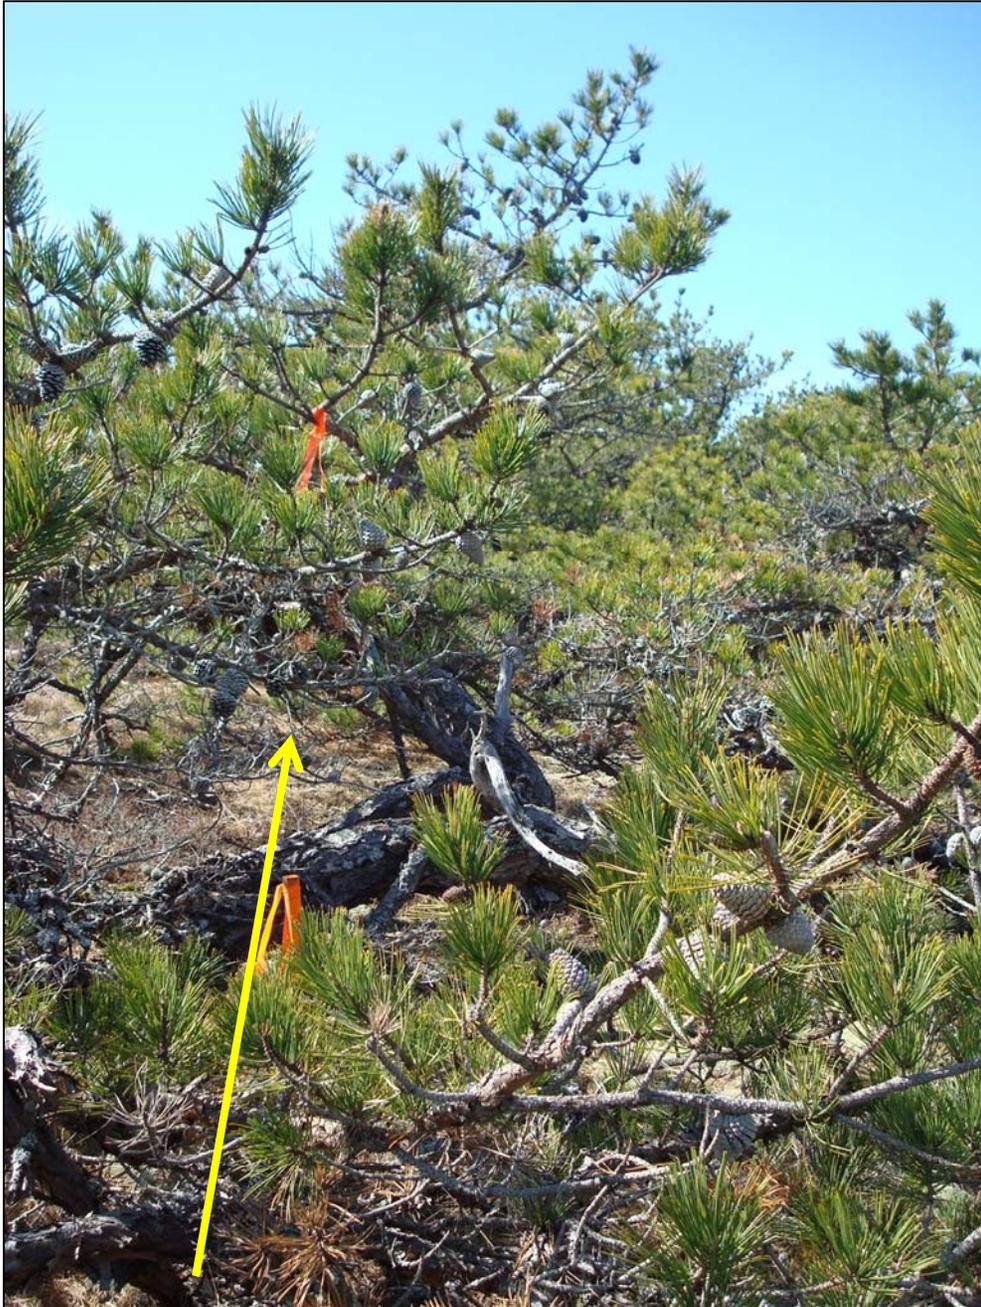
Approximate location of proposed fence alignment. Photo taken at fence stake #1106 (visible). Vegetation maintenance will be limited to selective removal of individual pitch pine trees and pitch pine limbs only. There are several open pockets of dune with sparse groundcover (i.e., lichens and *Hudsonia*) among the trees. The fence may be shifted south (left) slightly to further avoid pruning and selective removal of pitch pine, to the maximum extent possible.

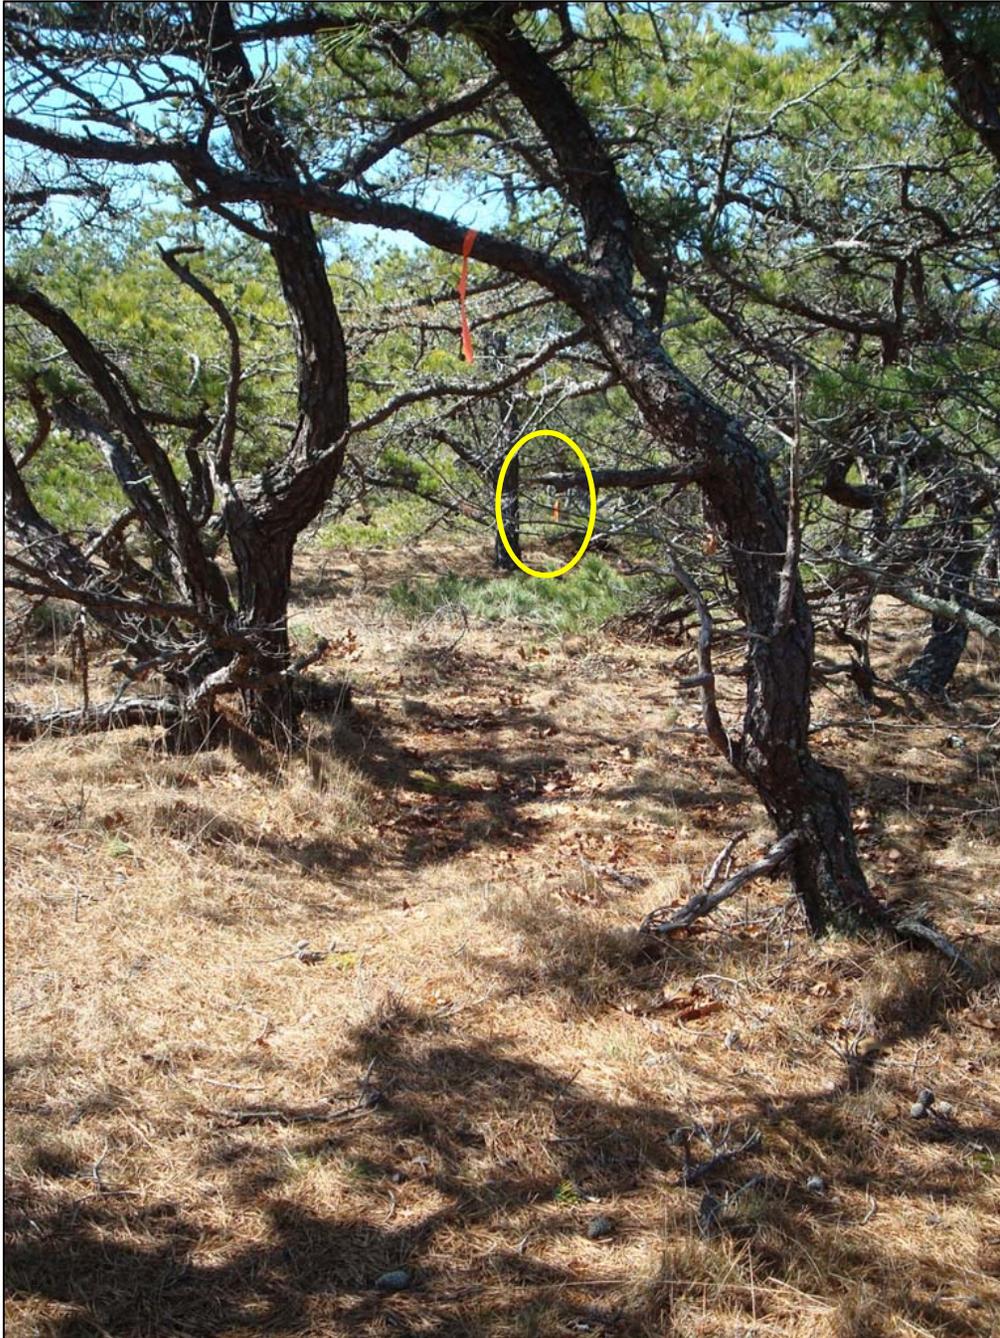
Approximate location of proposed fence alignment. Photo taken at fence stake #1104 (visible). Vegetation maintenance will be limited to selective removal of individual pitch pine trees and pitch pine limbs only. The majority of this area consists of open pockets of dune with sparse groundcover (i.e., lichens and *Hudsonia*) among the trees.

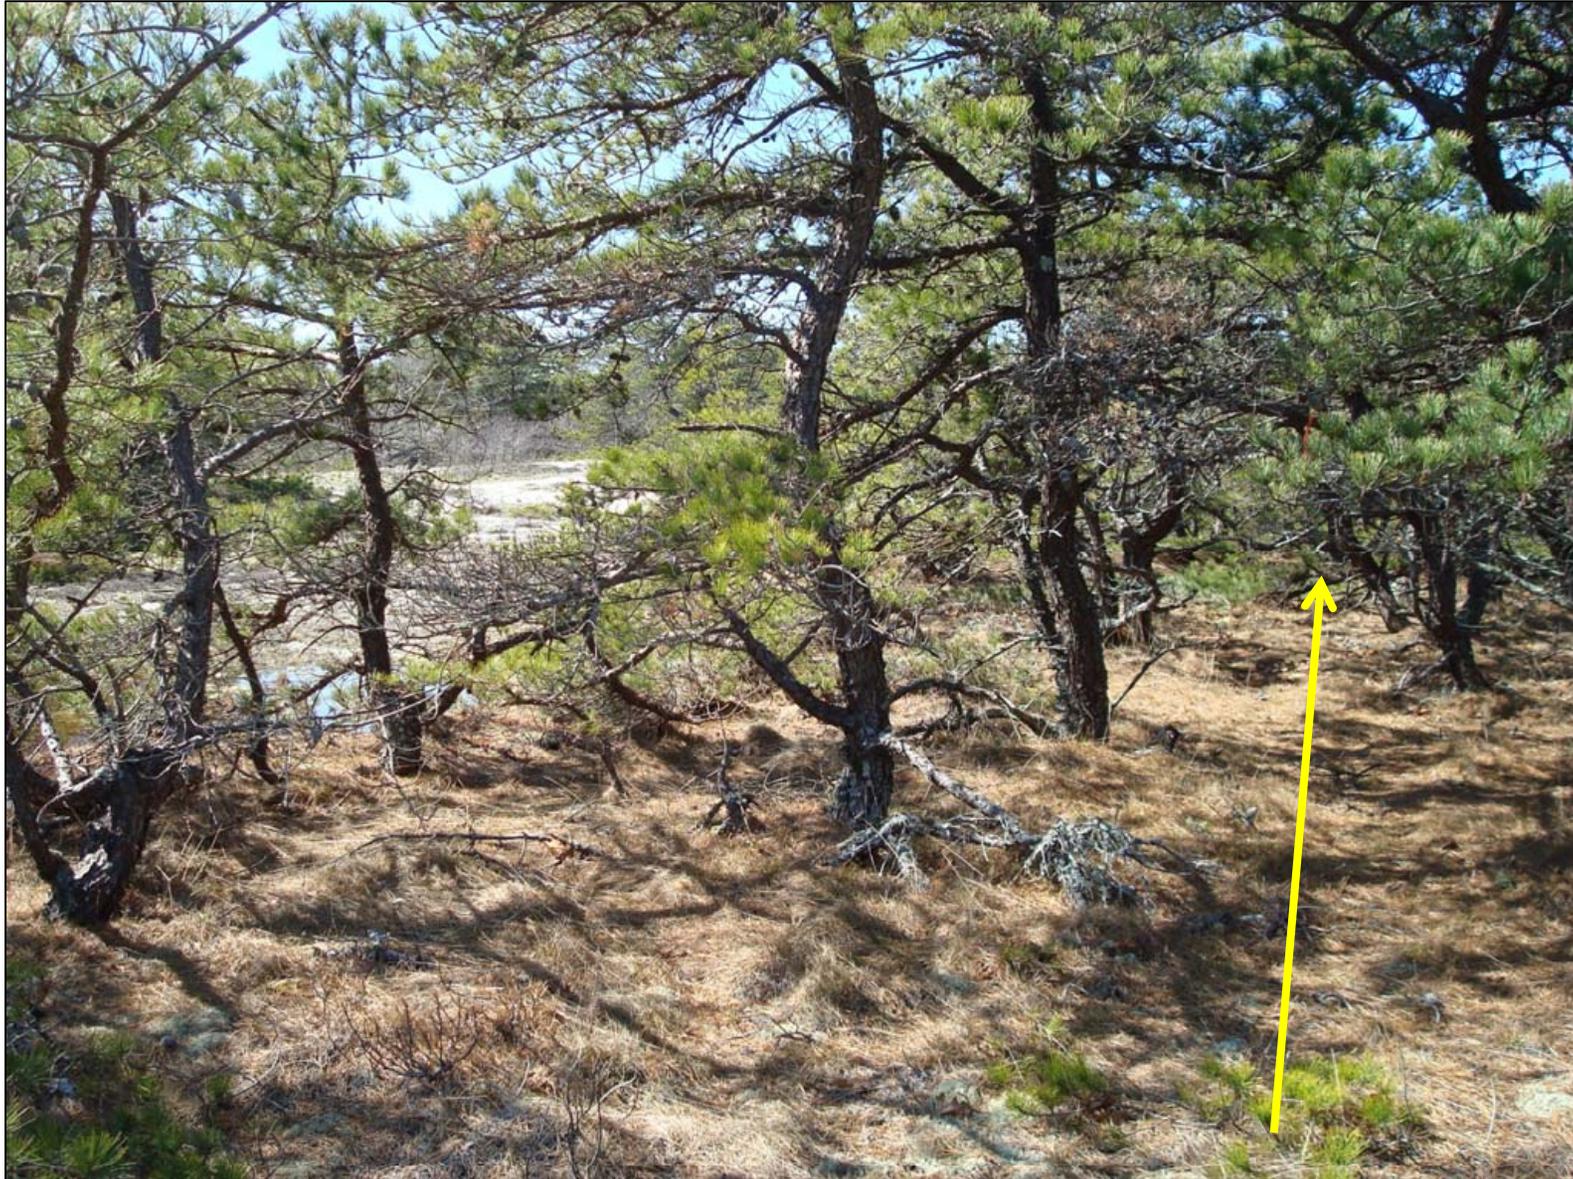
Approximate location of proposed fence alignment. Fence stake #1102 is visible through the trees. Vegetation maintenance will be limited to selective removal of individual pitch pine trees and pitch pine limbs only. The majority of this area consists of open pockets of dune with sparse groundcover (i.e., lichens and *Hudsonia*) among the trees. The fence may be shifted south (left) slightly to further avoid pruning and selective removal of pitch pine, to the maximum extent possible.
