Proposed Fence Alignment “Concept 6”

Provincetown Municipal Airport
Provincetown, MA

“Southern Section”

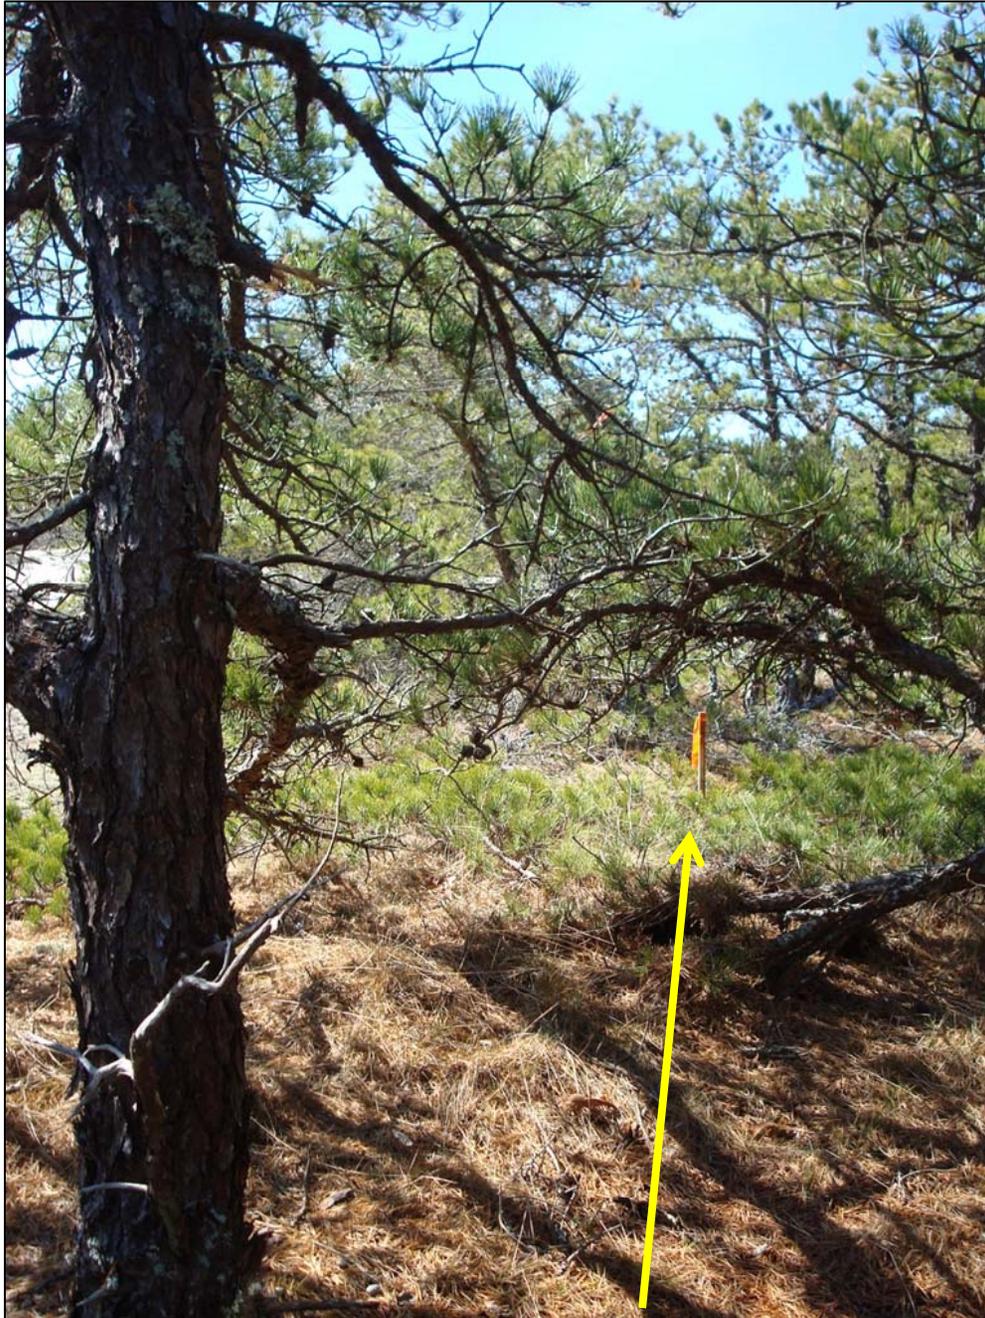
Approximate location of proposed fence alignment, looking southwest. Vegetation maintenance will be limited to selective removal of individual pitch pine trees and pitch pine limbs only. The fence may be shifted south (left) slightly to further avoid pruning and selective removal of pitch pine, to the maximum extent possible.

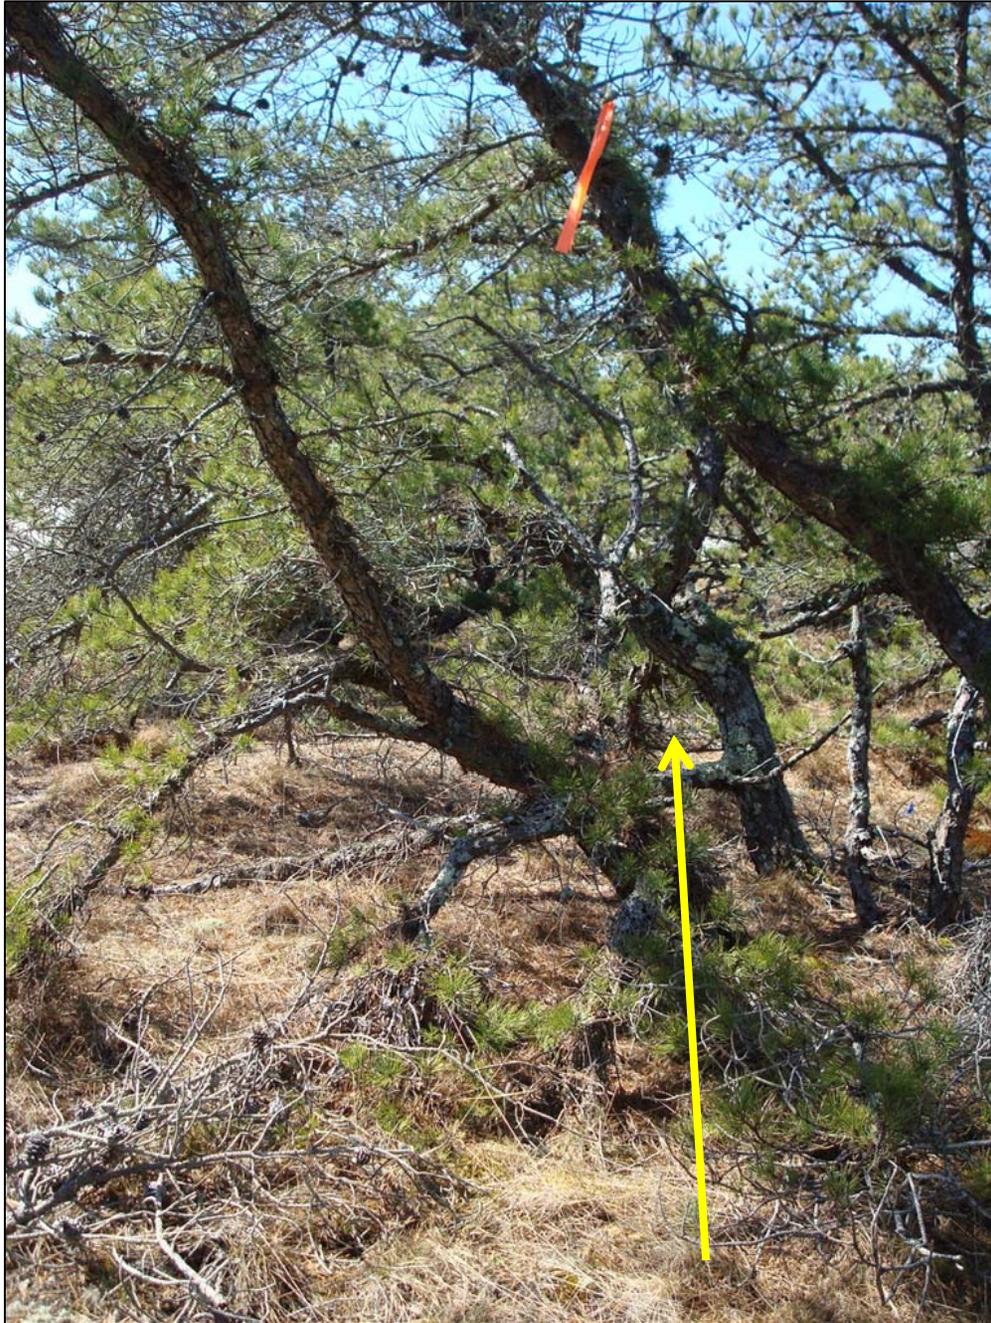
Open area of dune south of proposed fence alignment. The fence may be shifted to traverse this area to avoid several areas of pitch pine that the fence is currently proposed to go through. Near fence stake #1102.

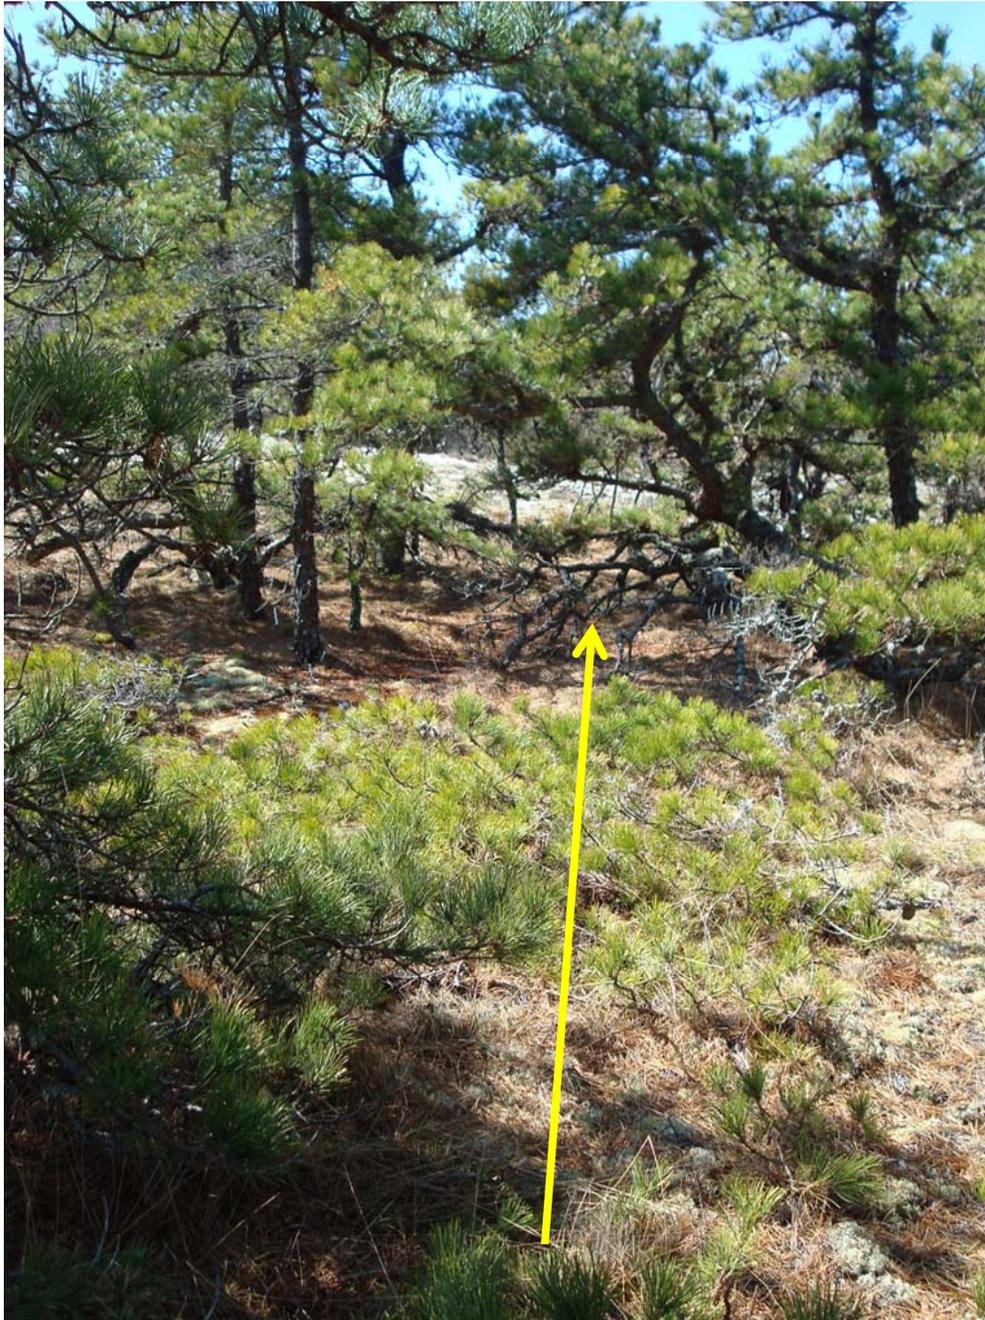
Approximate location of proposed fence alignment. Photo near fence stake #1102. Vegetation maintenance will be limited to selective removal of individual pitch pine trees and pitch pine limbs only. Several open pockets of dune with sparse groundcover (i.e., lichens and *Hudsonia*) occur among the trees. The fence may be shifted south (left) slightly to further avoid pruning and selective removal of pitch pine, to the maximum extent possible.

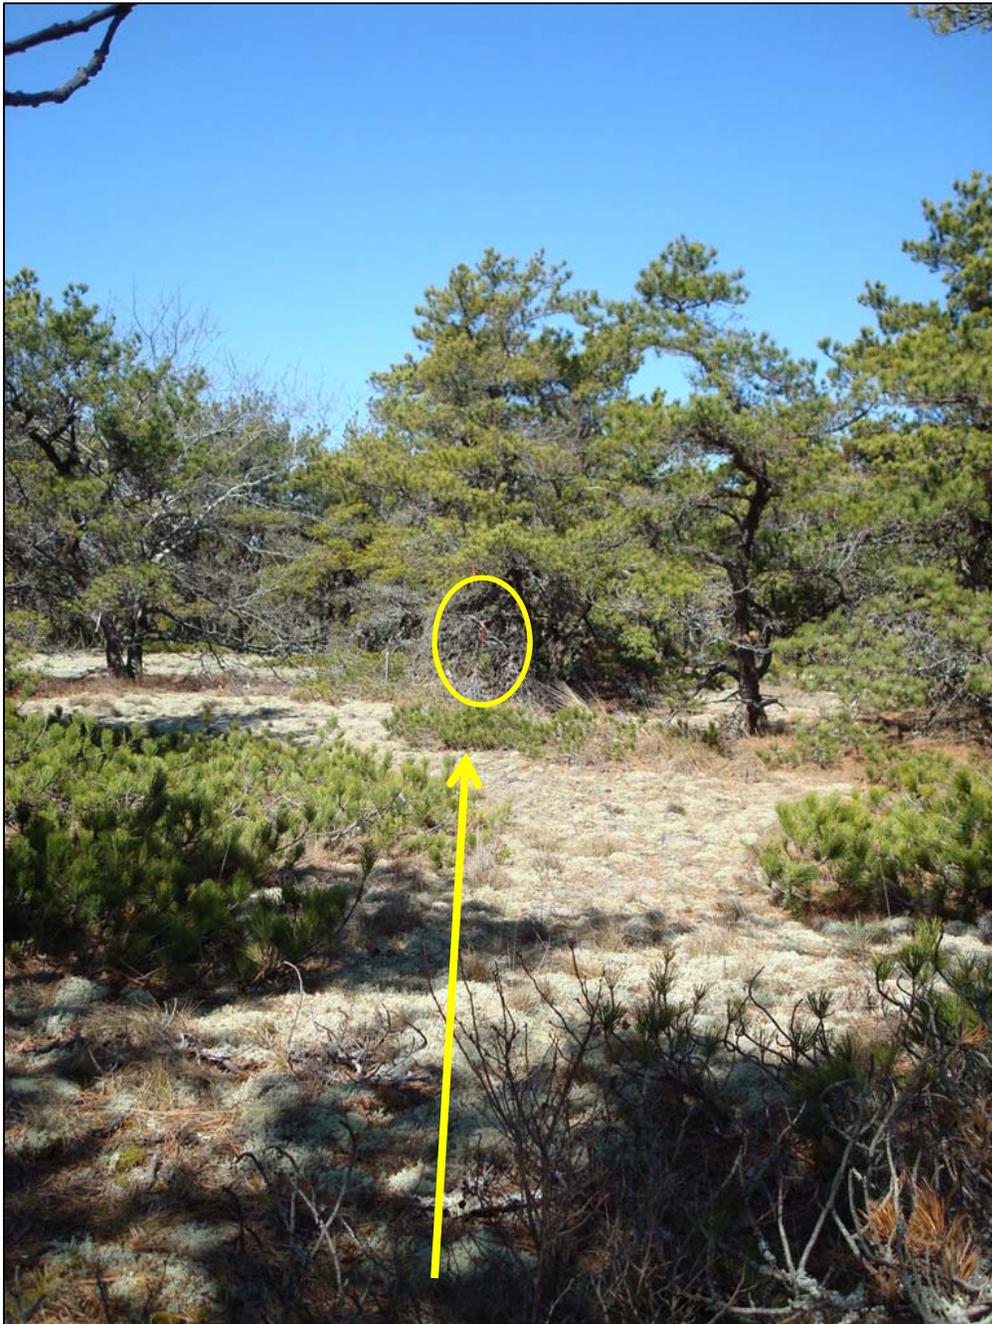
Proposed alignment of Fence Concept 6. Photo taken at fence stake #1101 (fence corner). Vegetation maintenance will be limited to selective removal of individual pitch pine trees and limbs only. The majority of this area consists of open pockets of dune with sparse groundcover (i.e., lichens and *Hudsonia*) among the trees. The fence may be shifted south to southwest (left) slightly to further avoid pruning and selective removal of pitch pine.

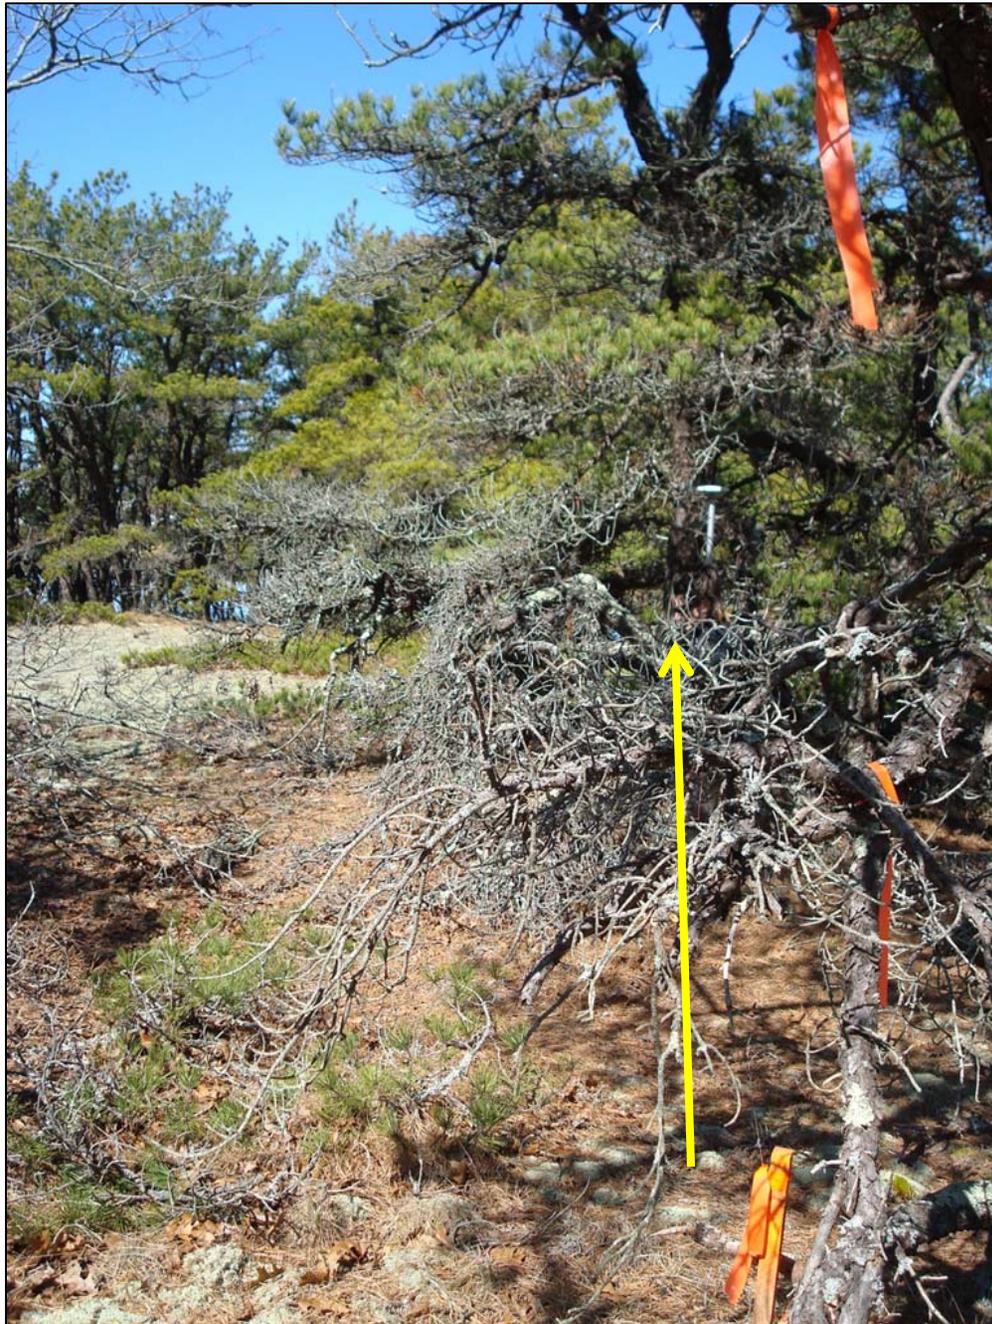
Approximate location of proposed fence alignment. Photo taken near fence stake #1100. Fence stake #1099 is visible (inside circle). Vegetation maintenance will be limited to selective removal of individual pitch pine trees and pitch pine limbs only. A large portion of this area consists of open pockets of dune with sparse groundcover (i.e., lichens and *Hudsonia*) among the trees.

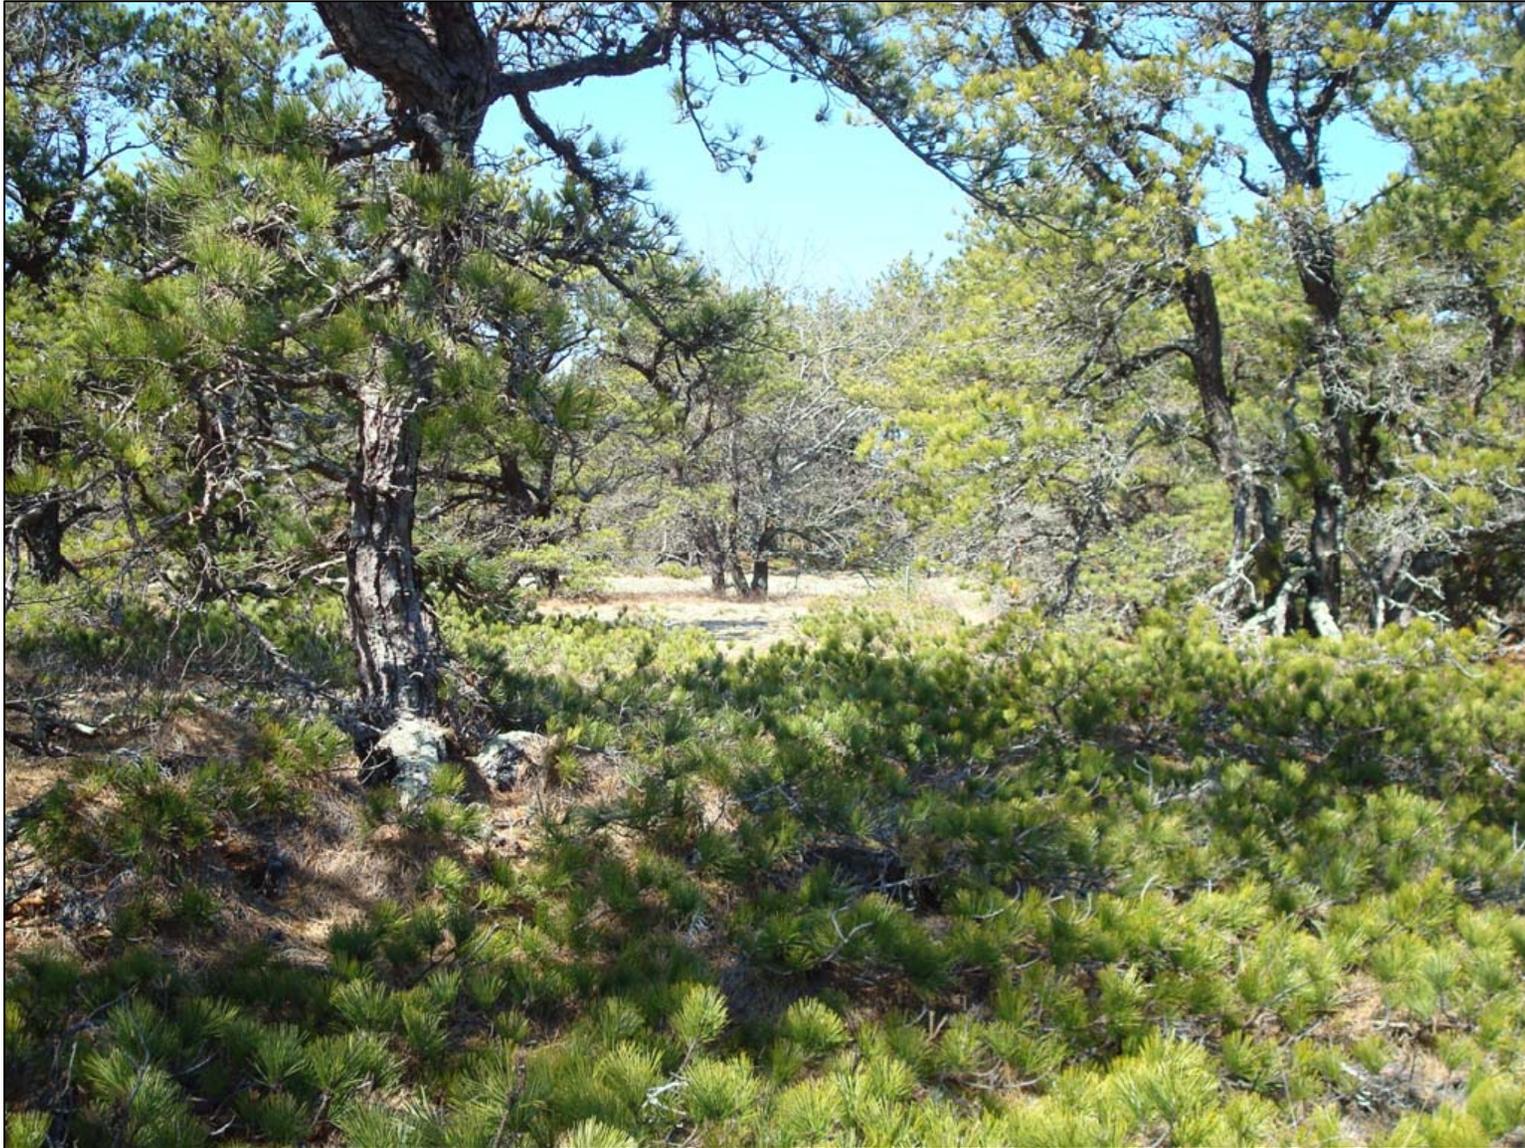
Approximate location of proposed fence alignment. Photo taken at fence stake #1099. Vegetation maintenance will be limited to selective removal of individual pitch pine trees and pitch pine limbs only. There are several open pockets of dune with sparse groundcover (i.e., lichens and *Hudsonia*) among the trees. The fence may be shifted south/southwest (left) slightly to further avoid pruning and selective removal of pitch pine, to the maximum extent possible.

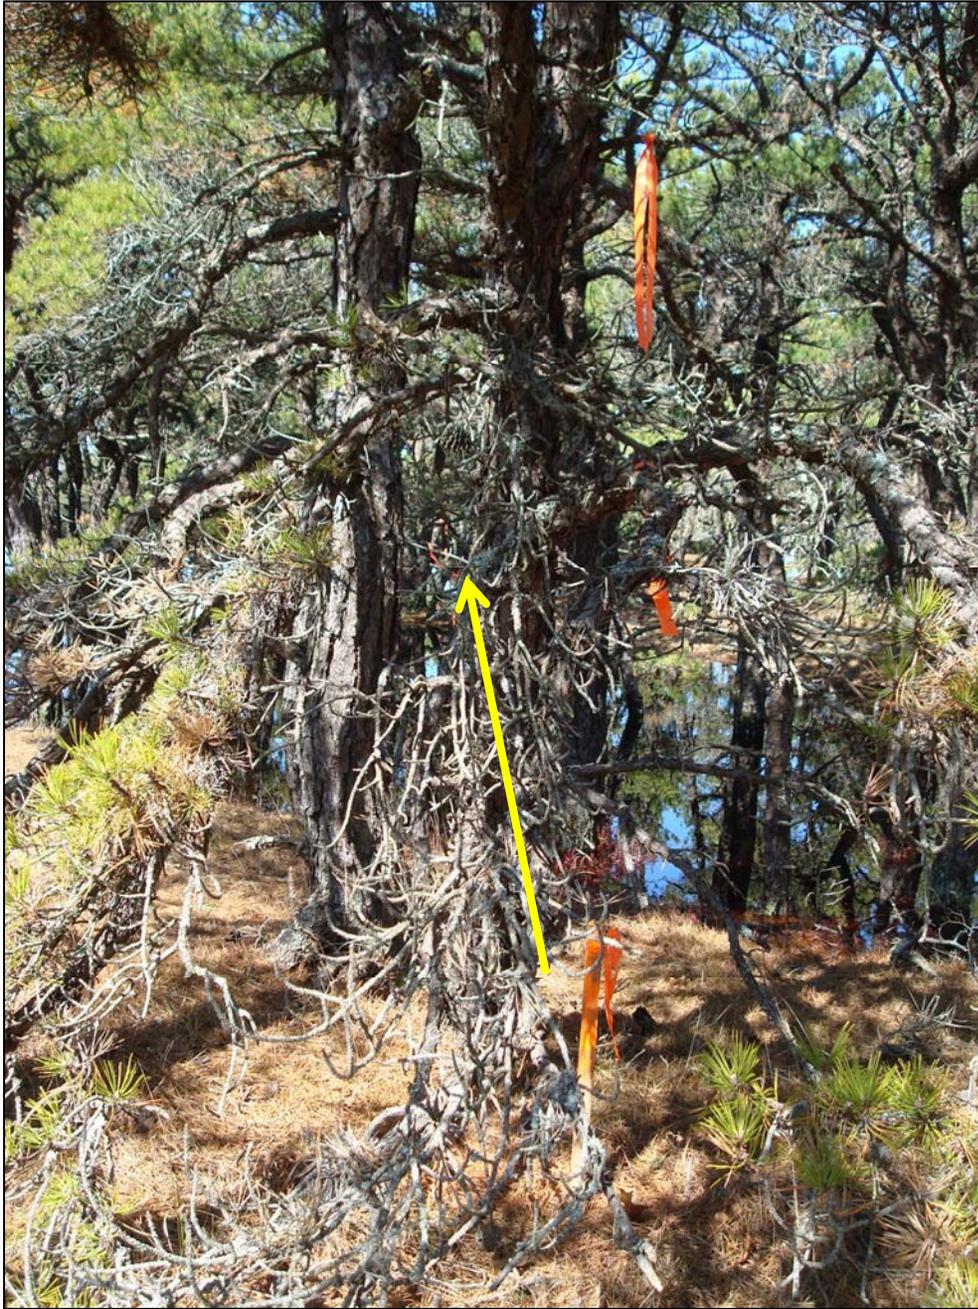
Approximate location of proposed fence alignment. Photo taken at fence stake #1097. Vegetation maintenance will consist of selective removal of individual pitch pine trees and pitch pine limbs only. The fence may be shifted south (left) slightly to further avoid pruning and selective removal of pitch pine and wetland impacts, to the maximum extent possible.

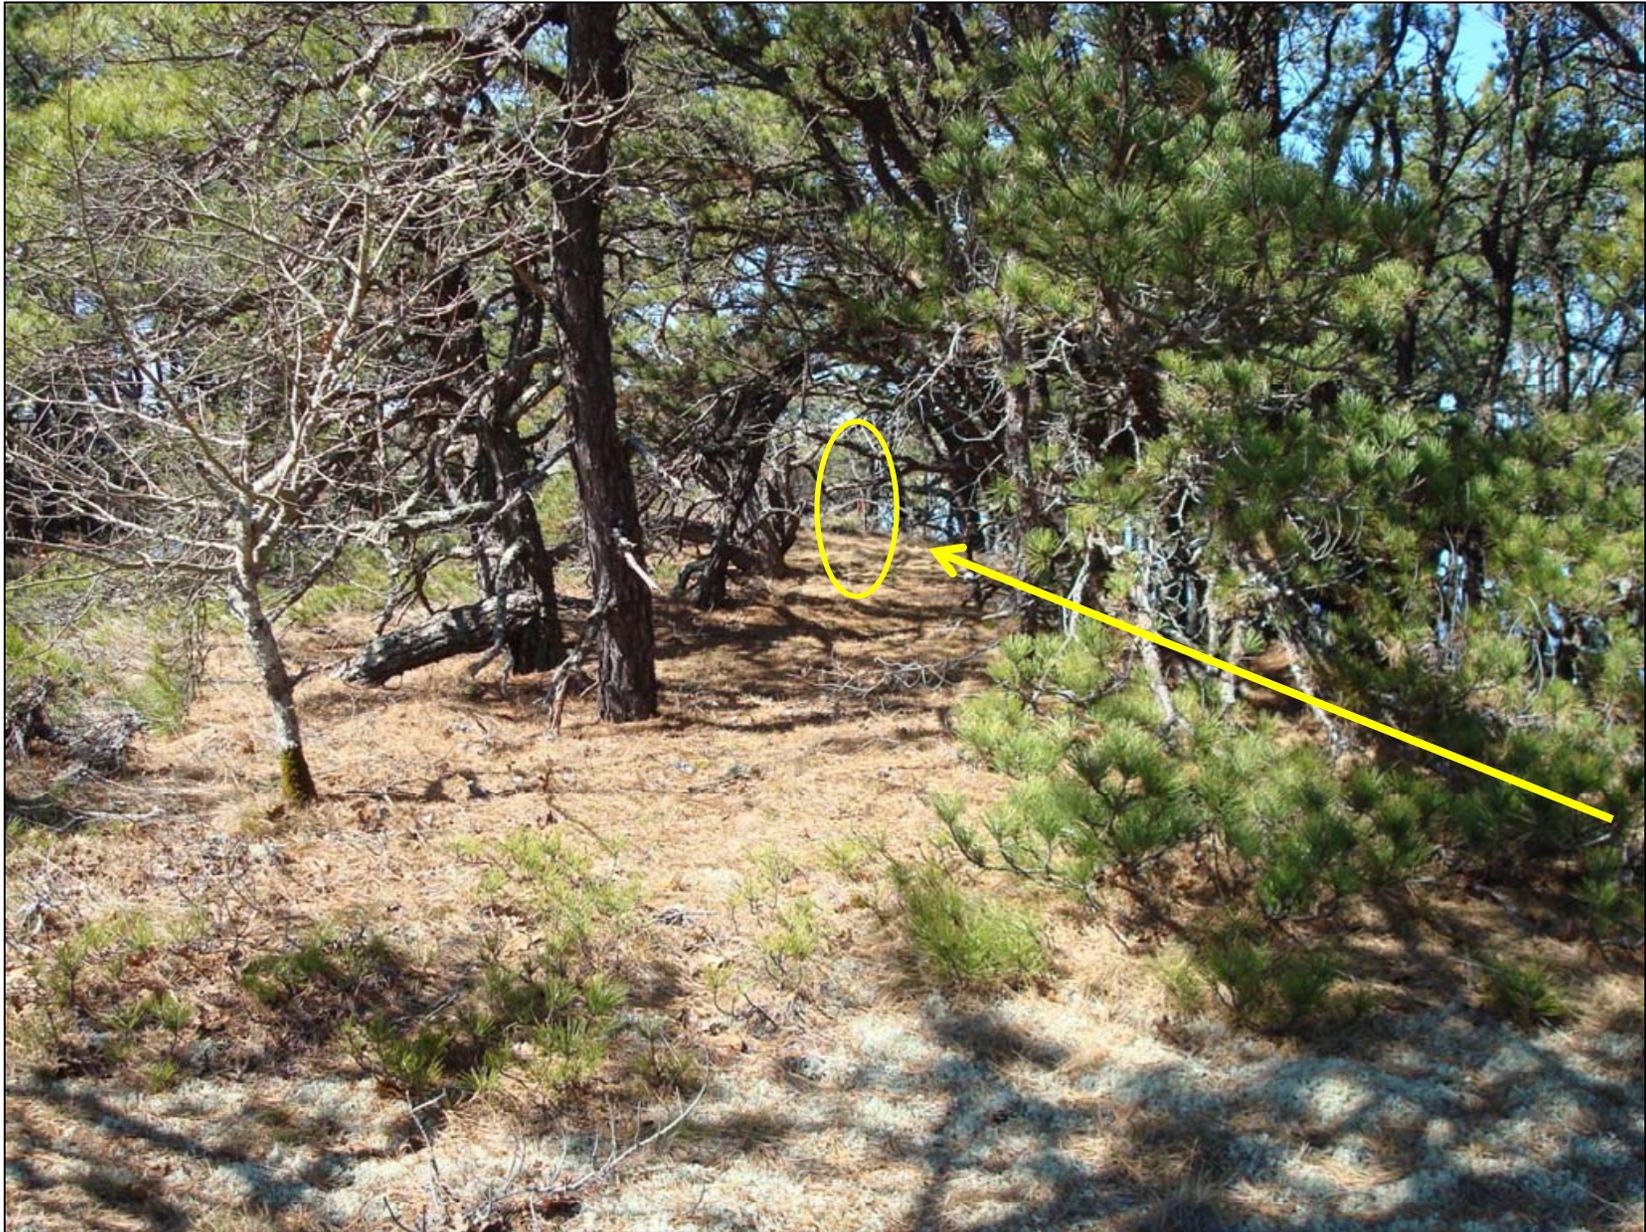
Approximate location of proposed fence alignment. Fence stake #1095 is visible (corner stake). Vegetation maintenance will consist of selective removal of individual pitch pine trees and pitch pine limbs only. The fence may be shifted south (left) slightly to further avoid pruning and selective removal of pitch pine and wetland impacts, to the maximum extent possible.

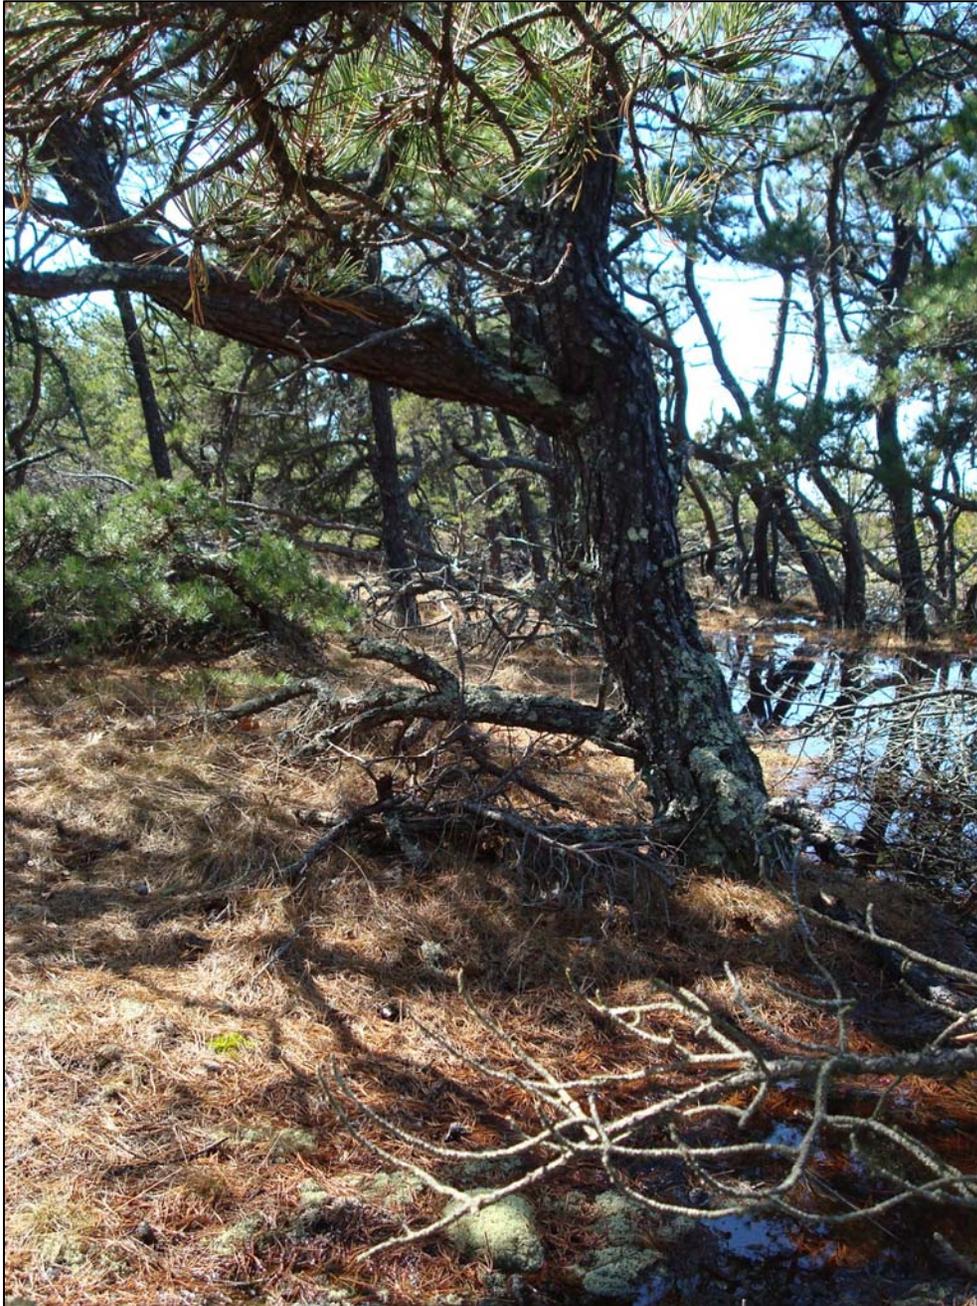
Approximate location of proposed fence alignment. Photo taken at fence stake #1089. Vegetation maintenance will consist of selective removal of individual pitch pine trees and pitch pine limbs only. The fence may be shifted south (left) slightly to further avoid pruning and selective removal of pitch pine and wetland impacts, to the maximum extent possible.

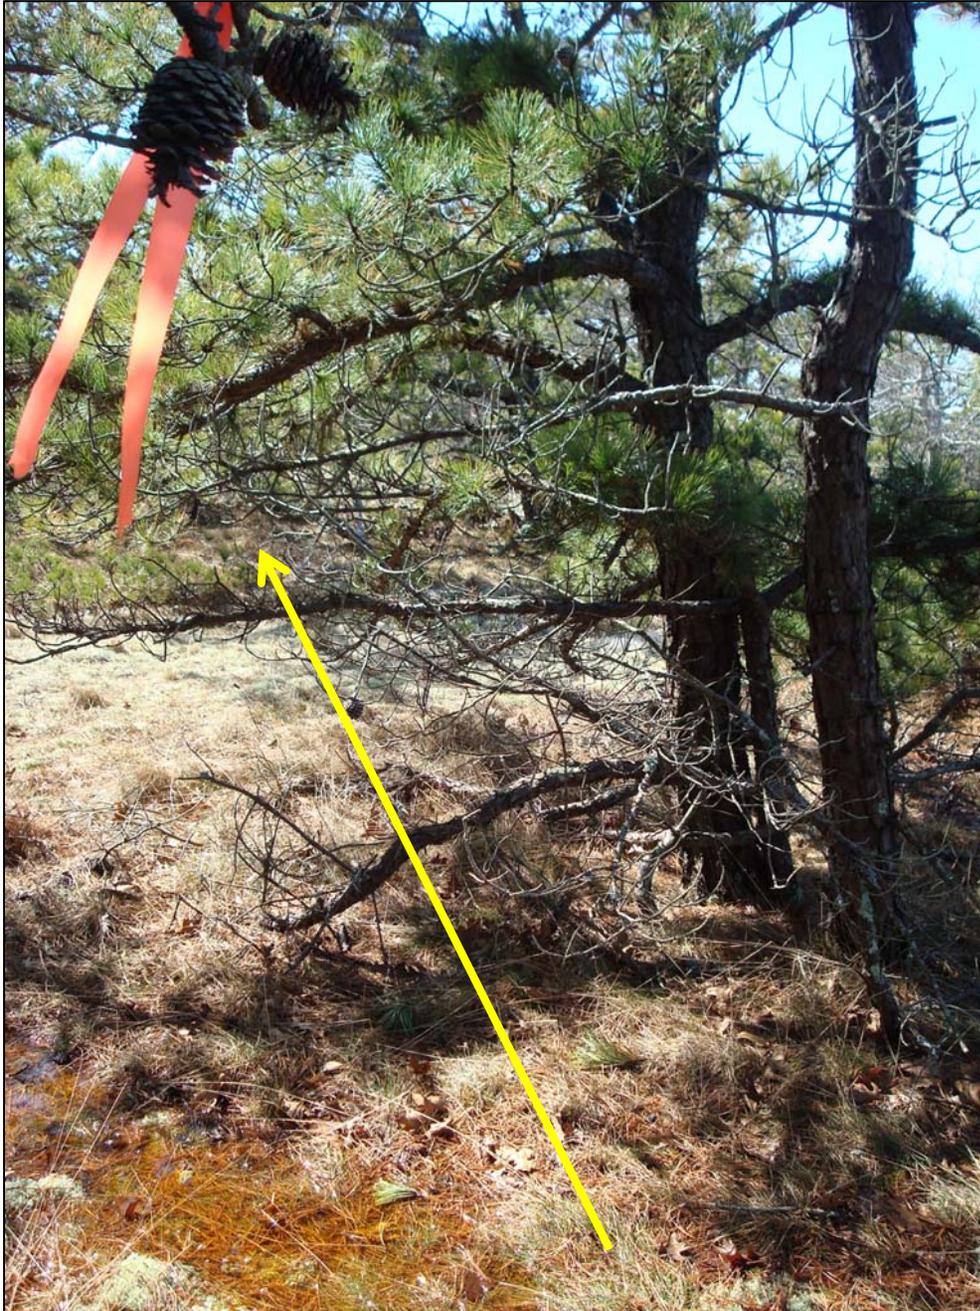
Approximate location of proposed fence alignment. Photo taken near fence stake #1089. Vegetation maintenance will consist of selective removal of individual pitch pine trees and pitch pine limbs only. There are several open pockets of dune with sparse groundcover (i.e., lichens and *Hudsonia*) among the trees.

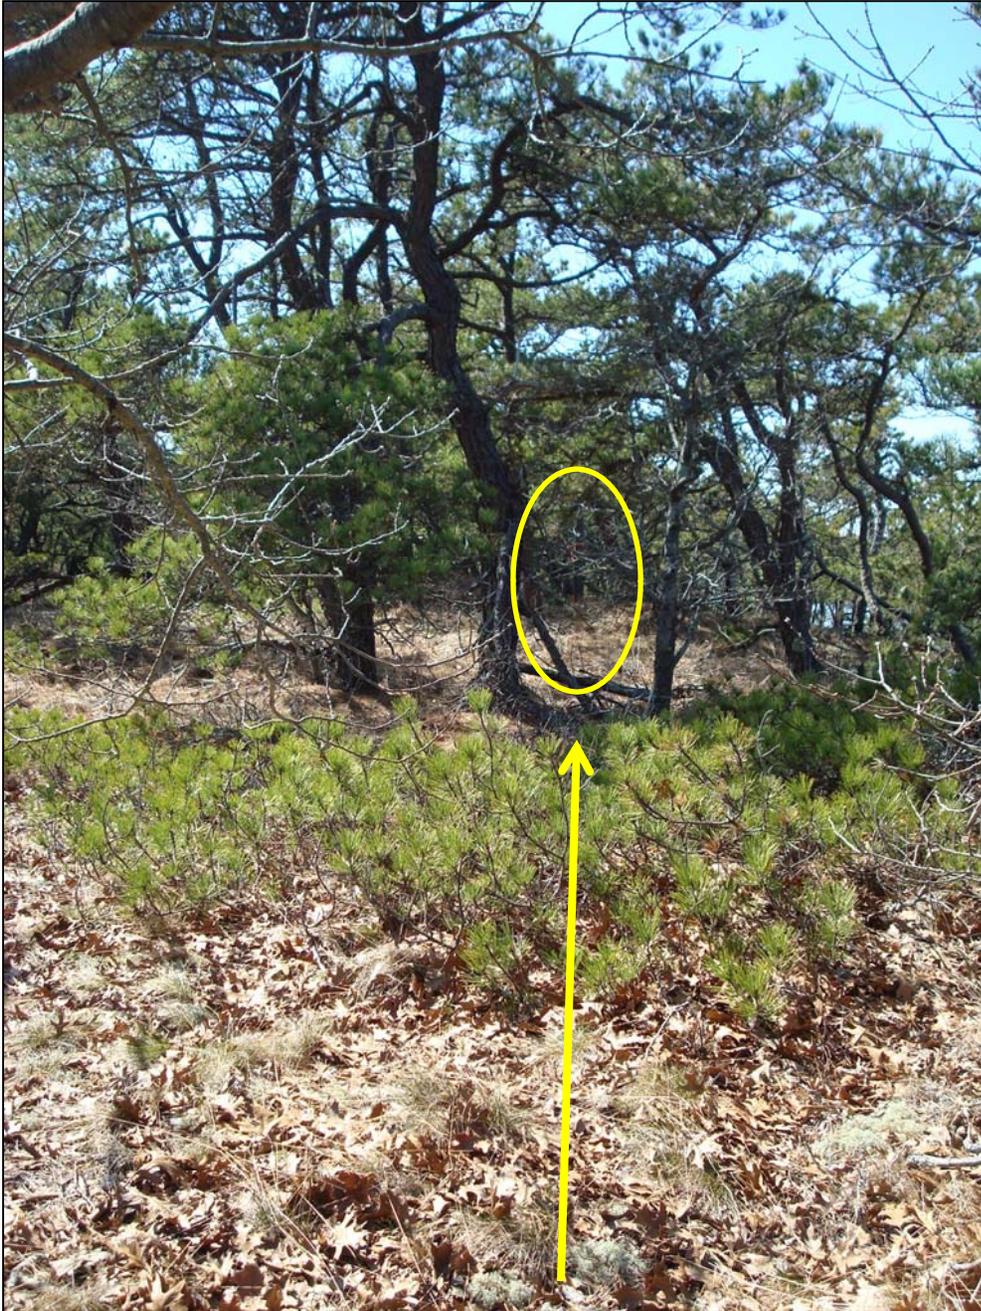
Approximate location of proposed fence alignment. Fence stake #1087 is visible. Vegetation maintenance will consist of selective removal of individual pitch pine trees and pitch pine limbs only. There are several open pockets of dune with sparse groundcover (i.e., lichens and *Hudsonia*) among the trees where no cutting would be necessary.

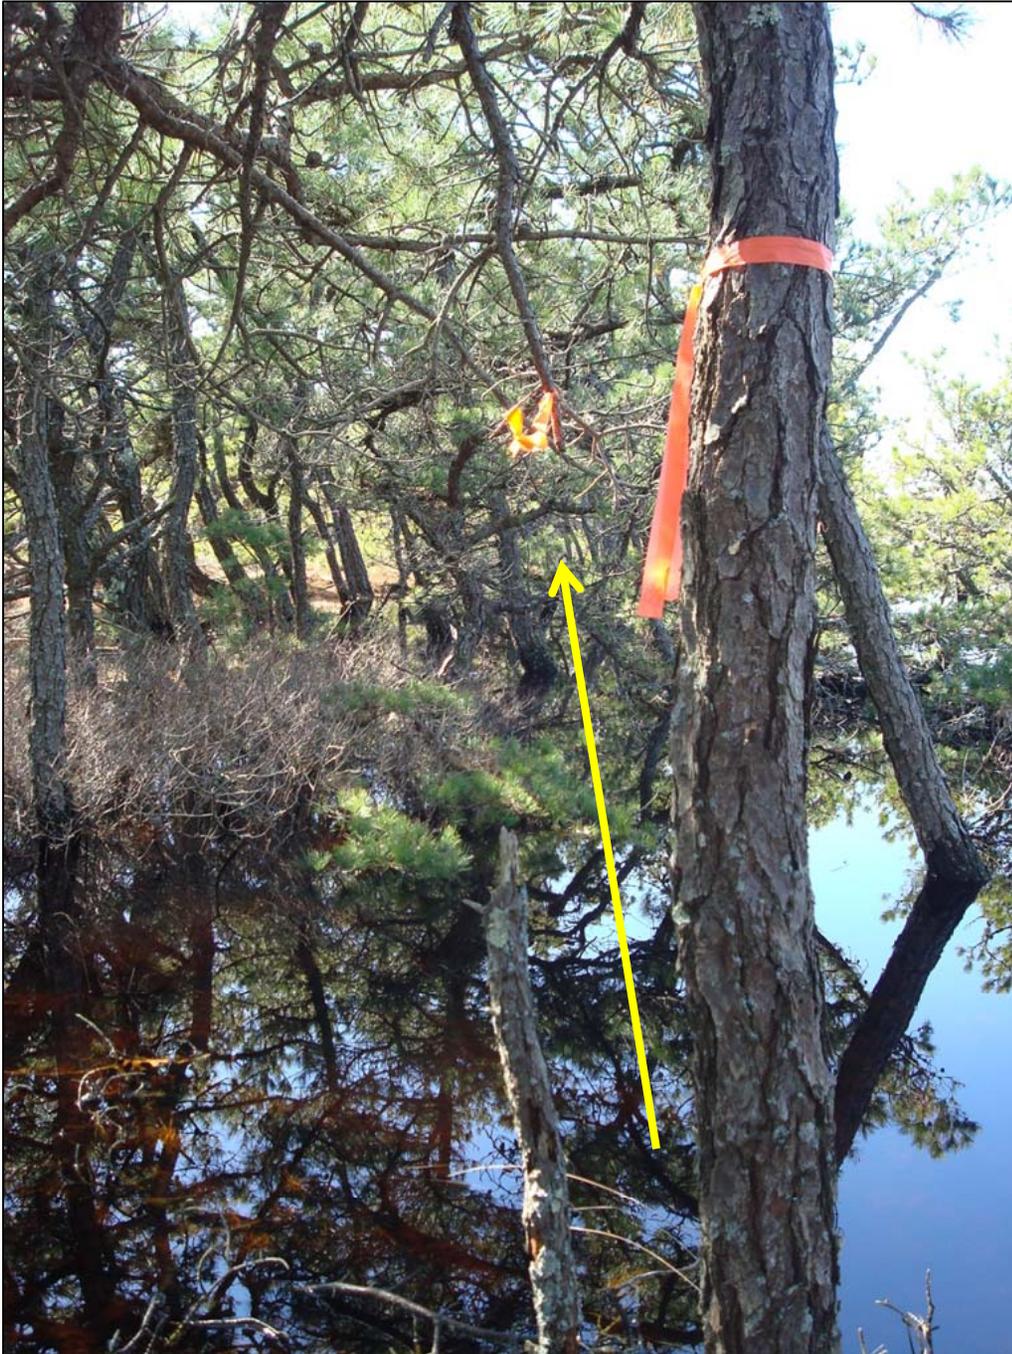
Example of area where shifting the fence alignment (Concept 6) would eliminate the need for cutting within otherwise undisturbed areas.

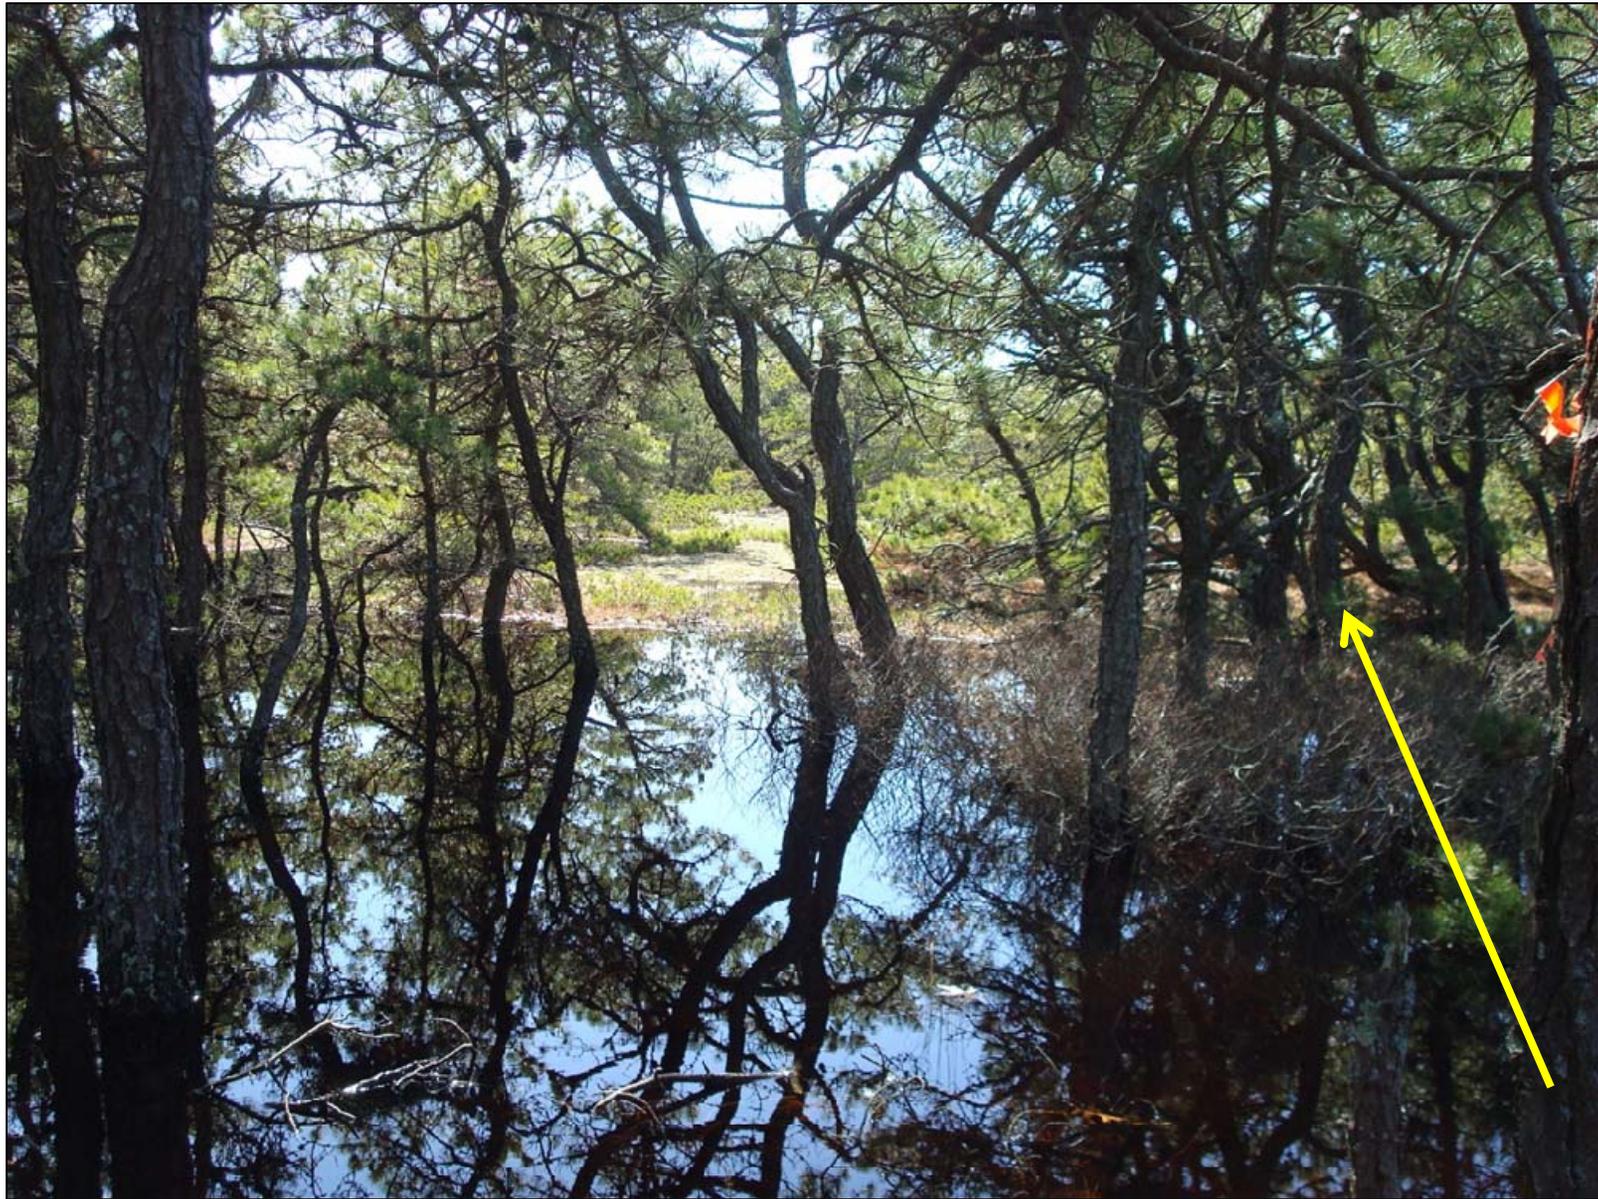
Approximate location of proposed fence alignment, near fence stake #1087. Vegetation maintenance will consist of selective removal of individual pitch pine trees and pitch pine limbs only. There are several open pockets of dune with sparse groundcover (i.e., lichens and *Hudsonia*) among the trees.

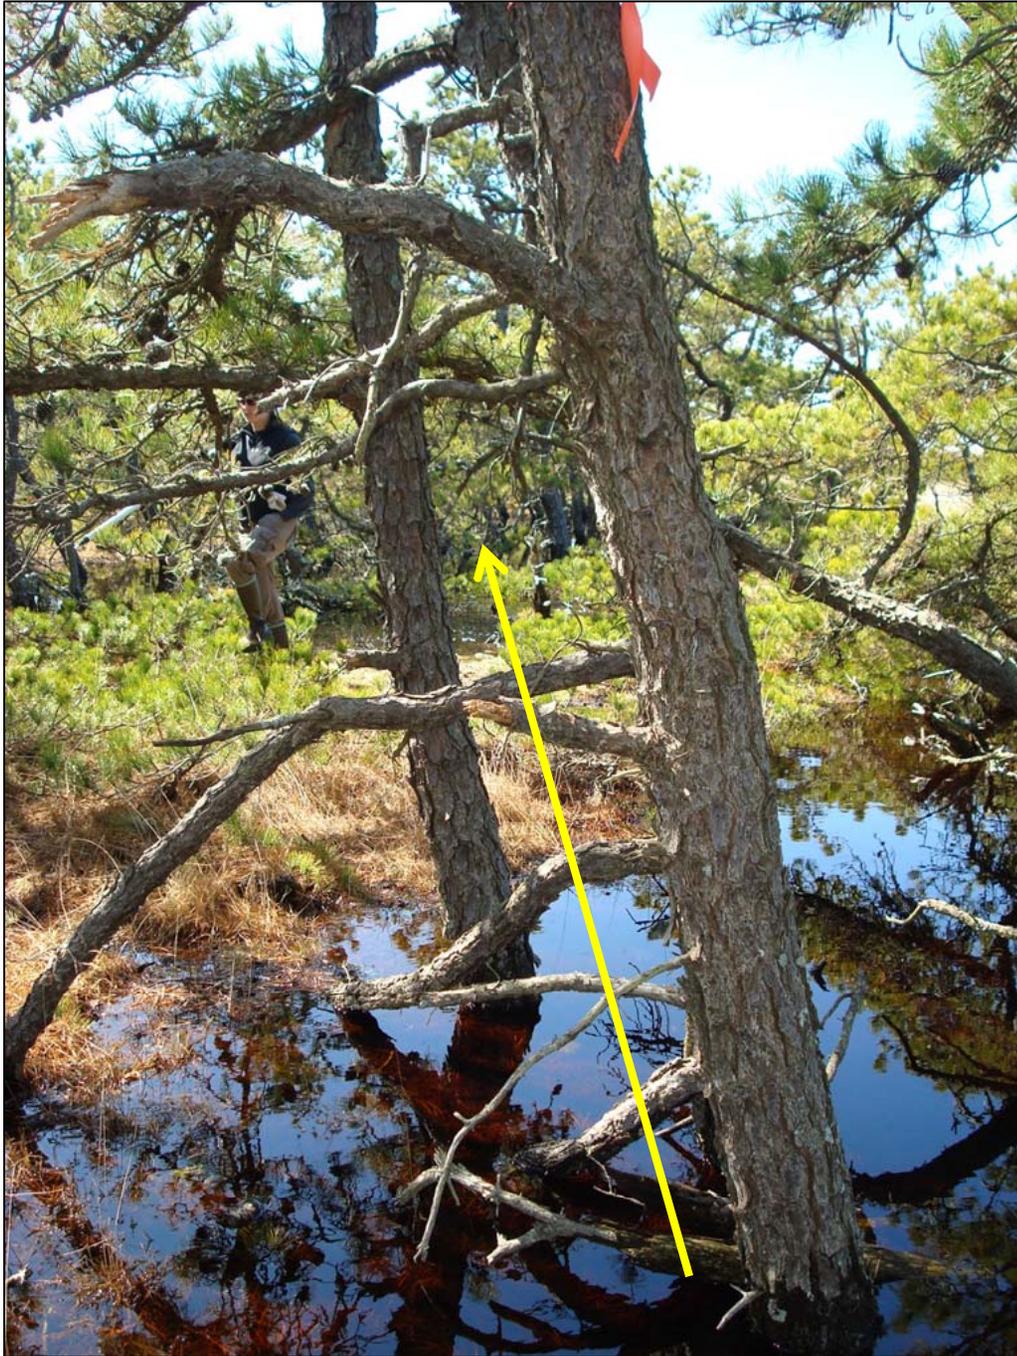
Approximate location of proposed fence alignment, near fence stake #1087. Vegetation maintenance will consist of selective removal of individual pitch pine trees and pitch pine limbs only. There are several open pockets of dune with sparse groundcover (i.e., lichens and *Hudsonia*) among the trees.

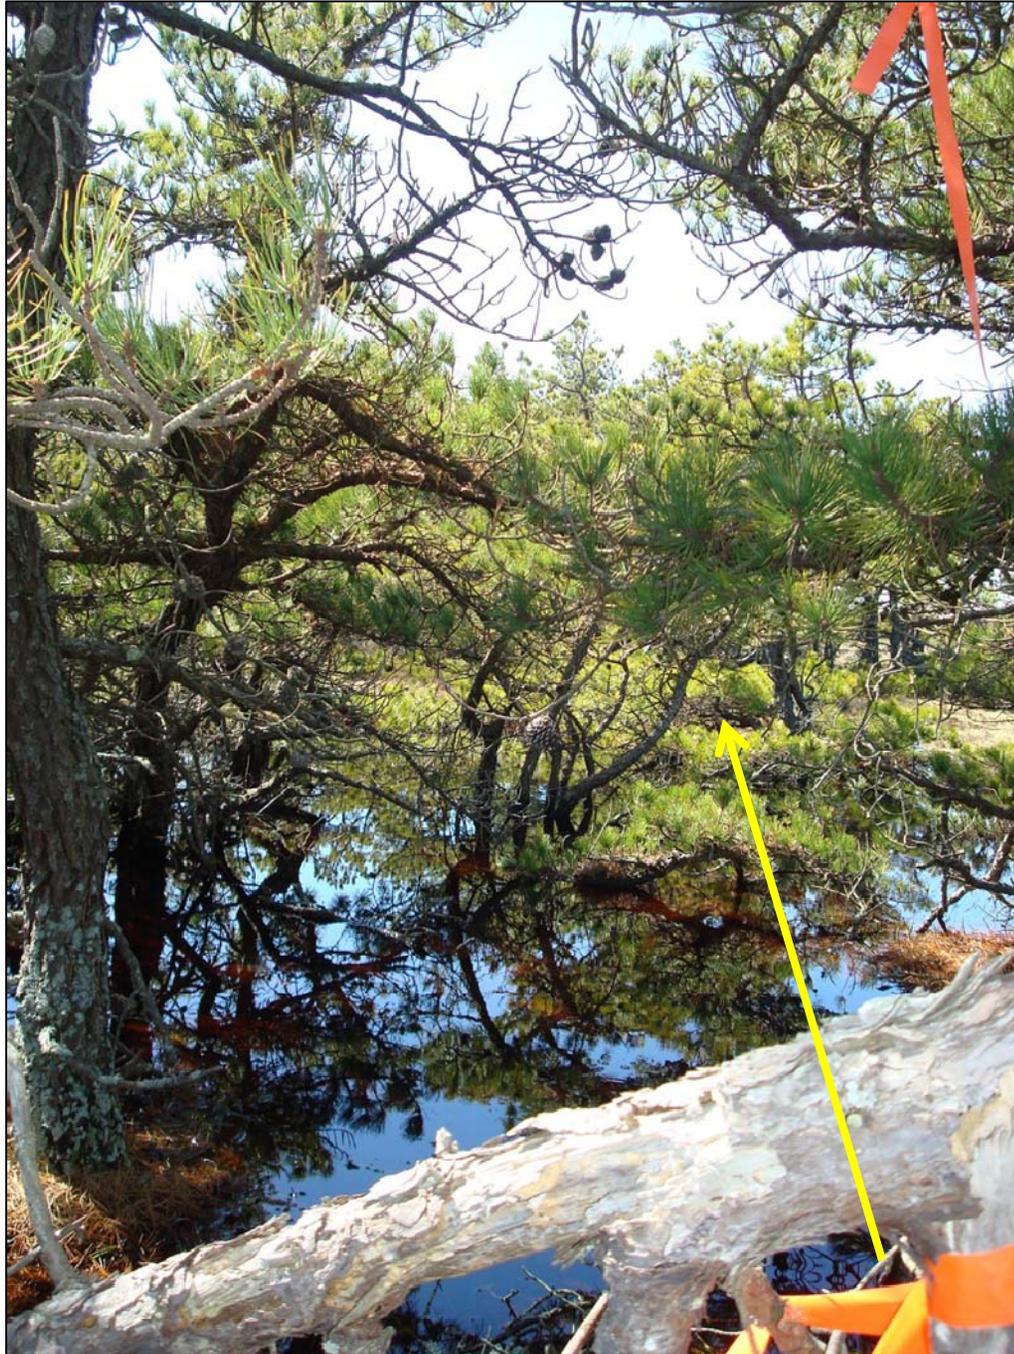
Approximate location of proposed fence alignment near fence stake #1085. Vegetation maintenance will consist of selective removal of individual pitch pine trees and pitch pine limbs only. There are several open pockets of dune with sparse groundcover (i.e., lichens and *Hudsonia*) among the trees.
