Proposed Fence Alignment “Concept 6”

Provincetown Municipal Airport
Provincetown, MA

“Southern Section”

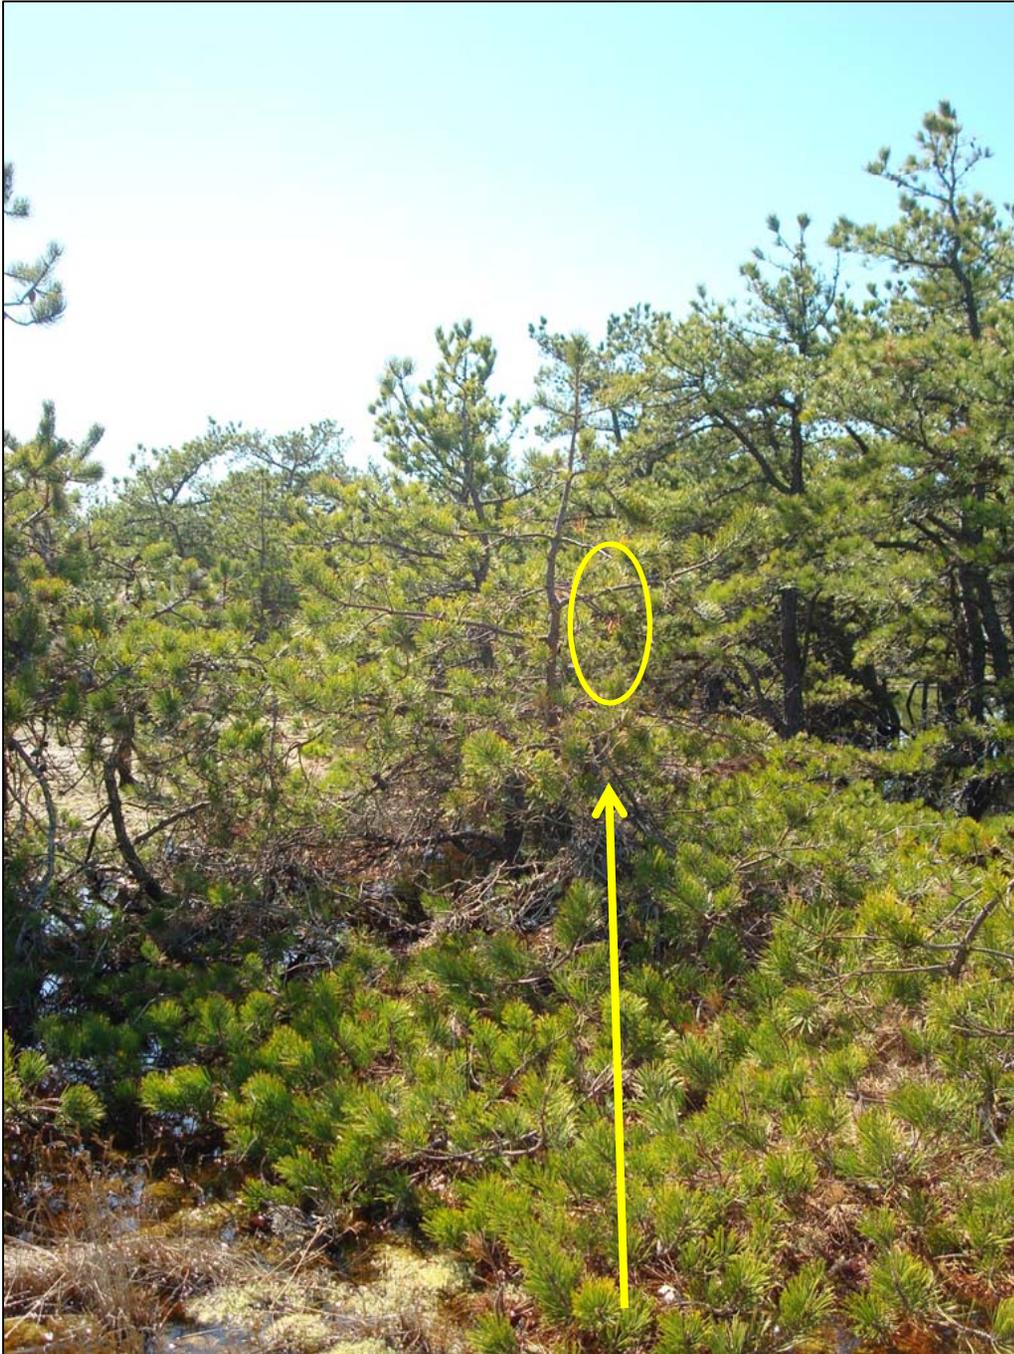
Approximate location of proposed fence alignment. Fence stake #1083 is in the foreground. Vegetation maintenance will consist of selective removal of individual pitch pine trees and pitch pine limbs only. There are several open pockets of dune with sparse groundcover (i.e., lichens and *Hudsonia*) among the trees.

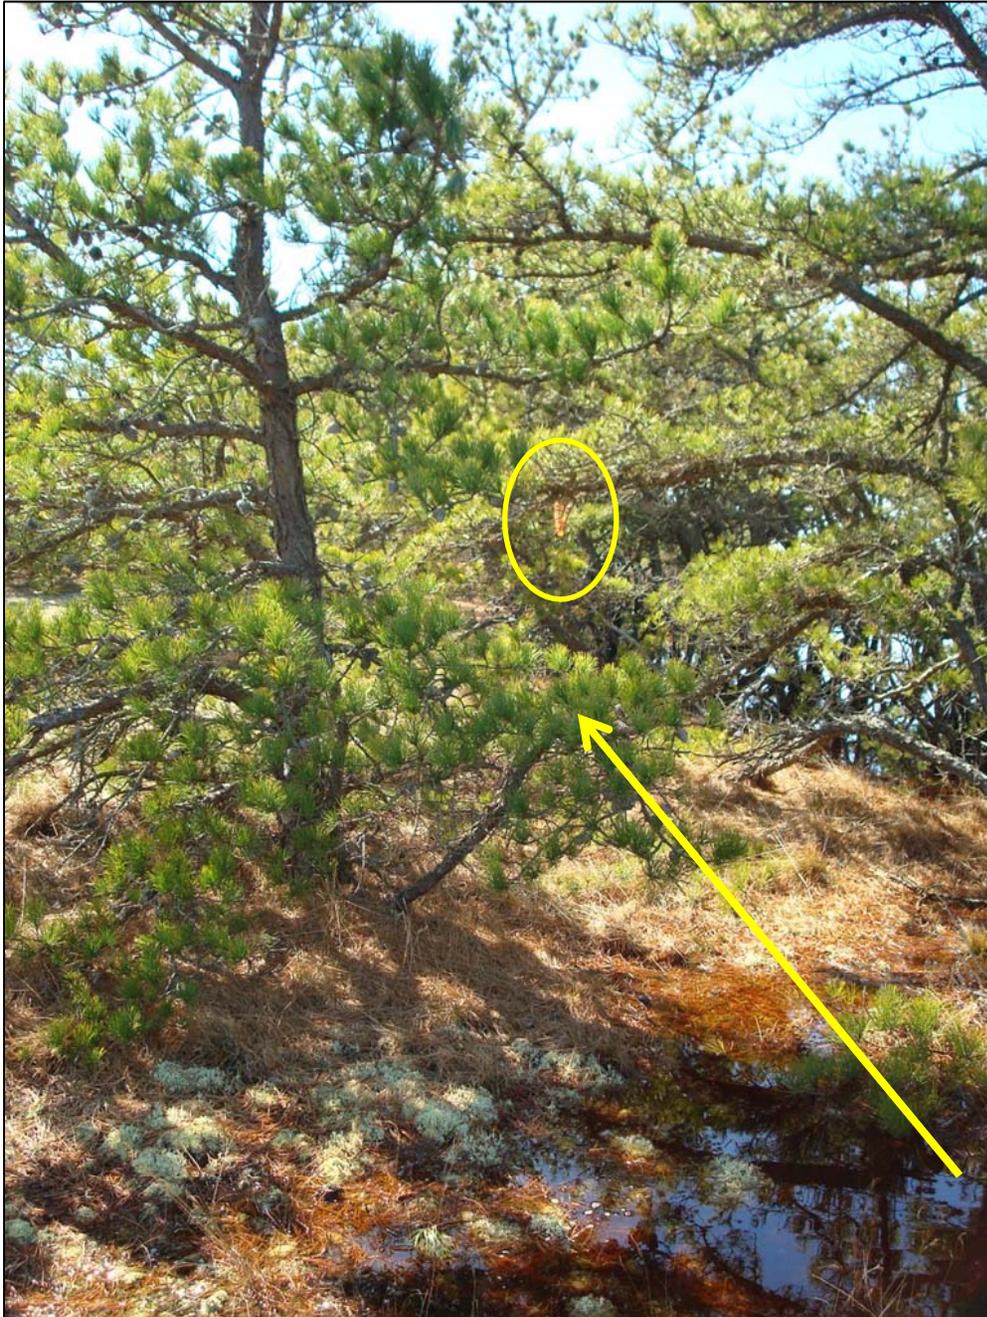
Approximate location of proposed fence alignment. Fence stake #1081 is visible. Vegetation maintenance will consist of selective removal of individual pitch pine trees and pitch pine limbs only. There are several open pockets of dune with sparse groundcover (i.e., lichens and *Hudsonia*) among the trees.

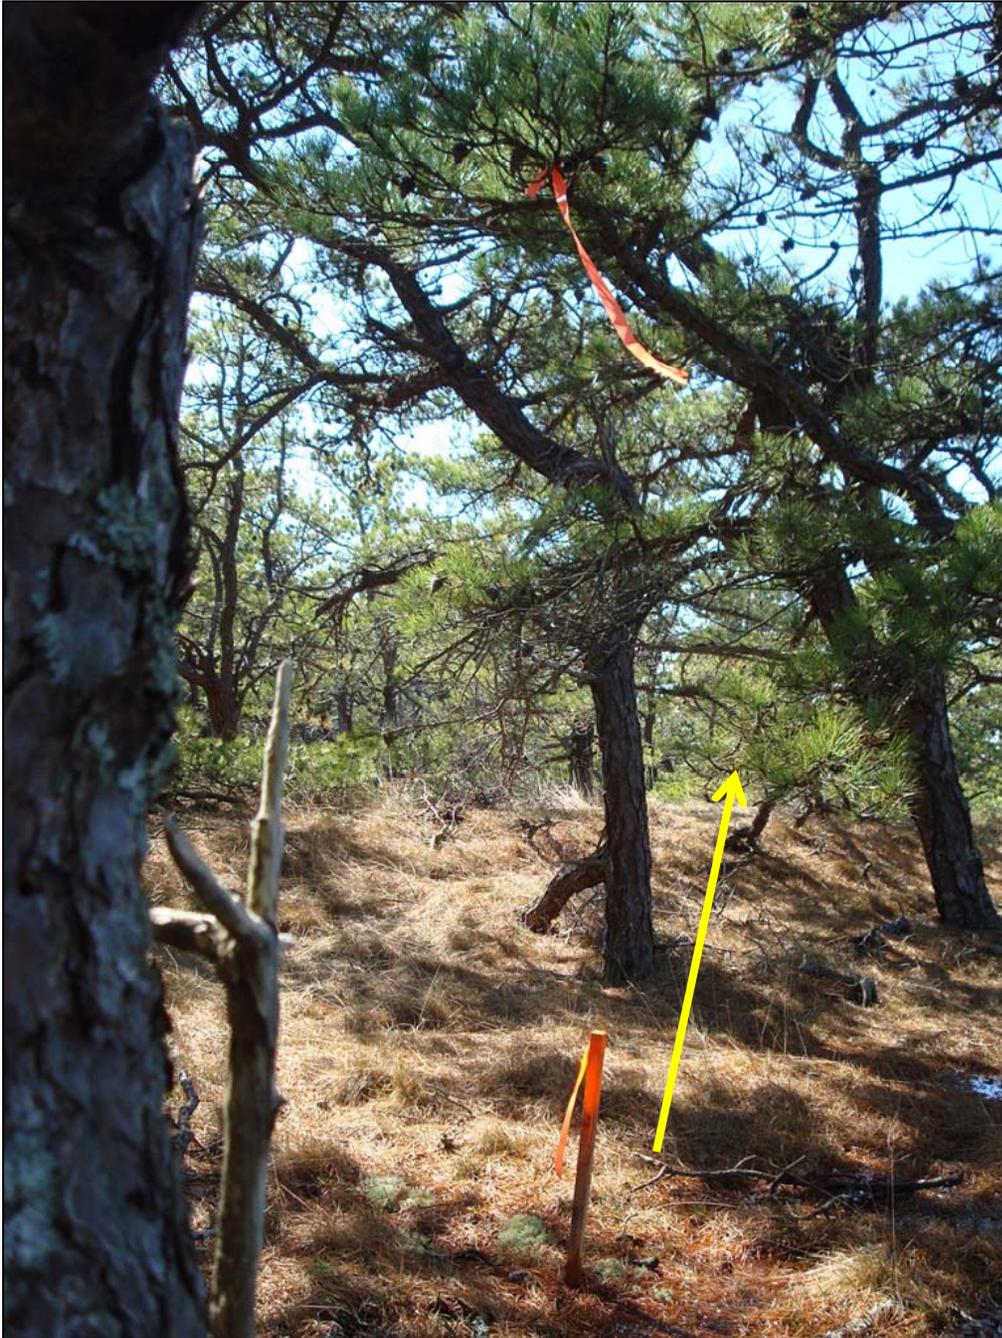
Area of open upland dune adjacent to fence stake #1081. Arrow depicts approximate fence line.

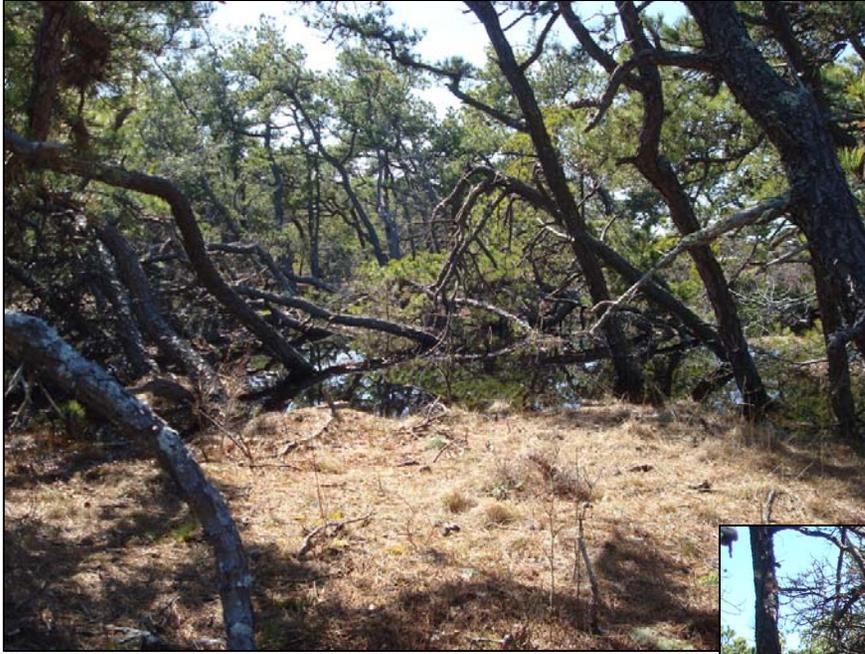
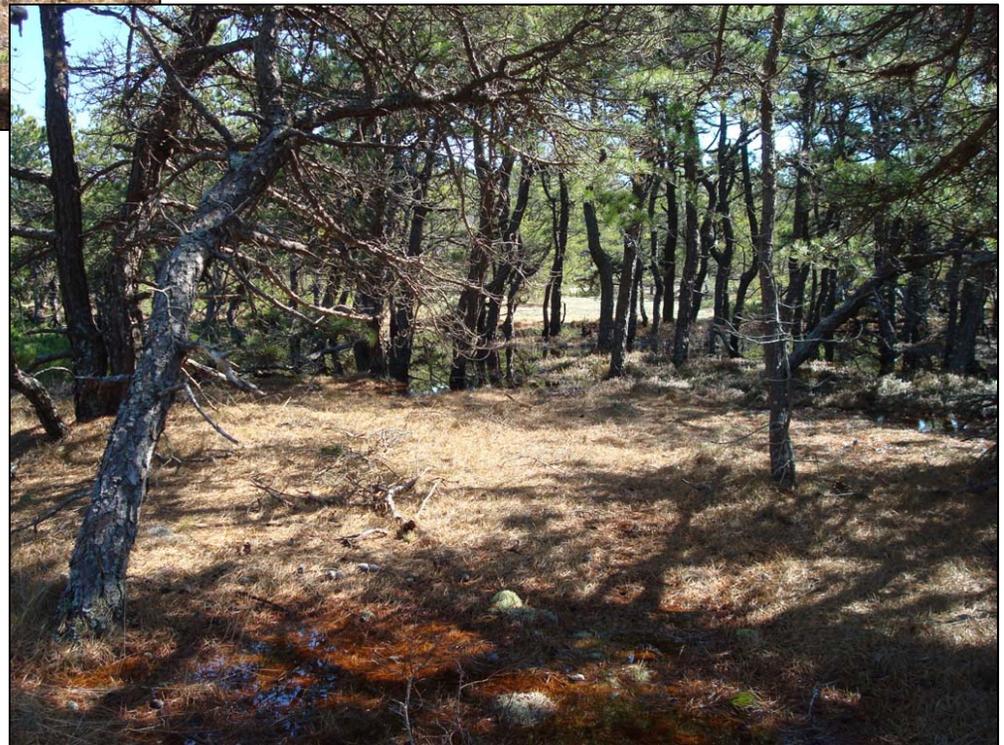
Examples of open areas where shifting the fence may be possible to avoid the need for cutting of vegetation.

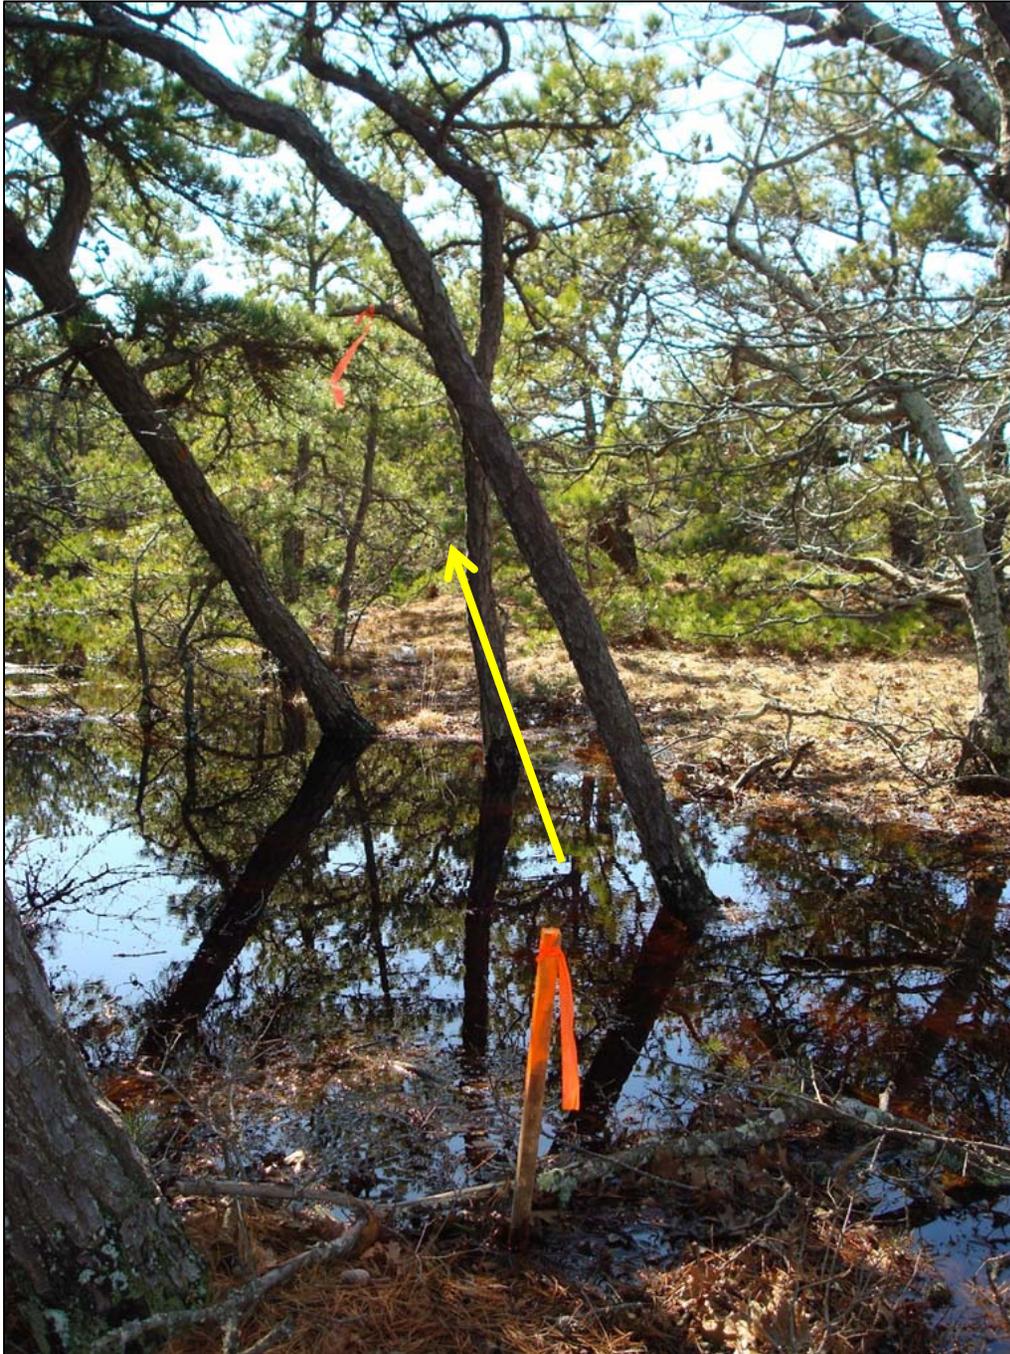
Approximate location of proposed fence alignment at fence stake #1077. Vegetation maintenance will consist of selective removal of individual pitch pine trees and pitch pine limbs only. There are several open pockets of dune with sparse groundcover (i.e., lichens and *Hudsonia*) among the trees.

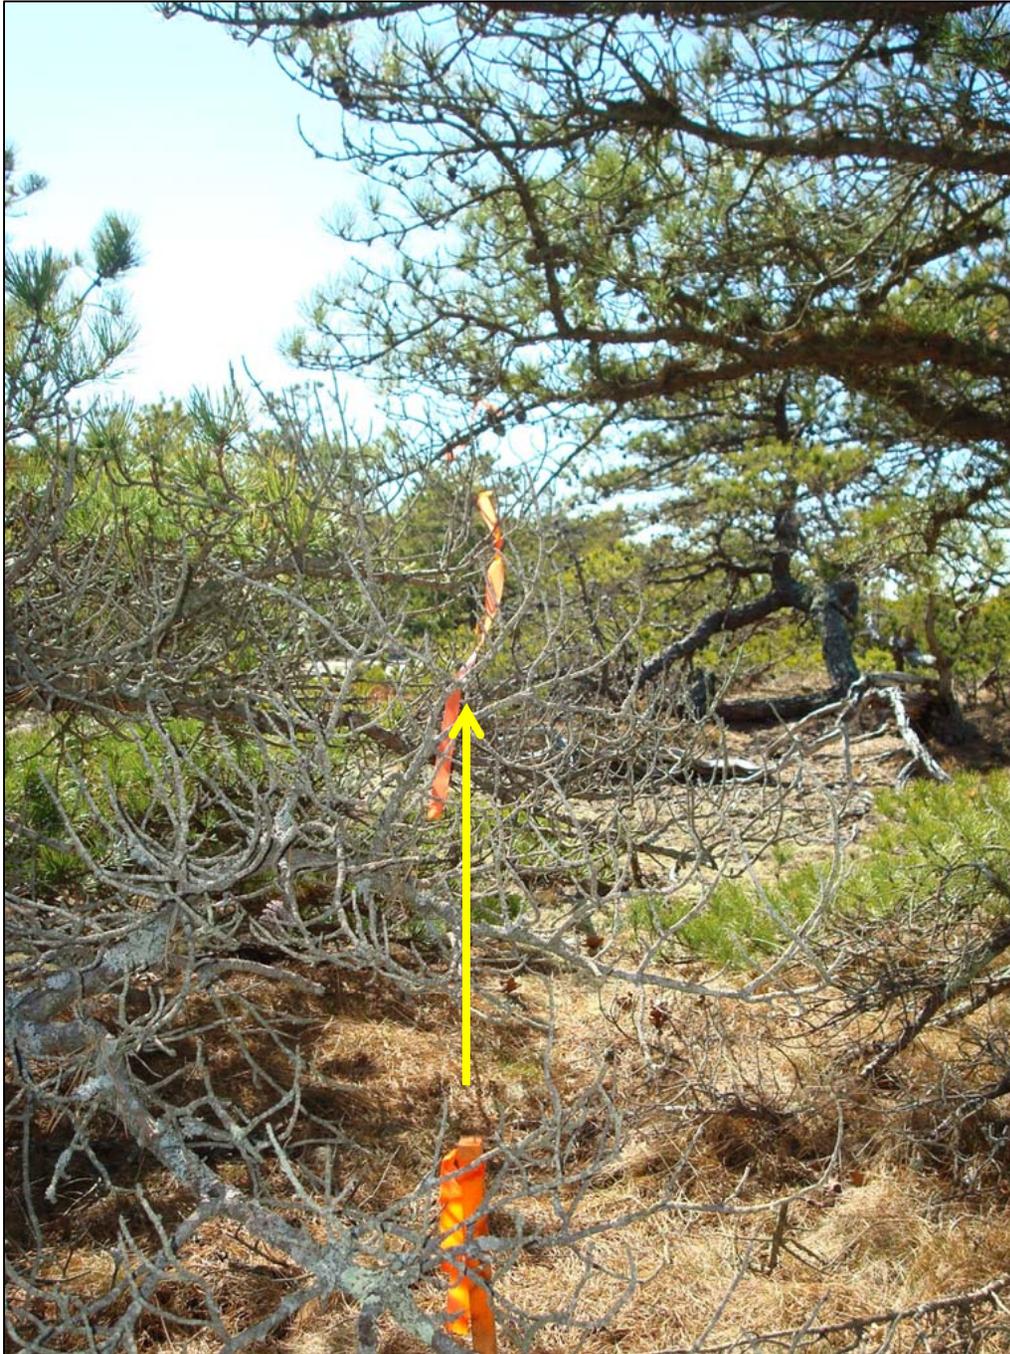
Approximate location of proposed fence alignment, near fence stake #1075. Vegetation maintenance will consist of selective removal of individual pitch pine trees and pitch pine limbs only. There are several open pockets of dune with sparse groundcover (i.e., lichens and *Hudsonia*) among the trees.

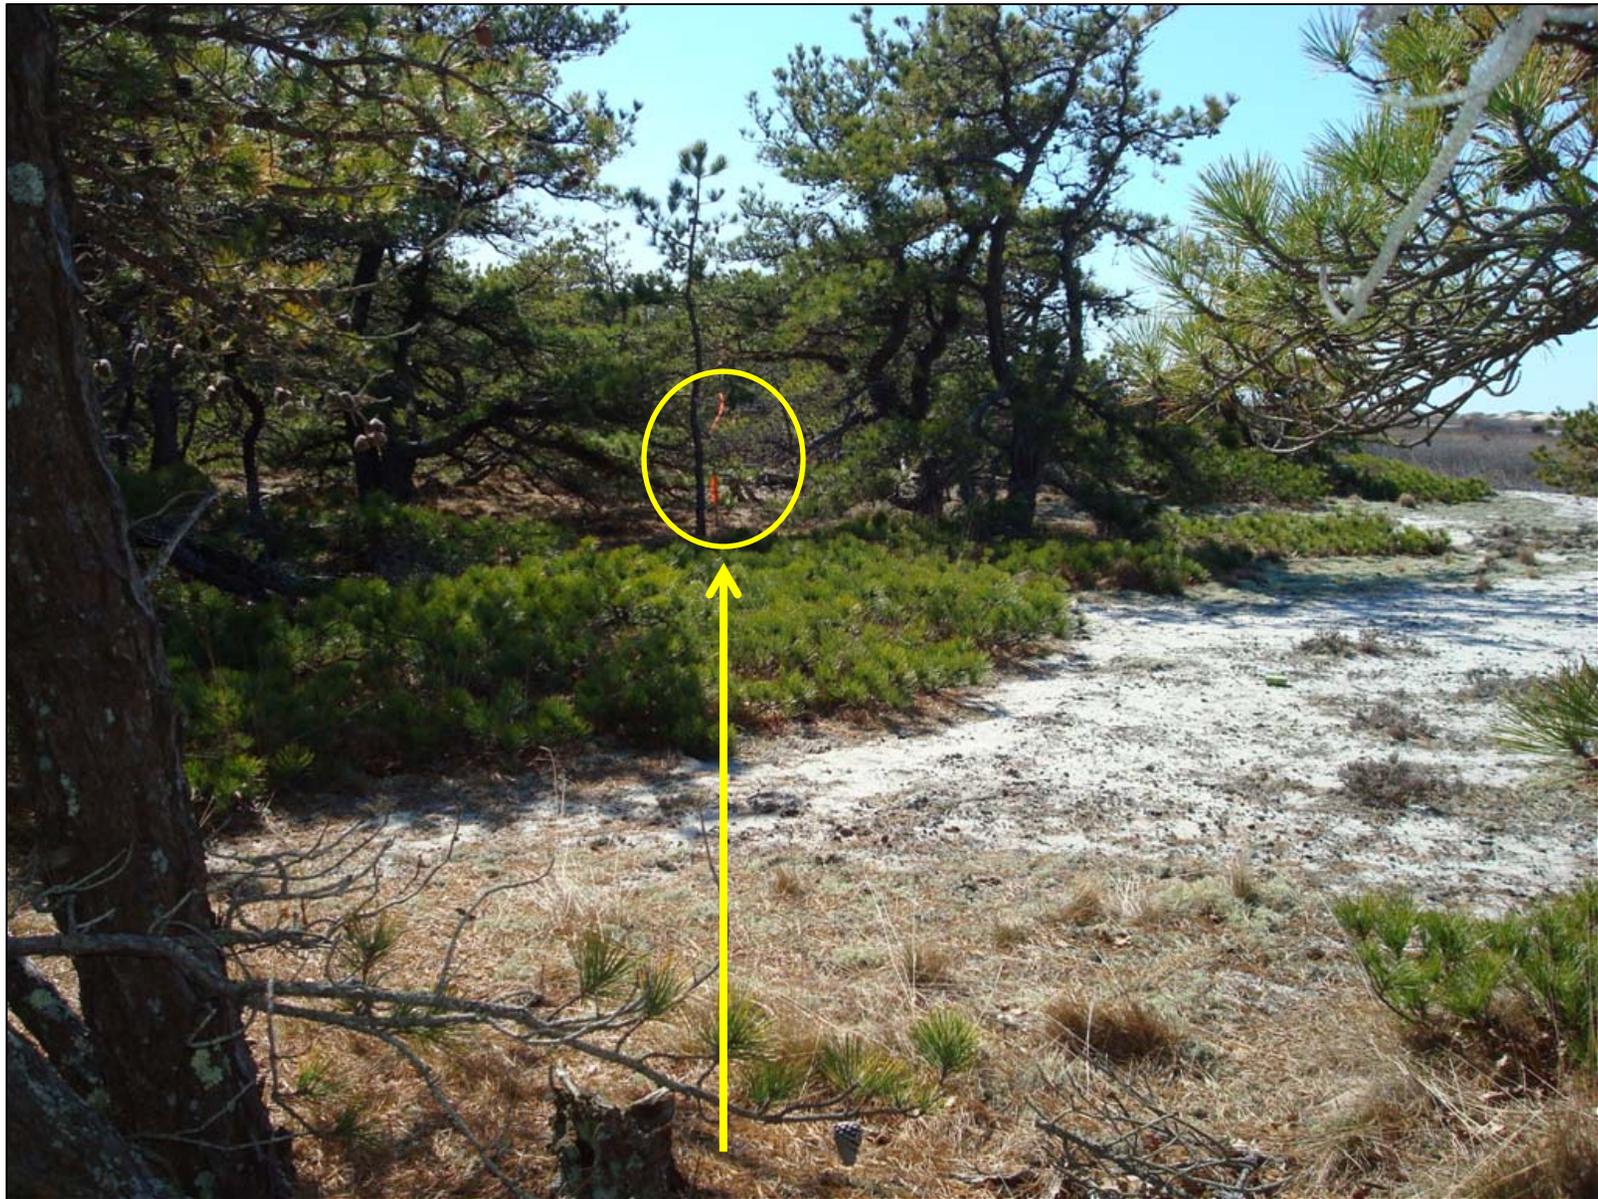
Approximate location of proposed fence alignment at fence stake #1073. Vegetation maintenance will consist of selective removal of individual pitch pine trees and pitch pine limbs only. There are several open pockets of dune with sparse groundcover (i.e., lichens and *Hudsonia*) among the trees. The yellow arrow depicts the approximate alignment of the fence.

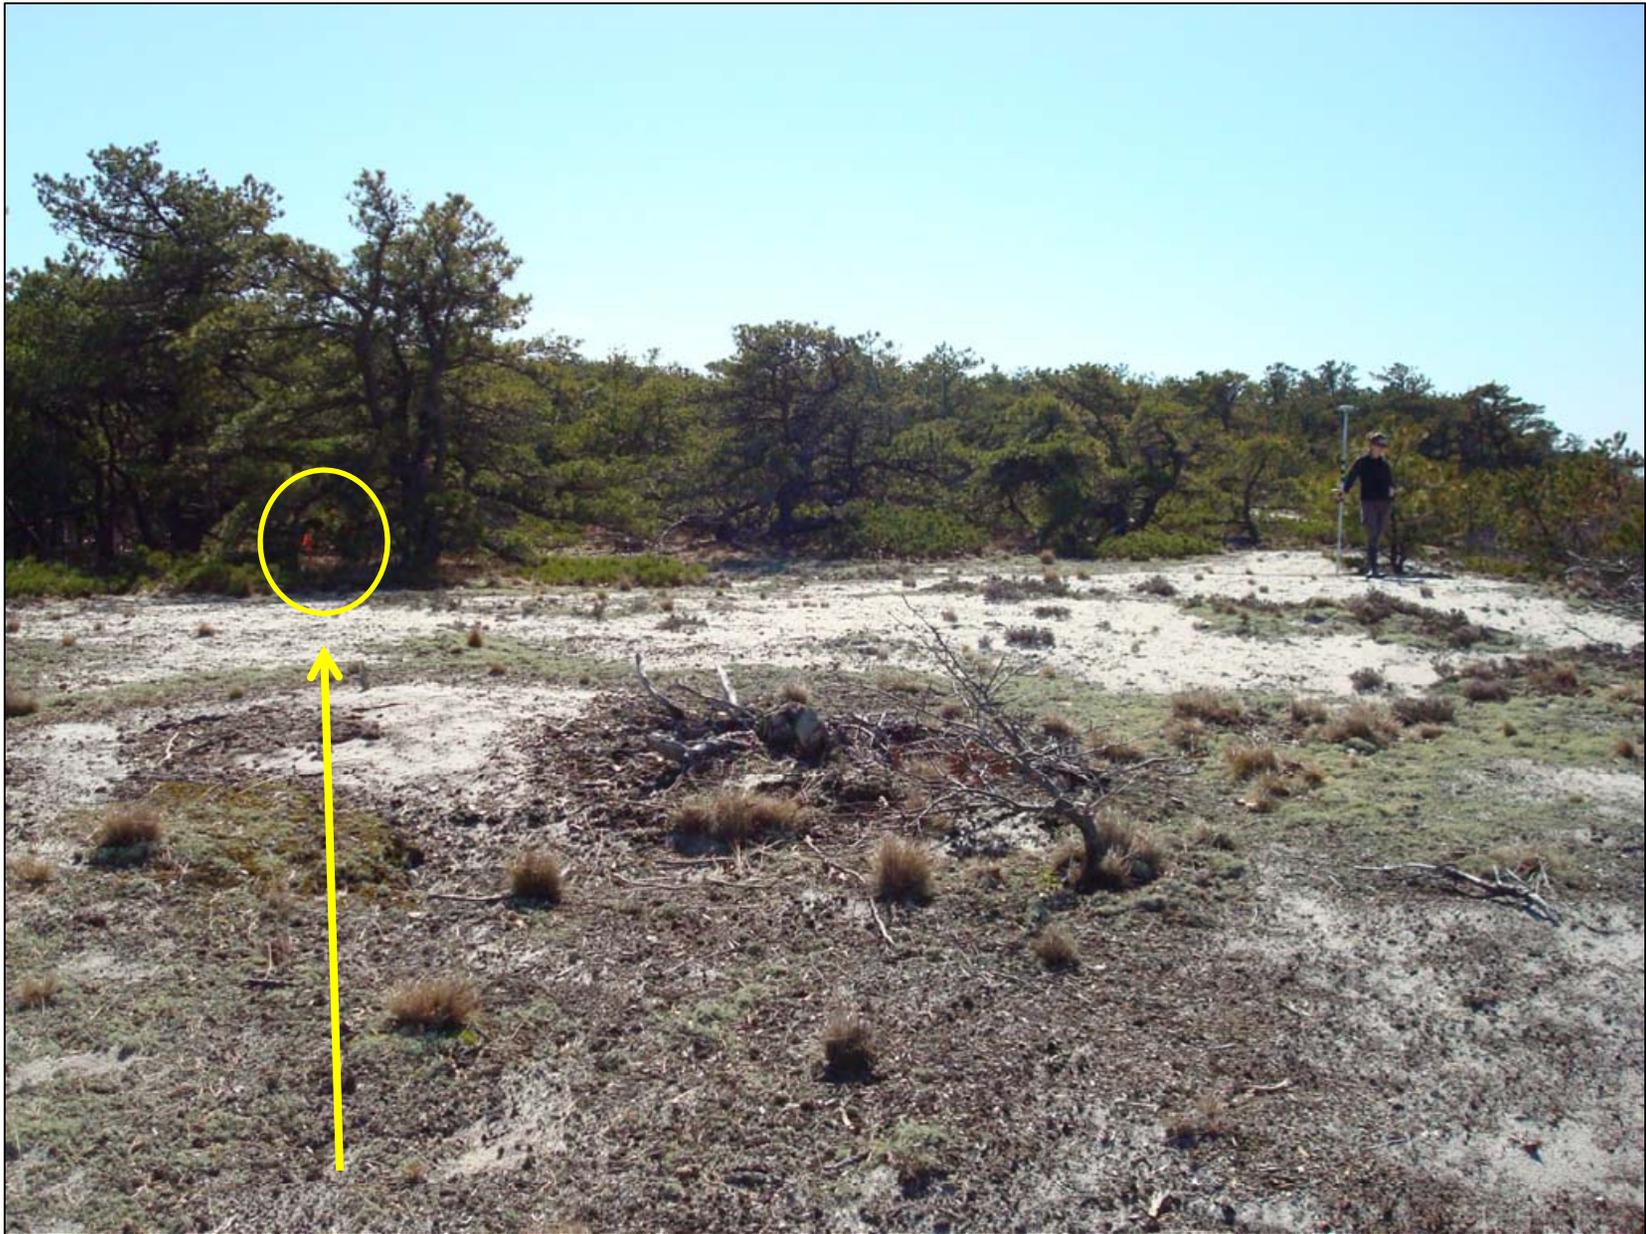
Approximate location of proposed fence alignment. Fence stake #1071 is visible. Vegetation maintenance will consist of selective removal of individual pitch pine trees and pitch pine limbs only. There are several open pockets of dune with sparse groundcover (i.e., lichens and *Hudsonia*) among the trees.

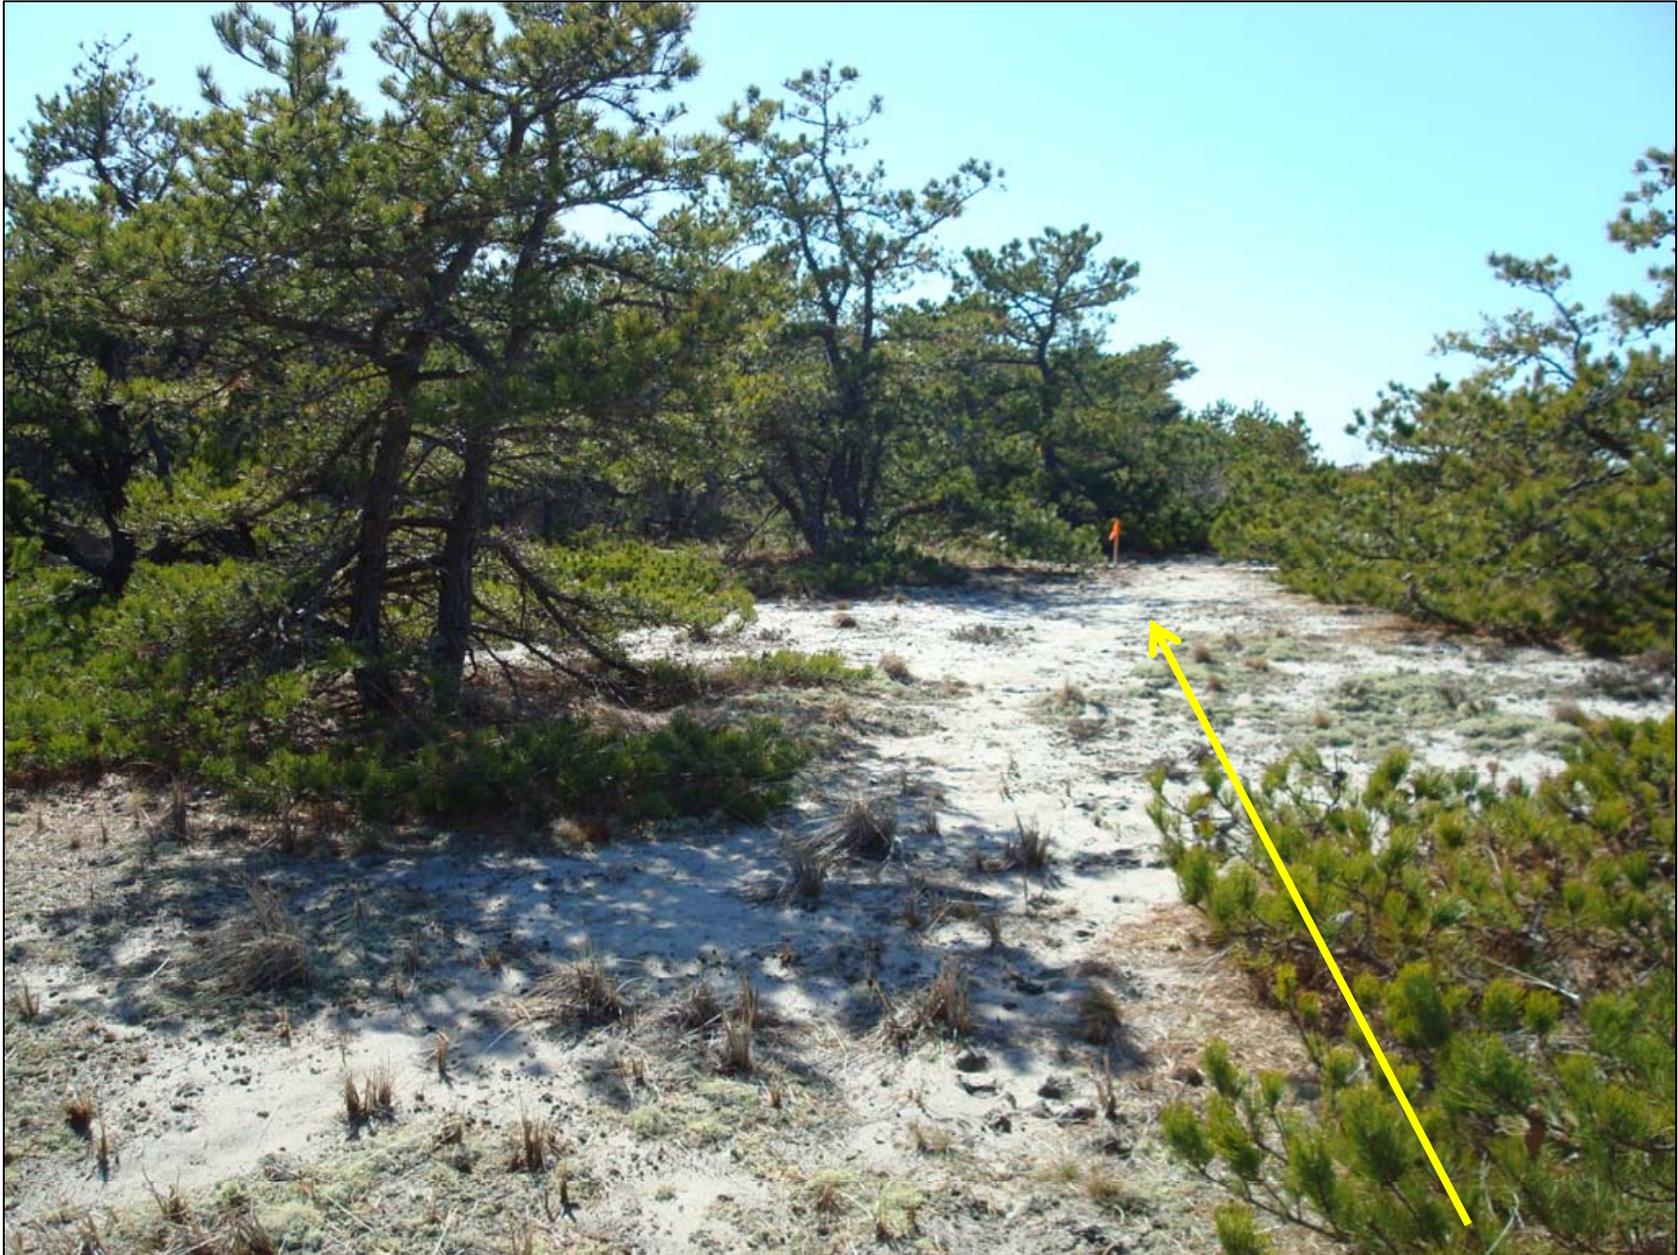
Additional view of the proposed fence alignment between fence stake #1071 and #1069. Vegetation maintenance will consist of selective removal of individual pitch pine trees and pitch pine limbs only. There are several open pockets of dune with sparse groundcover (i.e., lichens and *Hudsonia*) among the trees.

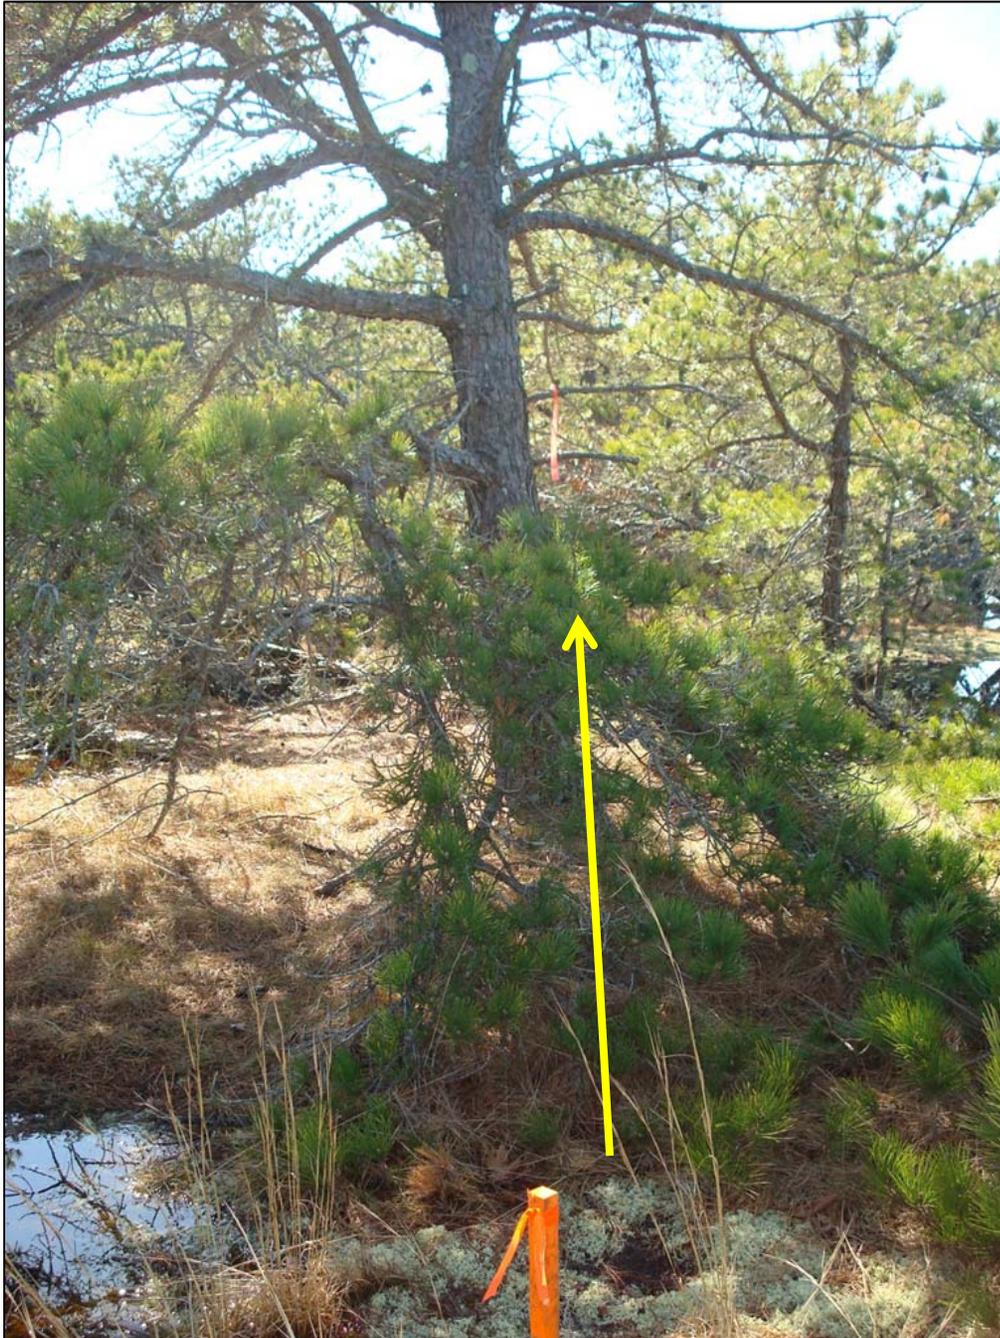
Approximate location of proposed fence alignment at fence stake #1069. Vegetation maintenance will consist of selective removal of individual pitch pine trees and pitch pine limbs only. There are several open pockets of dune with sparse groundcover (i.e., lichens and *Hudsonia*) interspersed among the trees. The yellow arrow depicts the approximate alignment of the fence.

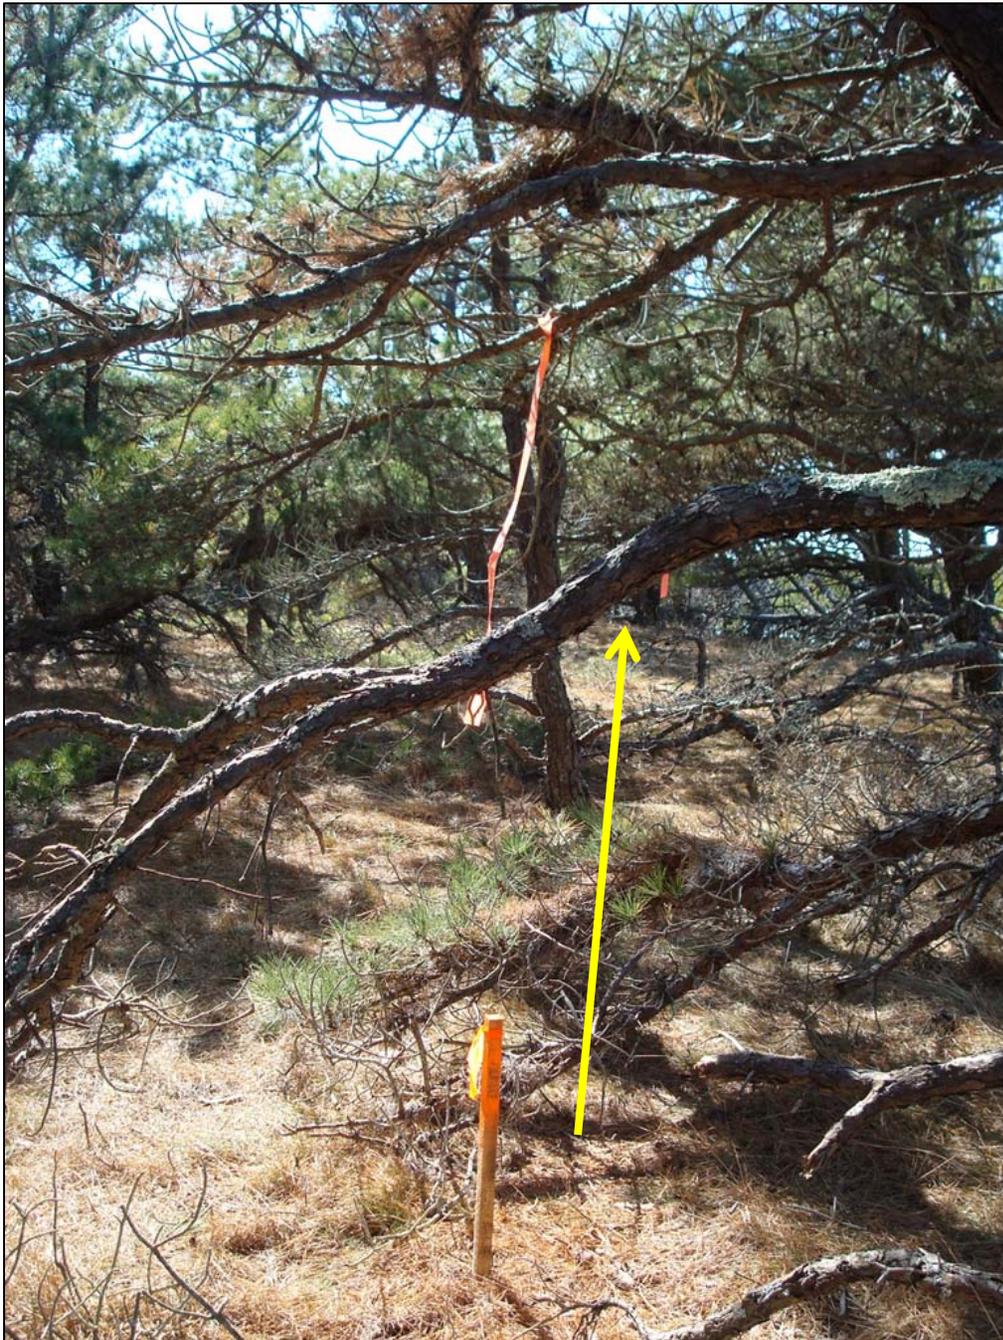
Approximate location of proposed fence alignment depicted by yellow arrow. Note fence stake #1067. Vegetation maintenance will consist of selective removal of individual pitch pine trees and pitch pine limbs only. There are several open pockets of upland/dune with sparse groundcover (i.e., lichens and *Hudsonia*) interspersed among the trees.

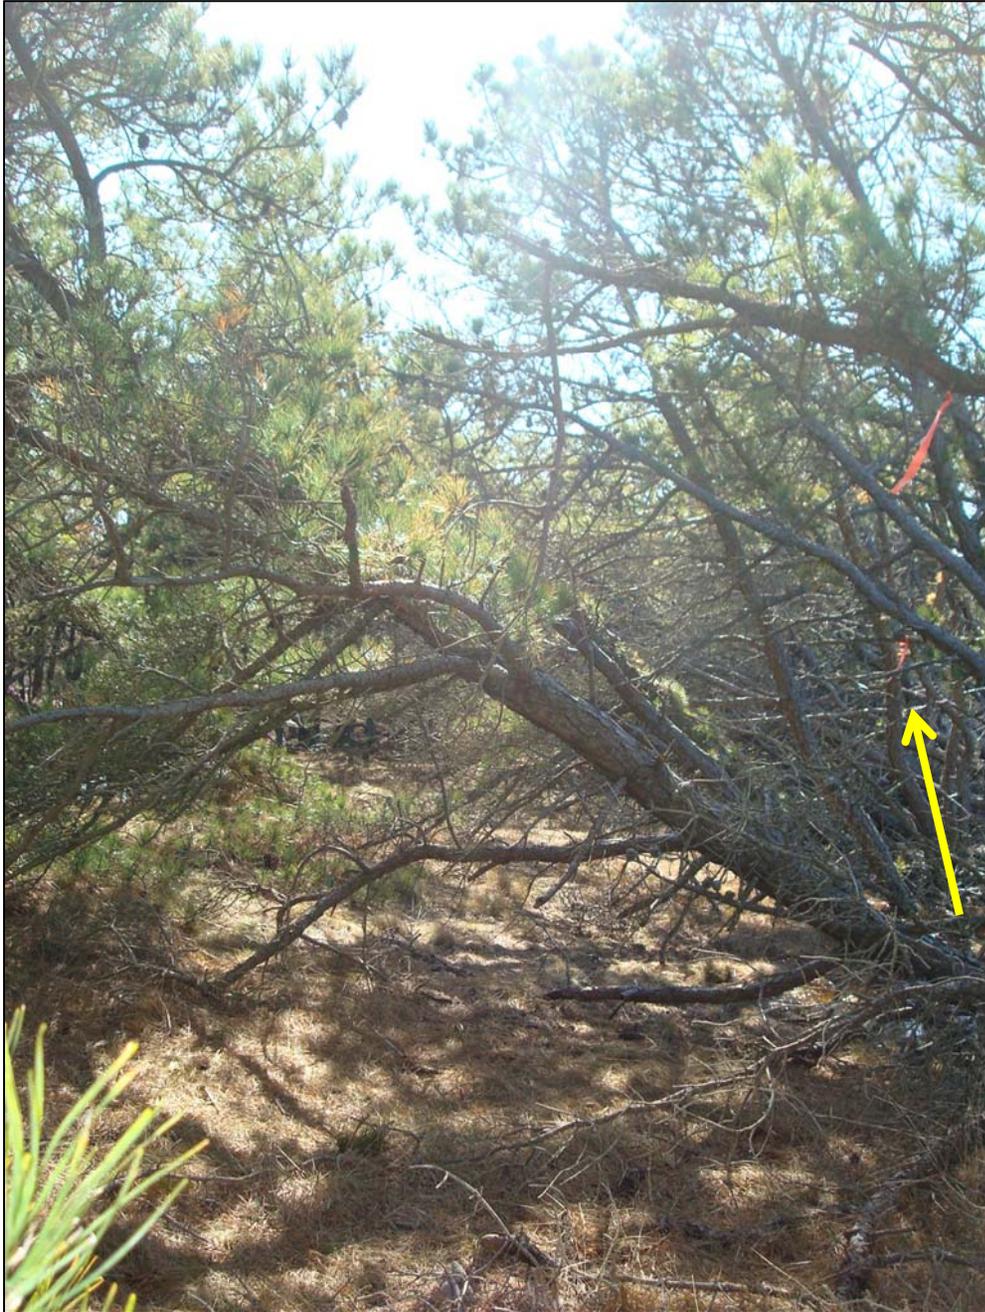
Proposed location of fence alignment near fence stake #1063 (yellow arrow). Vegetation maintenance will consist of selective removal of individual pitch pine trees and pitch pine limbs only. There are several open pockets of upland (dune) with sparse groundcover (i.e., lichens and *Hudsonia*) among the trees.

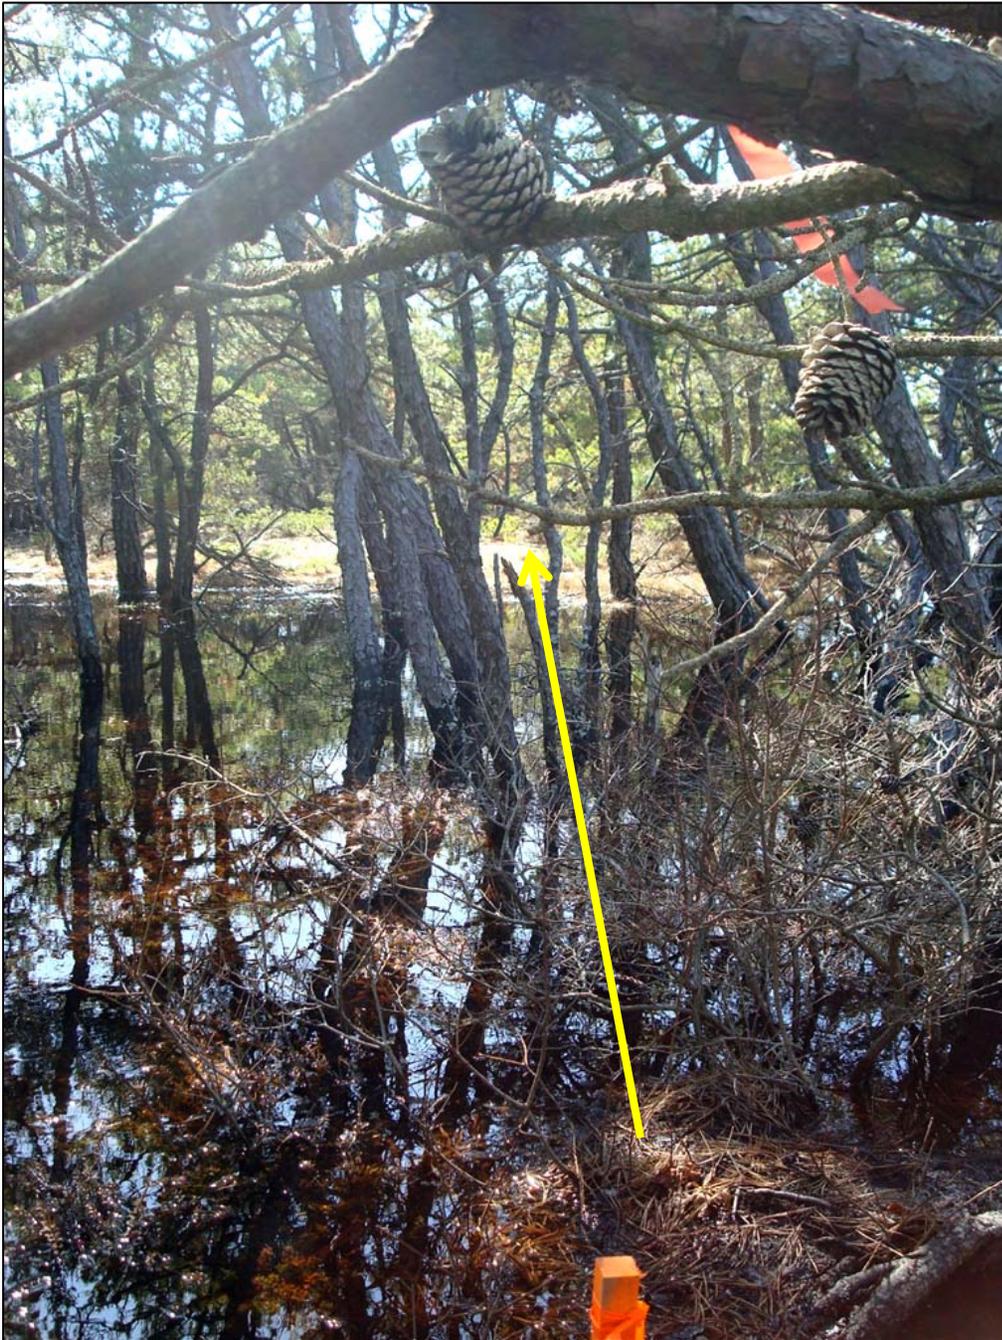
Approximate location of proposed fence alignment at fence stake #1061. Vegetation maintenance will consist of selective removal of individual pitch pine trees and pitch pine limbs only. There are several open pockets of upland/dune with sparse groundcover (i.e., lichens and *Hudsonia*) interspersed among the trees.

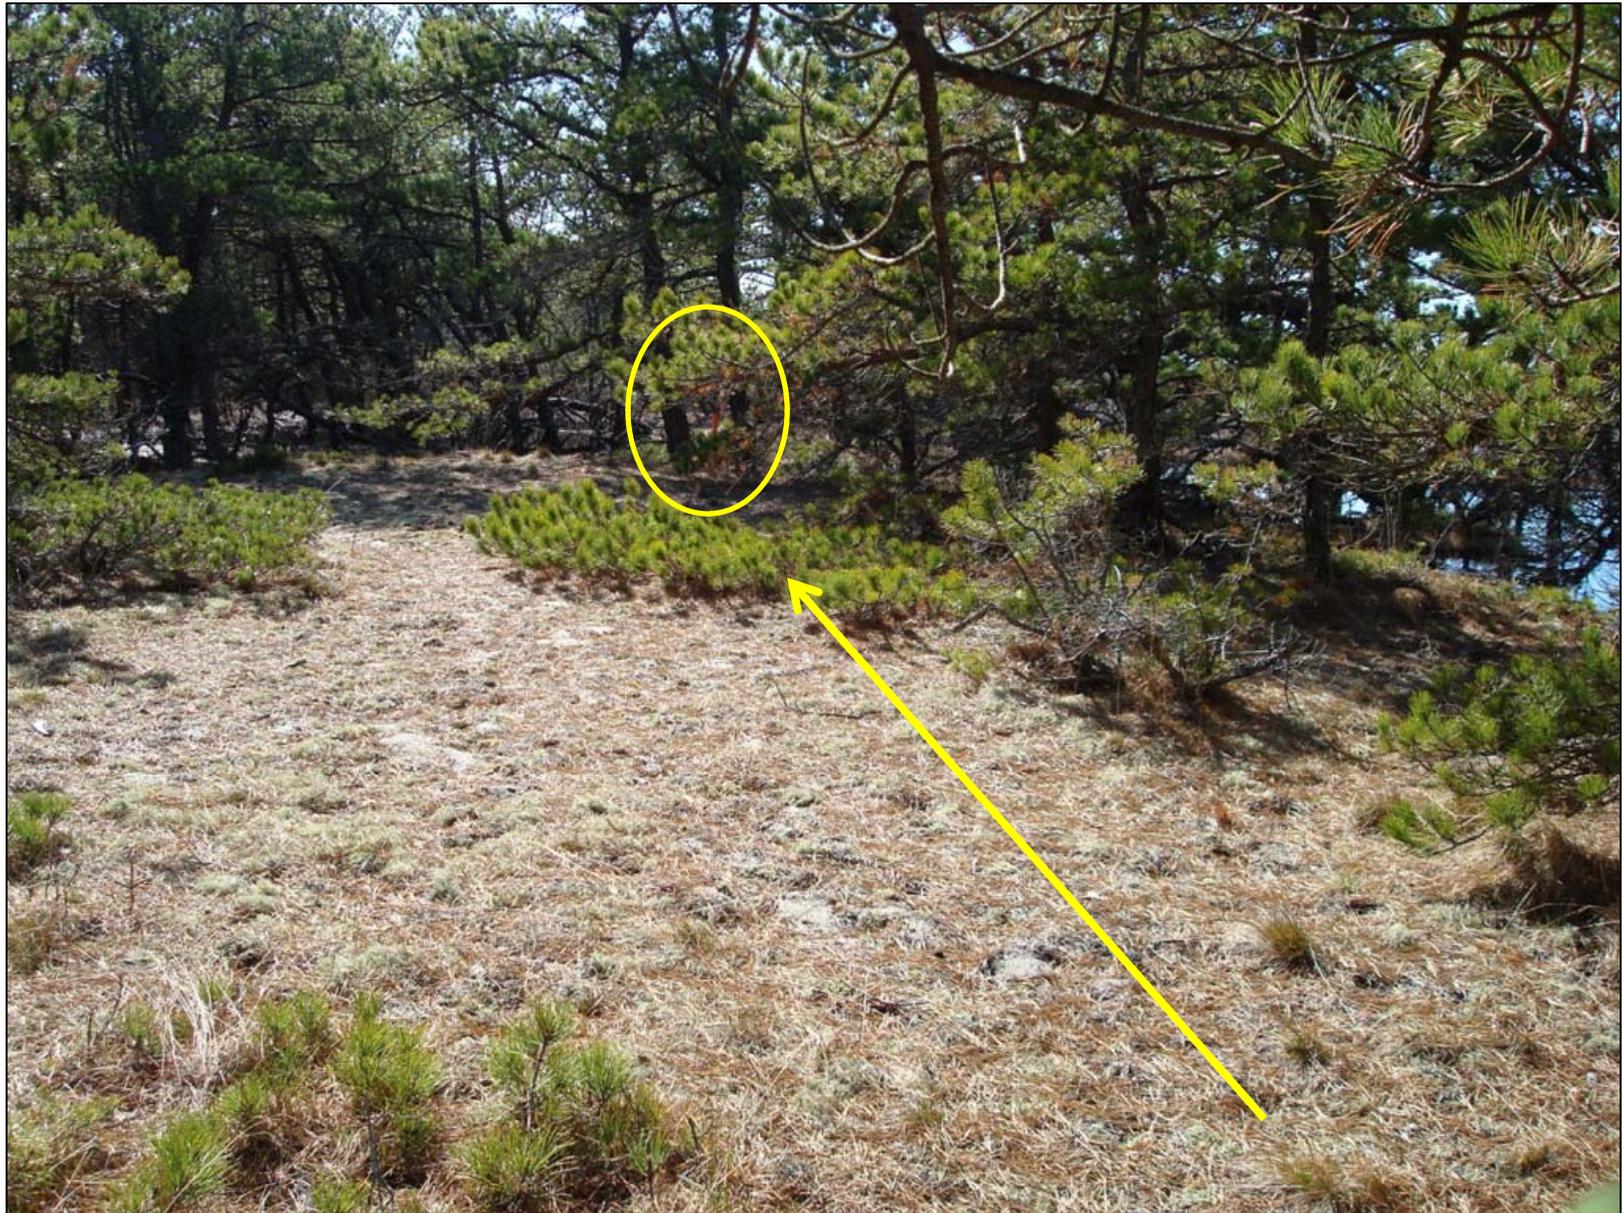
Fence stake #1059 along the proposed fence alignment. Vegetation maintenance will consist of selective removal of individual pitch pine trees and pitch pine limbs only. There are several open pockets of dune with sparse groundcover (i.e., lichens and *Hudsonia*) among the trees.
