Proposed Fence Alignment “Concept 6”

Provincetown Municipal Airport
Provincetown, MA

“Southern Section”

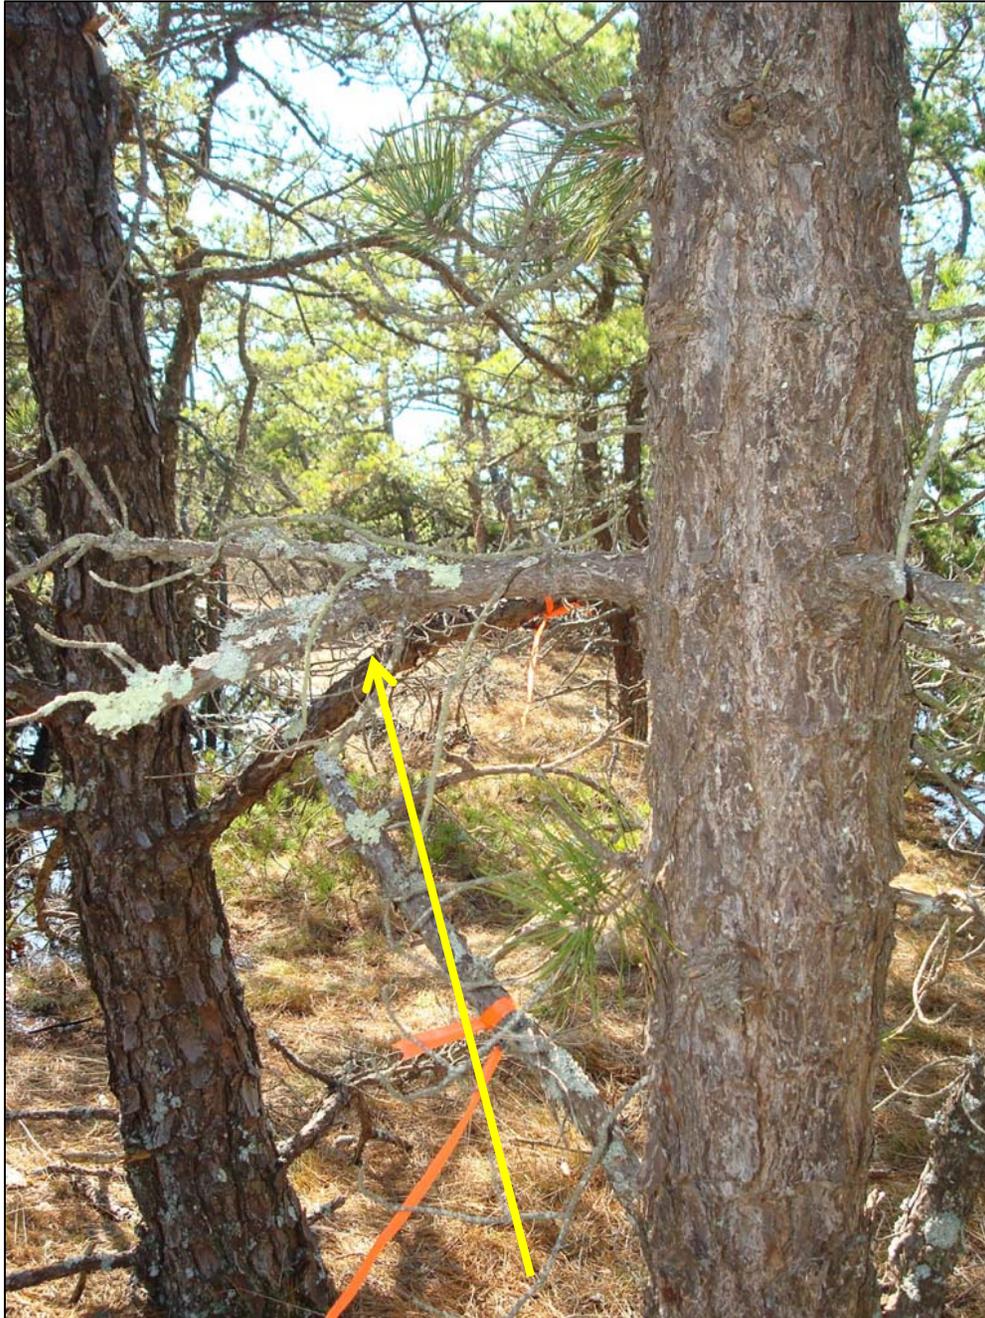
View corridor of approximate location of proposed fence alignment at fence stake #1057. Vegetation maintenance will consist of selective removal of individual pitch pine trees and pitch pine limbs only. There are several open pockets of dune with sparse groundcover (i.e., lichens and *Hudsonia*) among the trees.

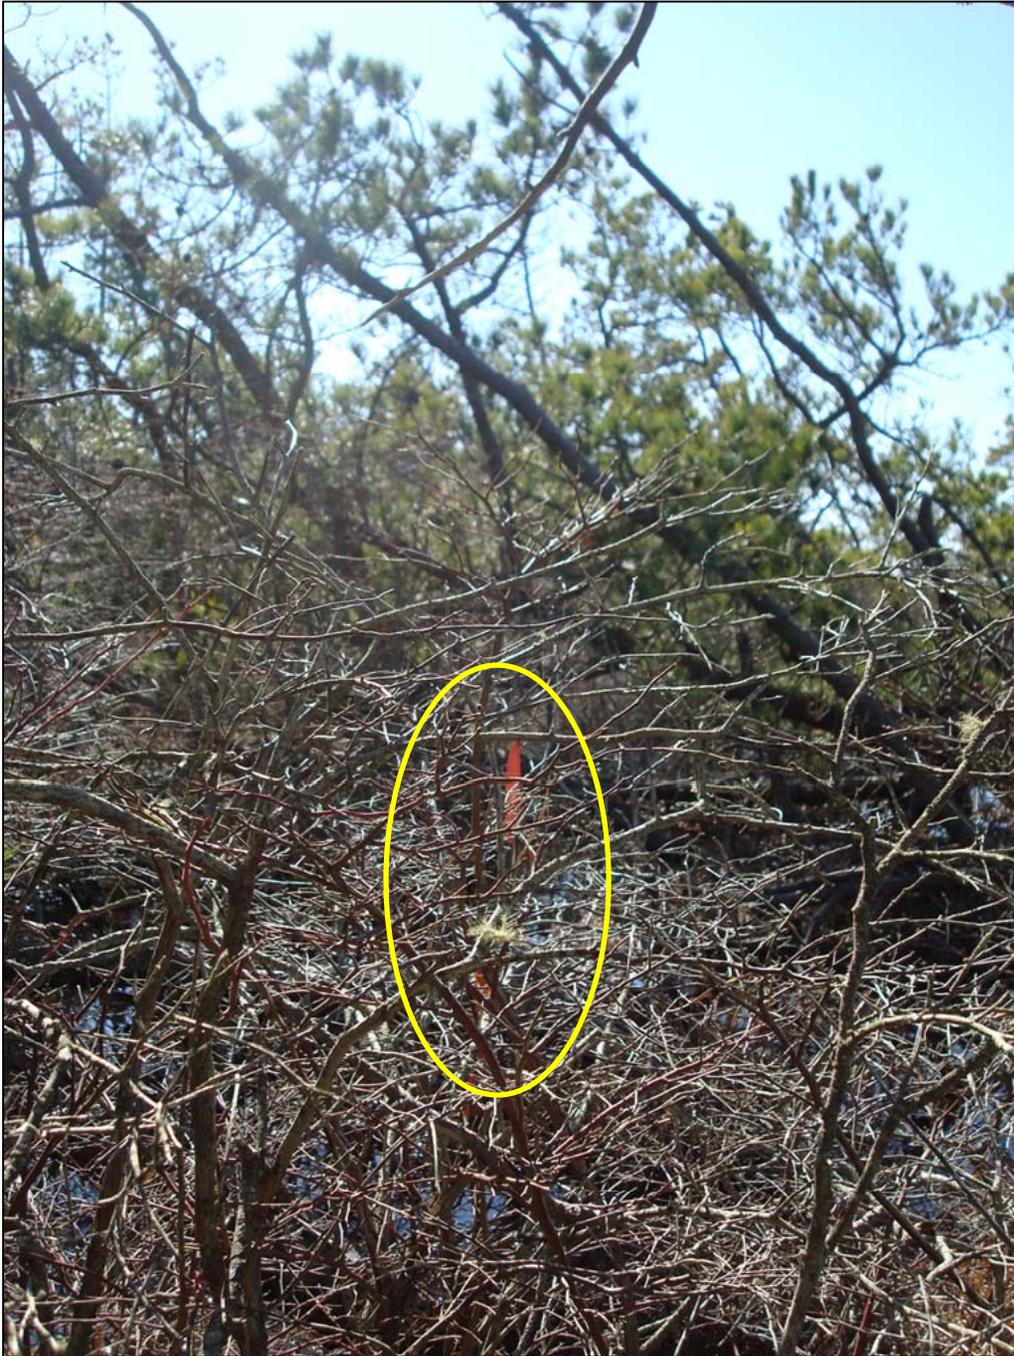
Additional view of proposed fence alignment from fence stake #1057. The yellow arrow depicts the approximate footprint of the fence. Vegetation maintenance will consist of selective removal of individual pitch pine trees and pitch pine limbs only. There are several open pockets of dune with sparse groundcover (i.e., lichens and *Hudsonia*) interspersed among the trees.

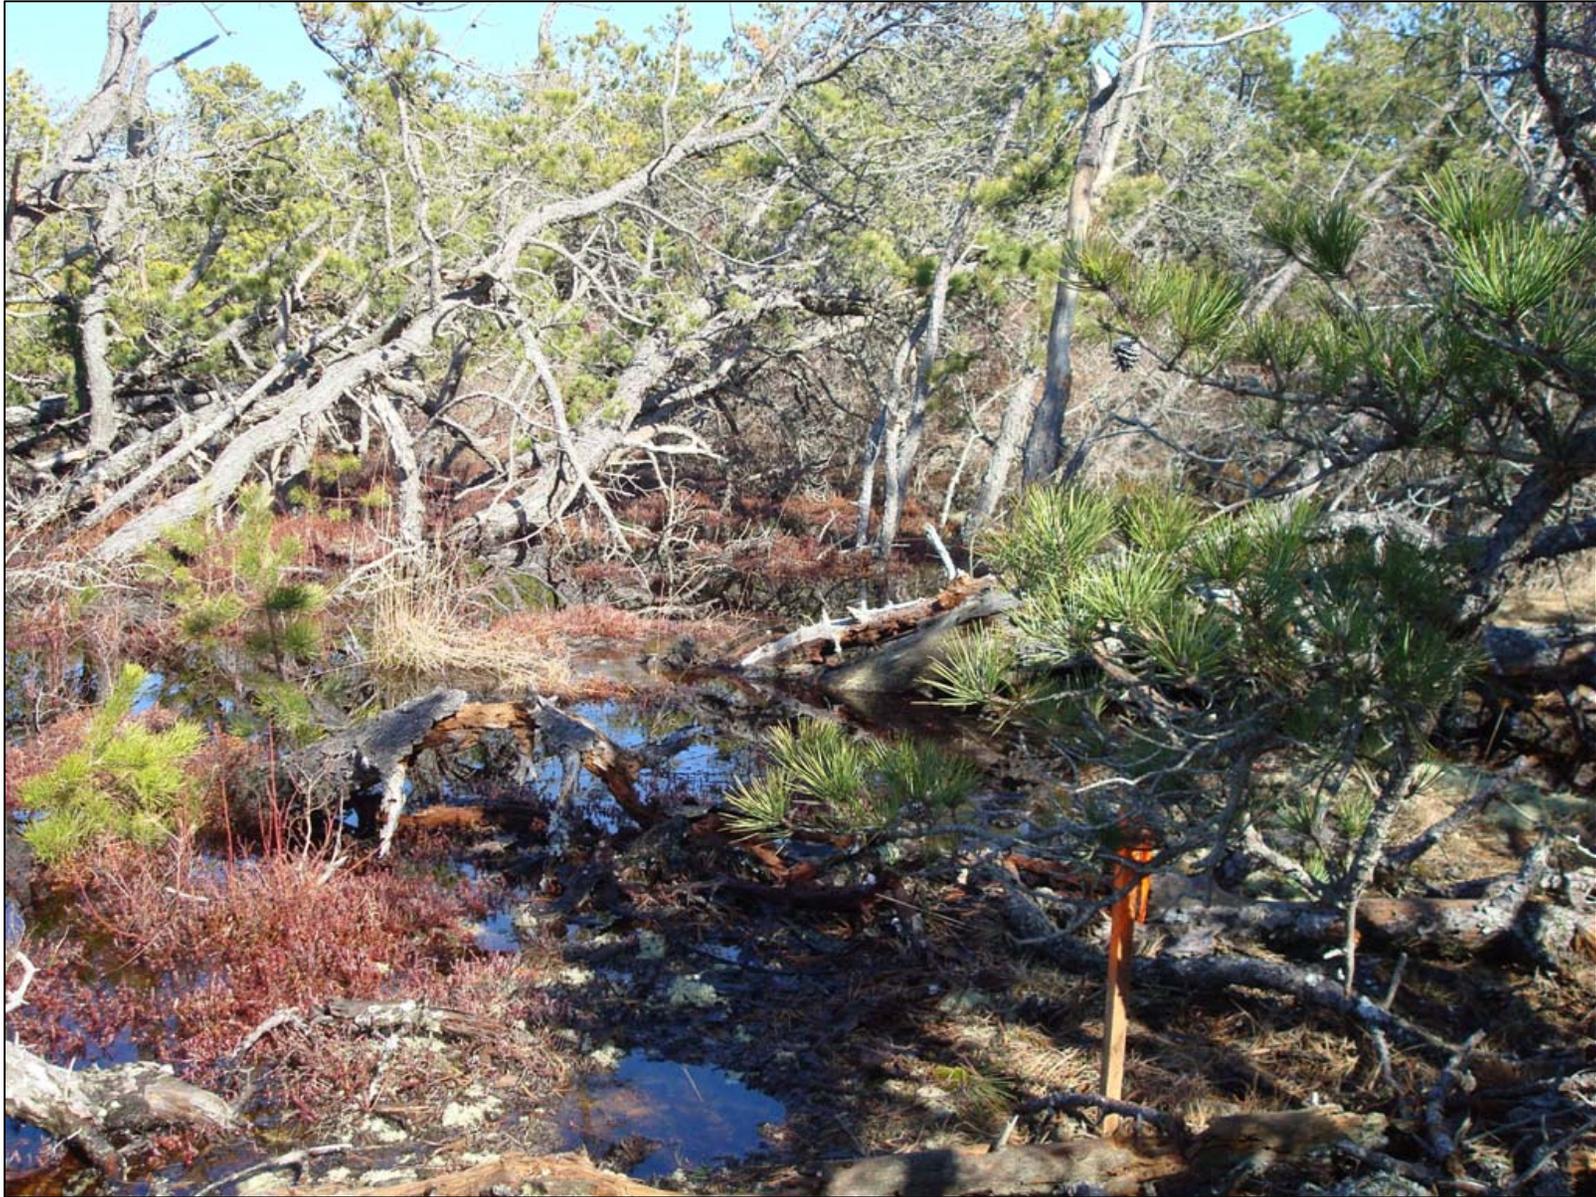
Approximate location of proposed fence alignment. Fence stake #1055 is visible. Vegetation maintenance will consist of selective removal of individual pitch pine trees and shrub removal.

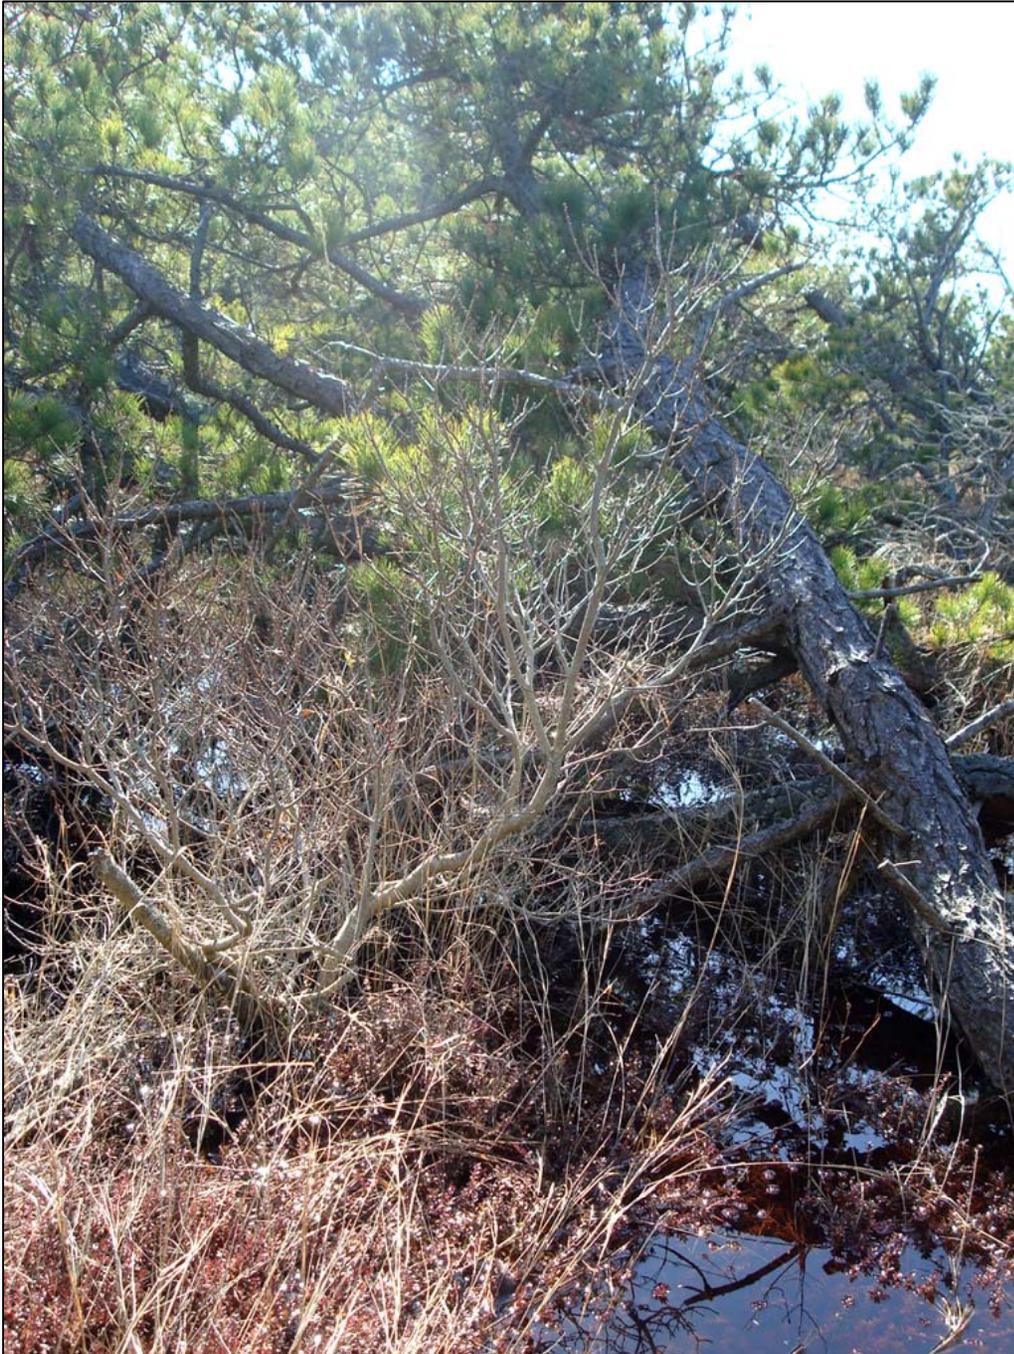
Approximate location of proposed fence alignment. Fence stake #1053 is visible. Vegetation maintenance will consist of selective removal of individual pitch pine trees and pitch pine limbs, along with occasional shrub removal. There are several open pockets among the trees.

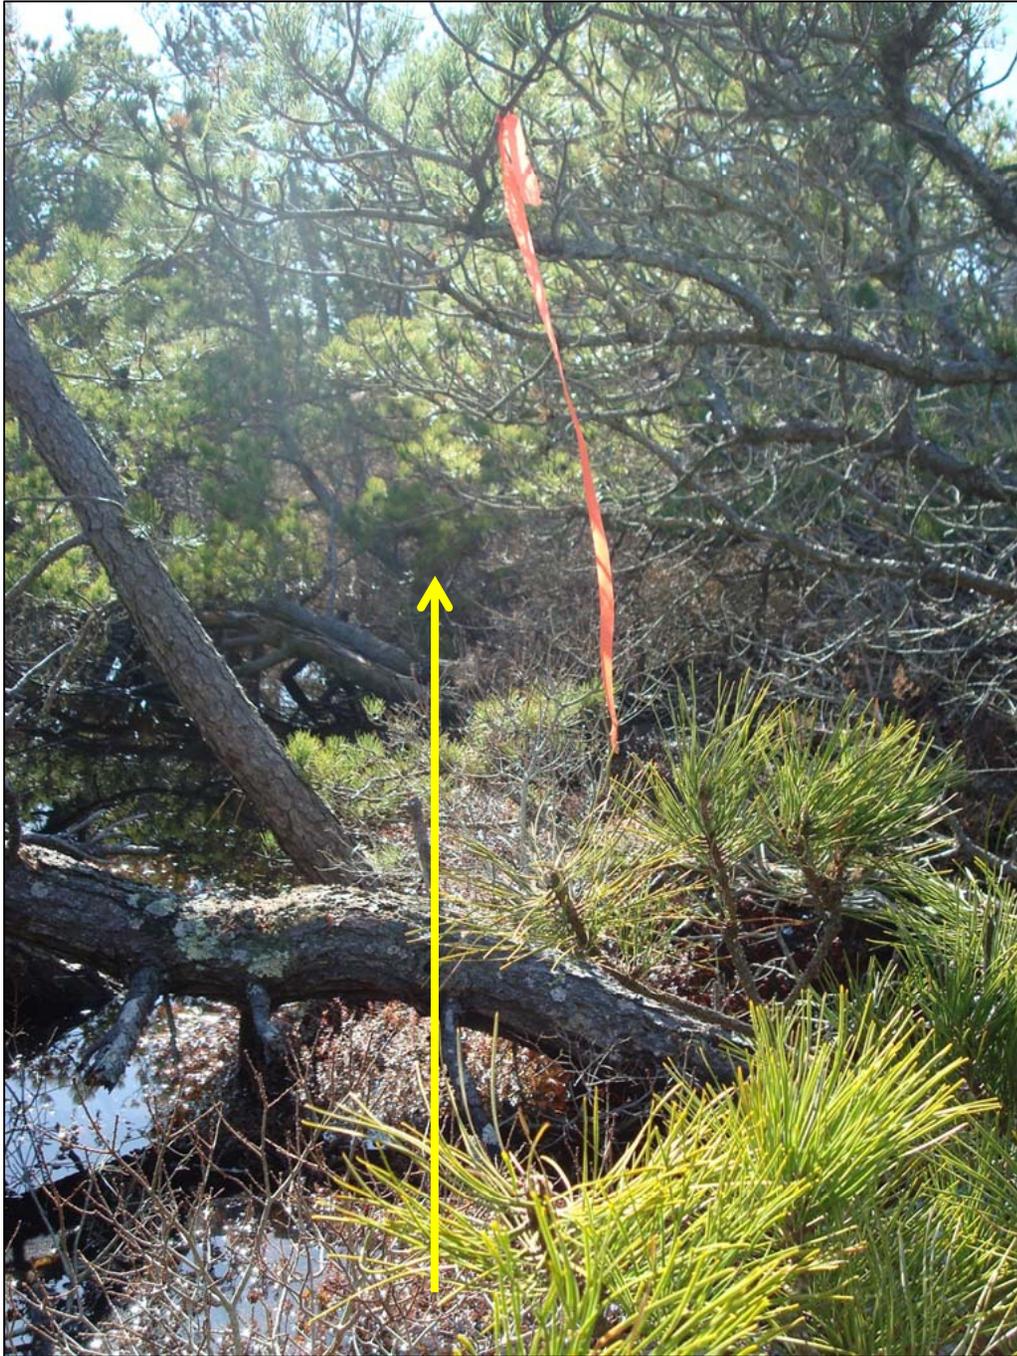
View of approximate location of proposed fence alignment near fence stake #1051. Vegetation maintenance will consist of selective removal of individual pitch pine trees and shrubs.

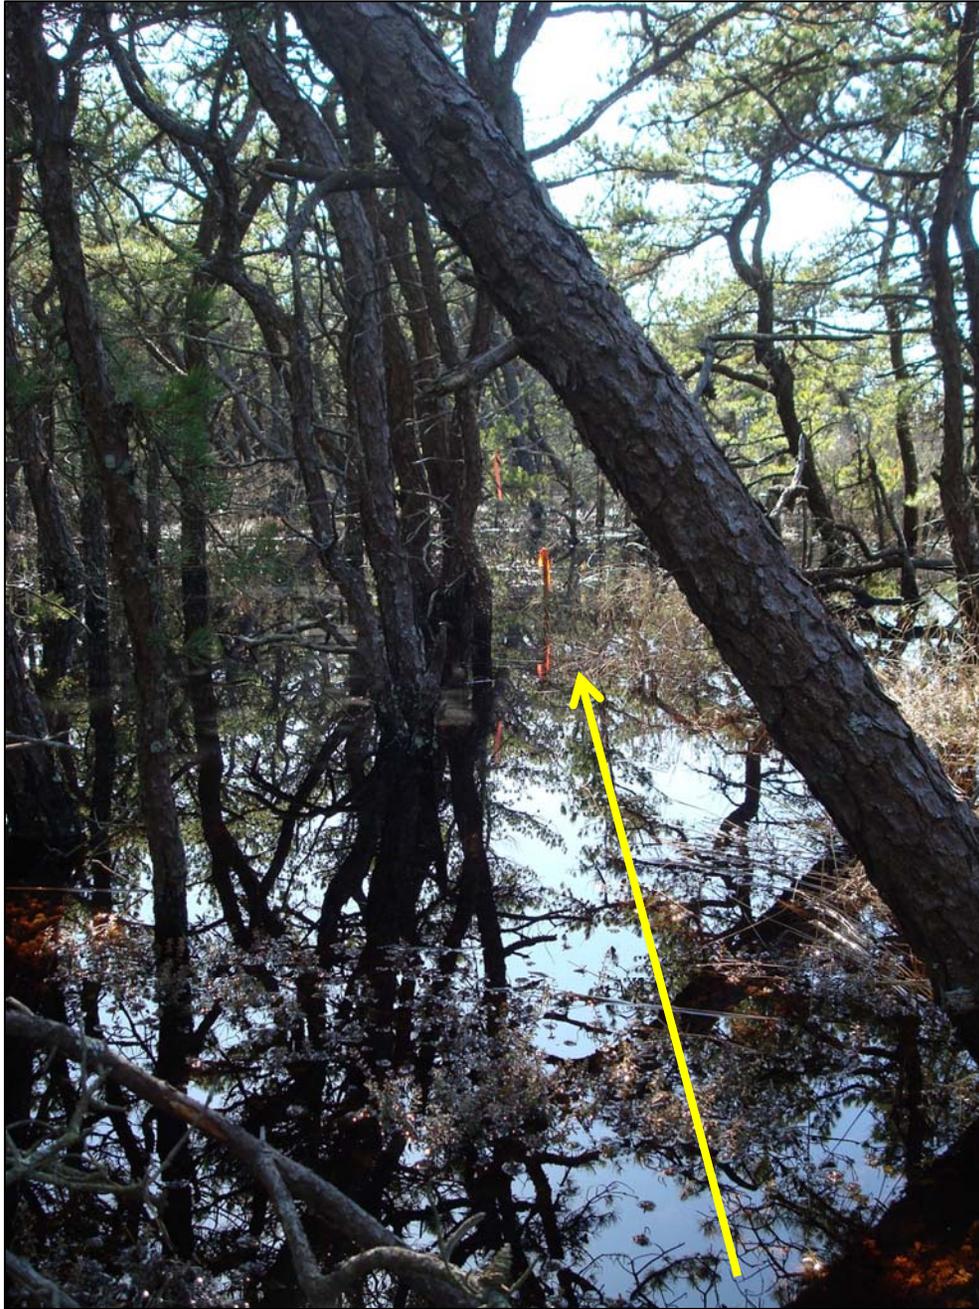
Approximate location of proposed fence alignment. Fence stake #1047 is visible. Vegetation maintenance will consist of selective removal of individual pitch pine trees and pitch pine limbs, along with occasional shrub removal.

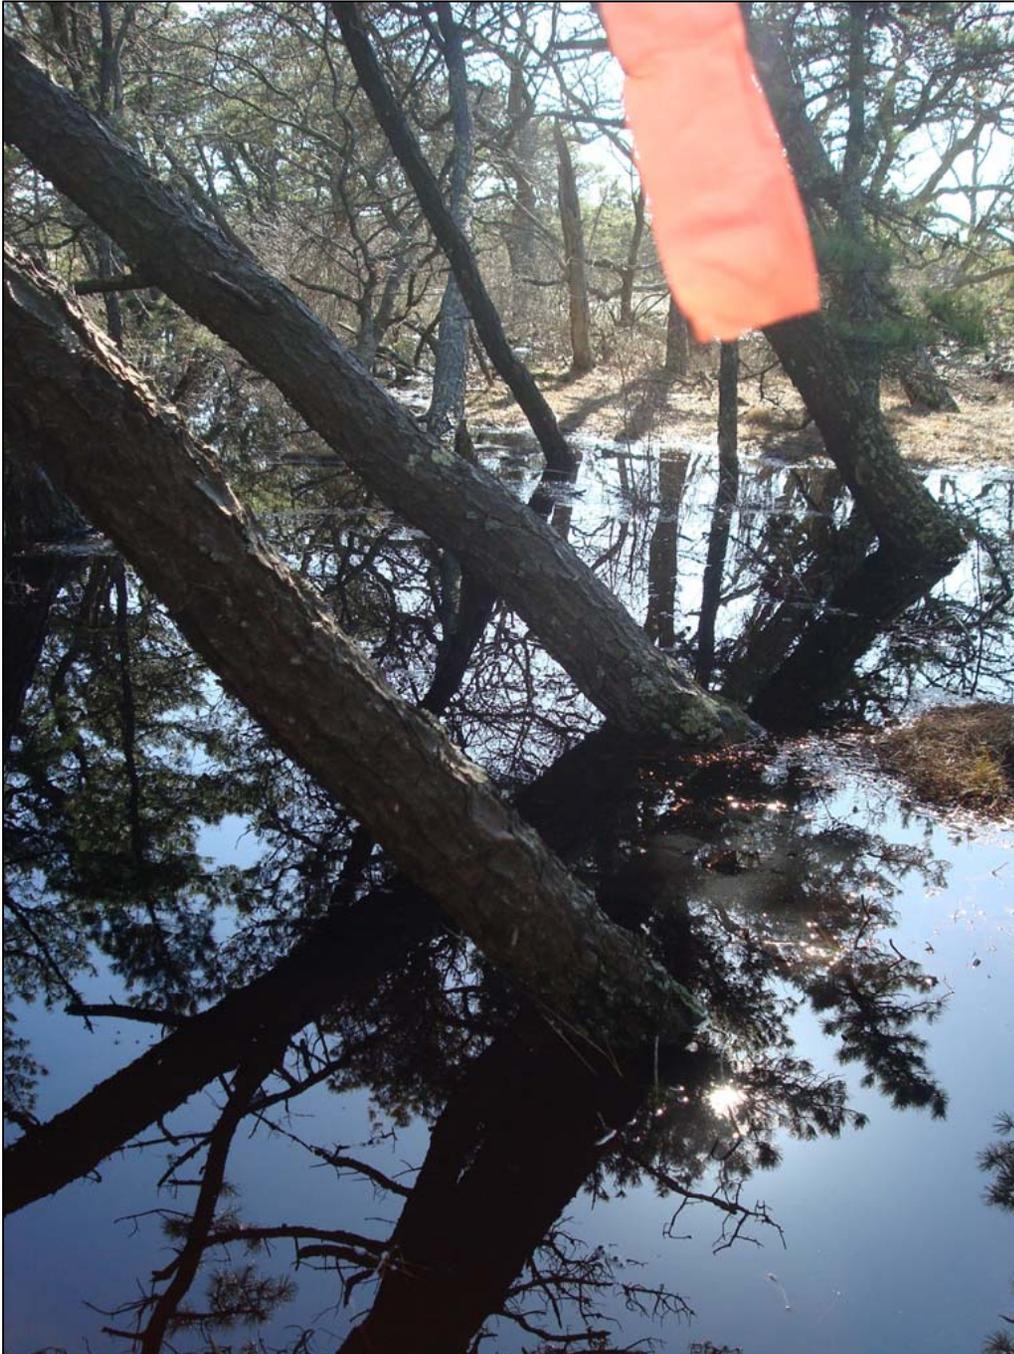
Approximate location of proposed fence alignment between fence stakes #1046 and #1045. Vegetation maintenance will consist of selective removal of individual pitch pine trees and removal of larger shrubs.

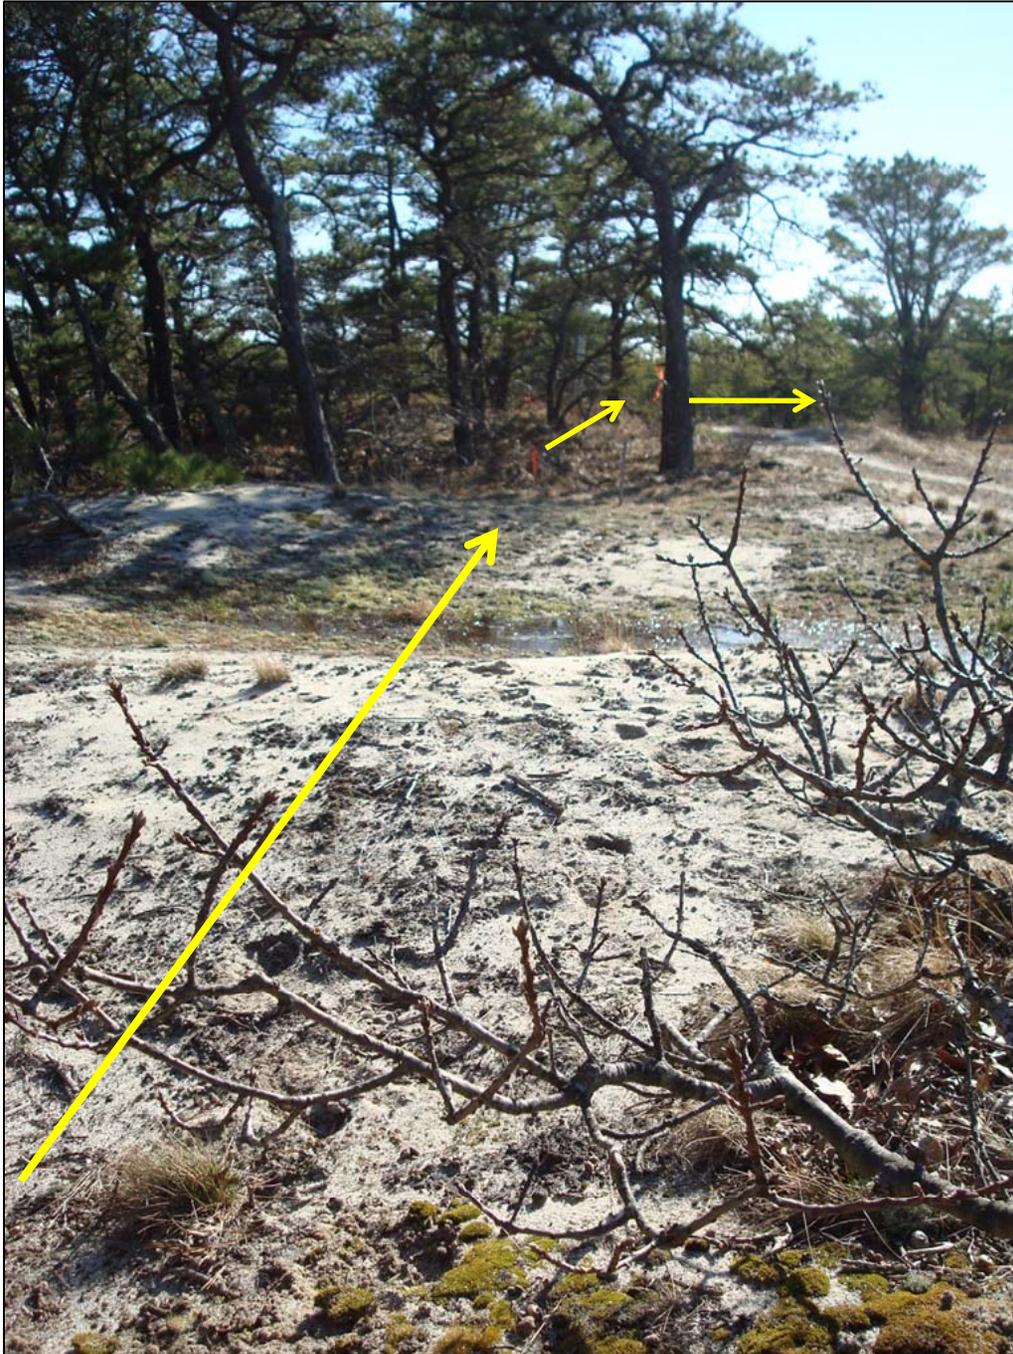
Approximate location of proposed fence alignment, near fence stake #1036. Vegetation maintenance will consist of selective removal of individual pitch pine trees and pitch pine limbs only.

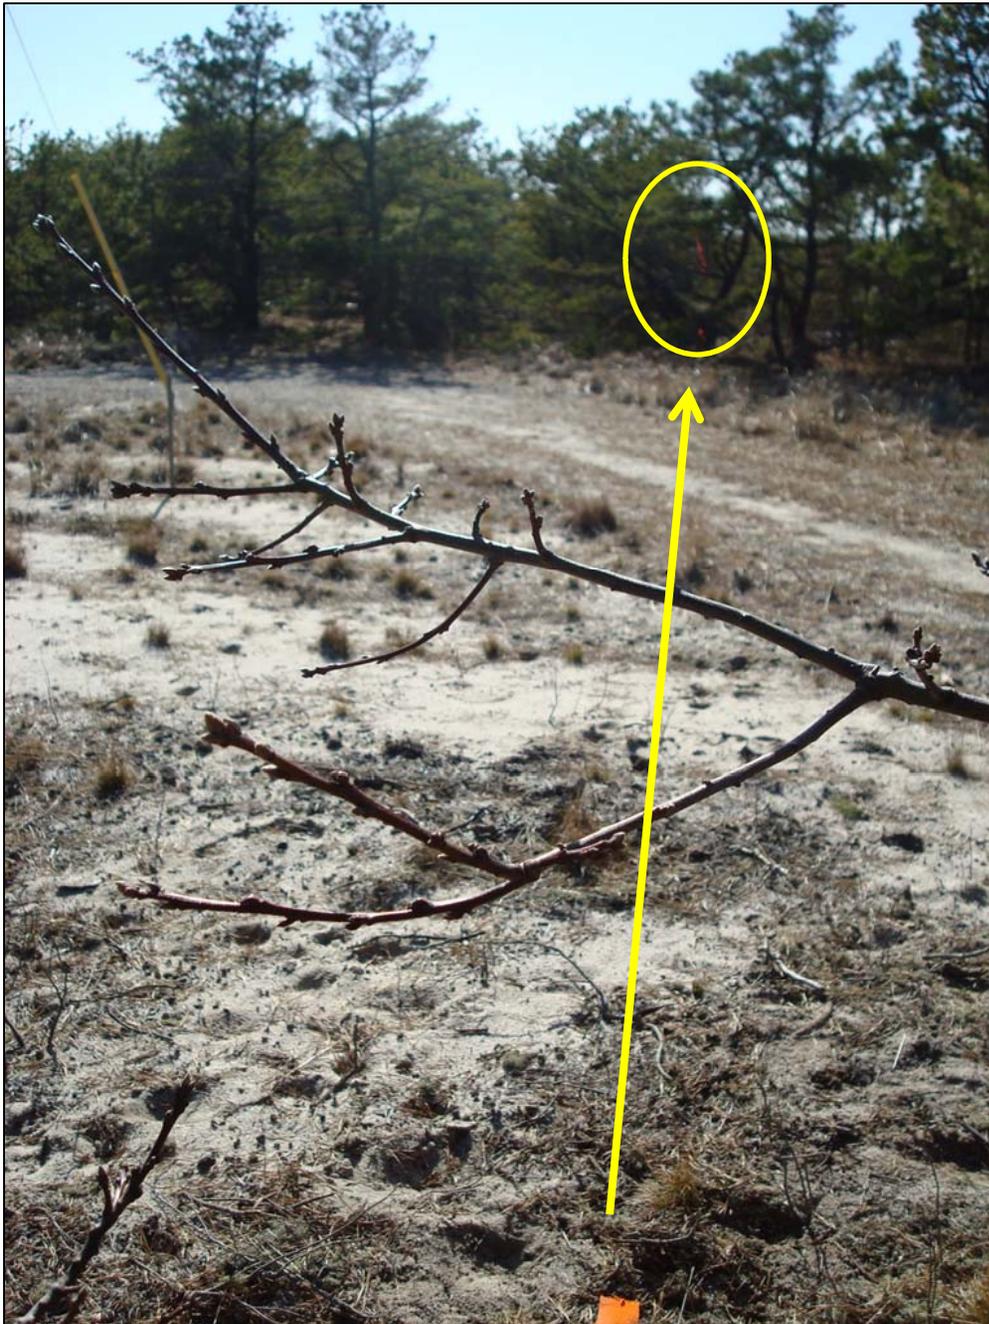
View of approximate location of proposed fence alignment near fence stakes #1035 and #1033. Vegetation maintenance will consist of selective removal of individual pitch pine trees and pitch pine limbs only. There are several open pockets of dune with sparse groundcover (i.e., lichens and *Hudsonia*) among the trees adjacent to the maintenance roadway.

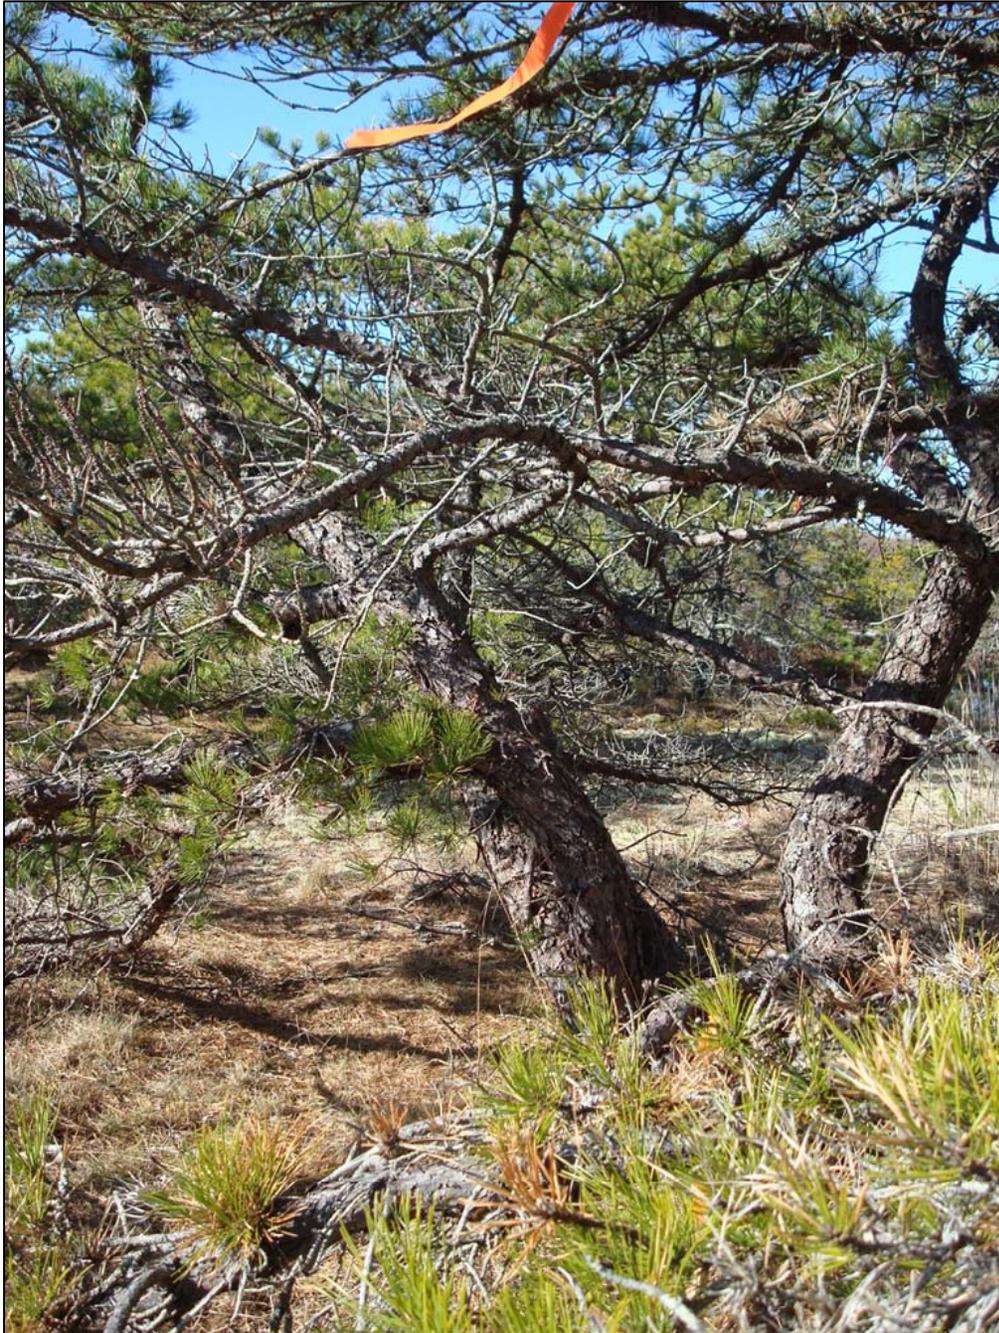
View of approximate location of proposed fence alignment between fence stakes #1033 and #1032. Vegetation maintenance will not be required in this area. A gate will be installed across the unimproved maintenance roadway.

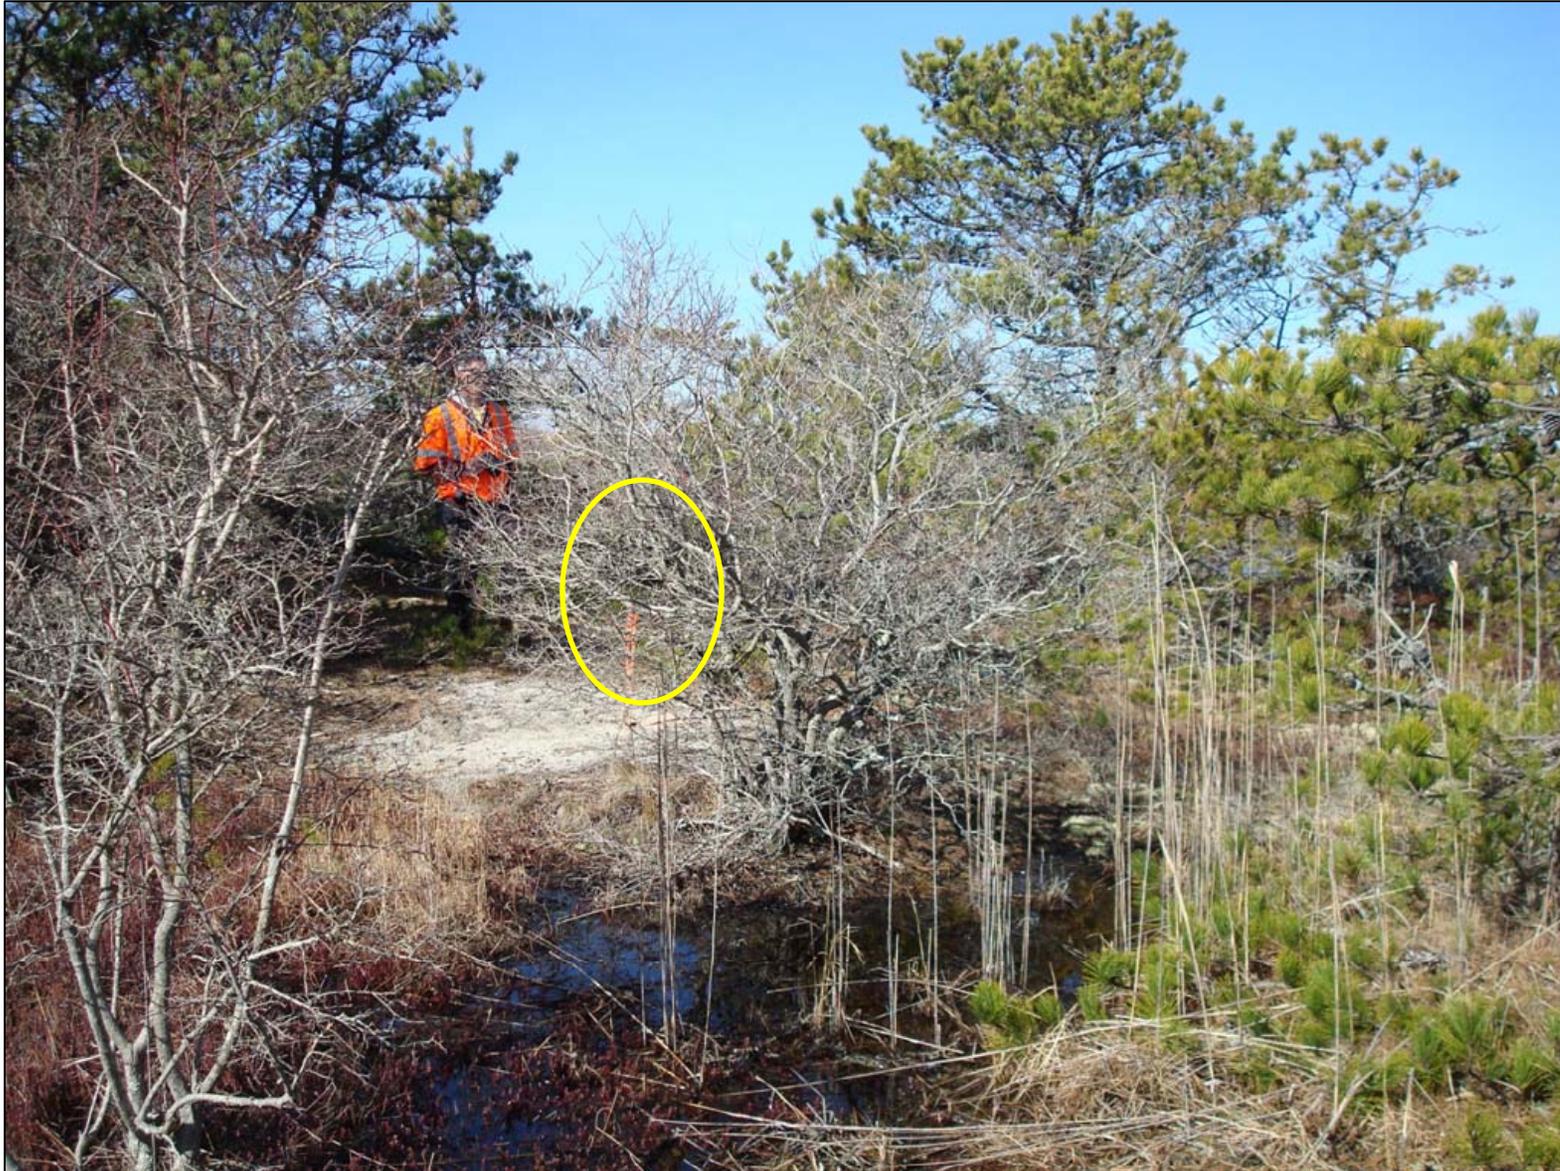
View of approximate location of proposed fence alignment near stake #1031. Vegetation maintenance will consist of selective removal of individual pitch pine trees and pitch pine limbs only. There are several open pockets of dune with sparse groundcover (i.e., lichens and *Hudsonia*) among the trees.

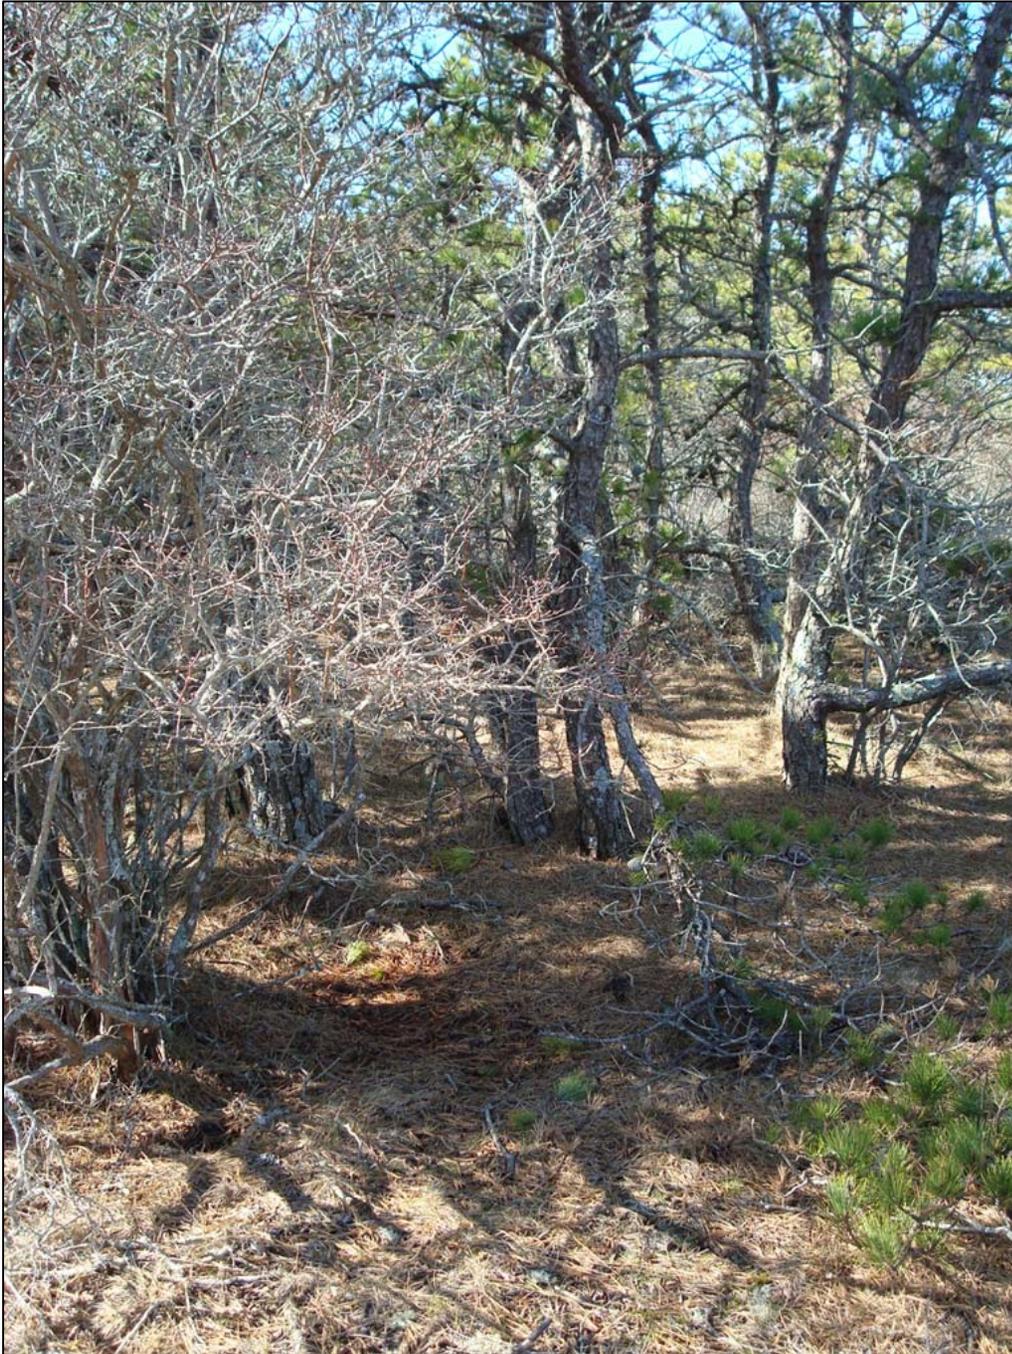
Approximate location of proposed fence alignment. Fence stake #1029 is visible. Vegetation maintenance will consist of selective removal of individual pitch pine trees and pitch pine limbs, along with occasional shrubs. There are several open pockets of dune and wetland with sparse groundcover where cutting will not be required.

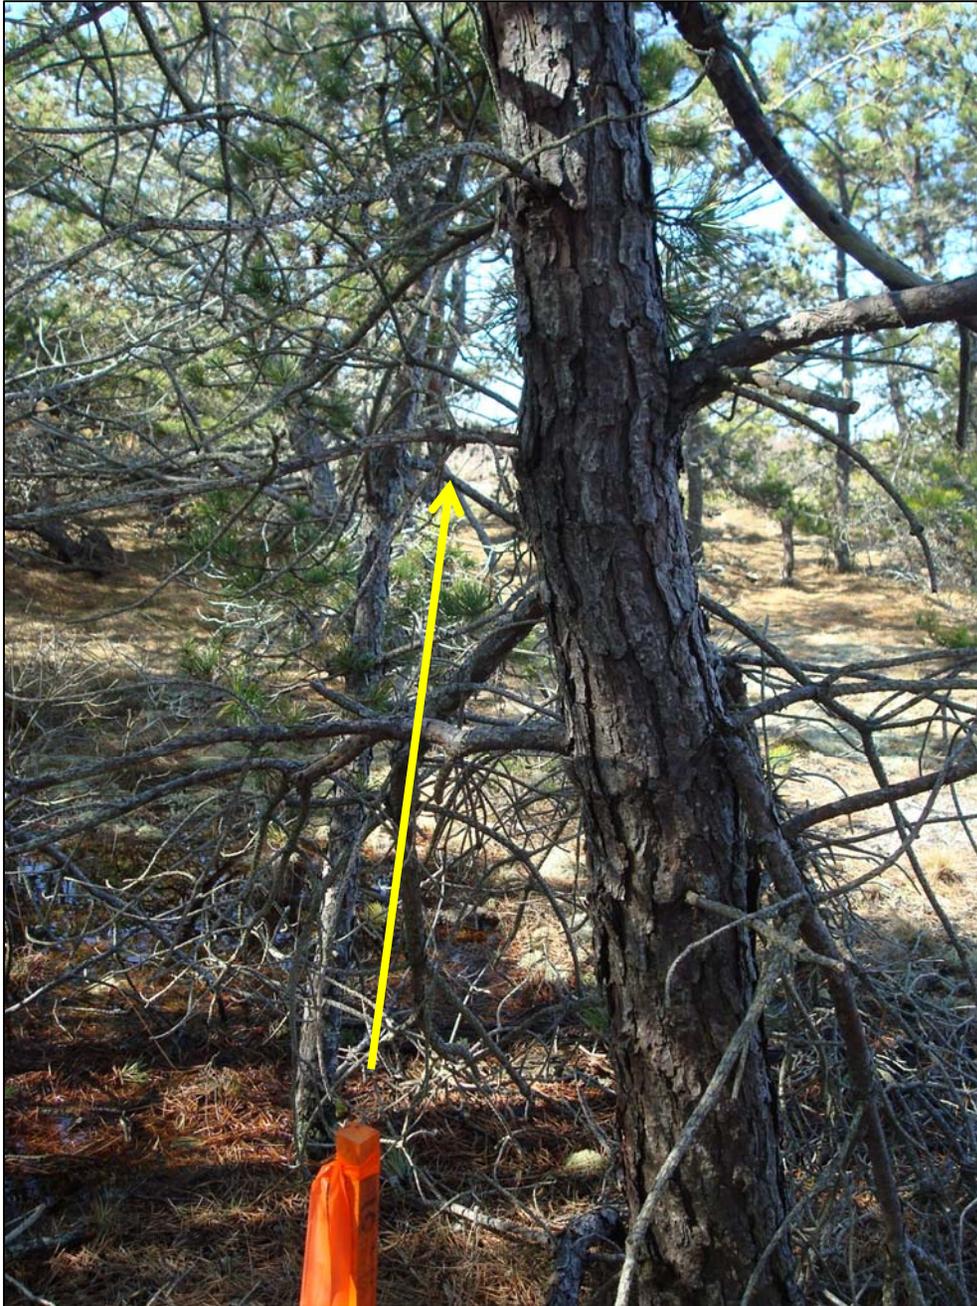
Approximate location of proposed fence alignment at fence stake #1027. Vegetation maintenance will consist of selective removal of individual pitch pine trees and pitch pine limbs only. There are several open pockets of dune with sparse groundcover (i.e., lichens and *Hudsonia*) among the trees that will not require vegetation removal.

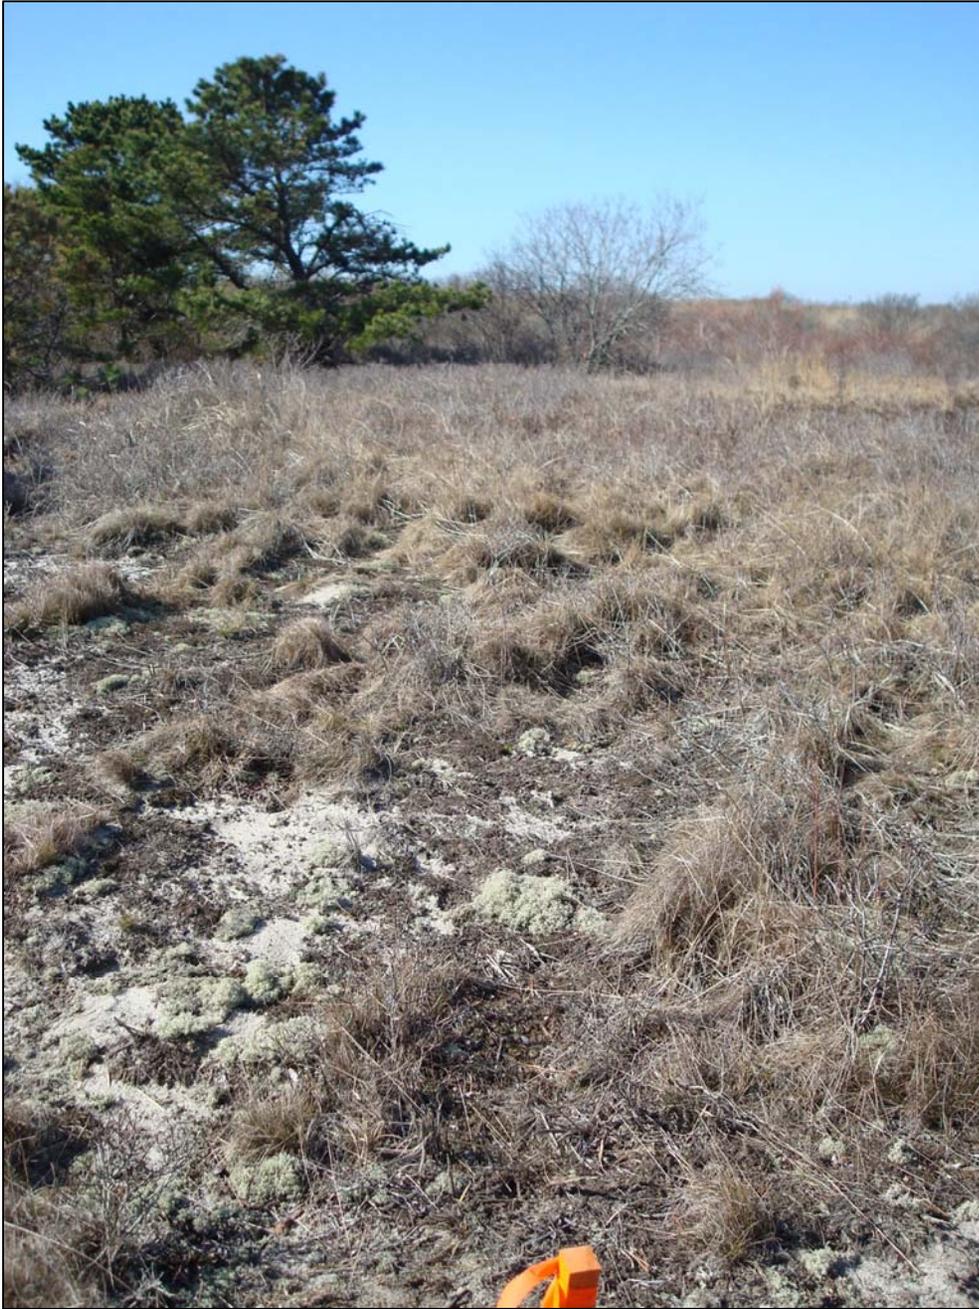
Approximate location of proposed fence alignment near fence stakes #1025 and #1023. Stake #1025 is visible. Vegetation maintenance will not be required in this area.

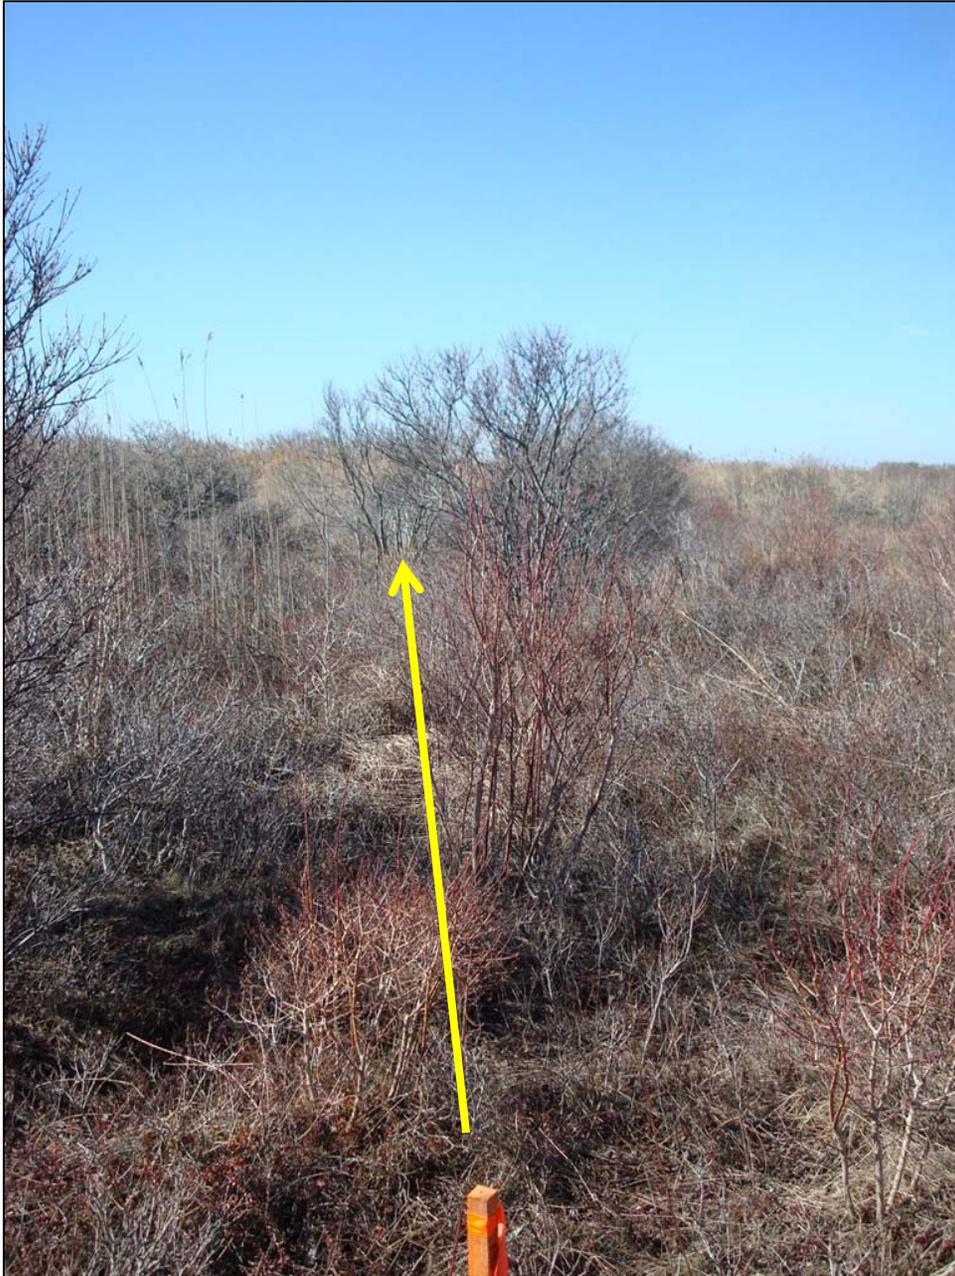
Approximate location of proposed fence alignment near fence stakes #1023 and #1021. Stake #1023 is visible. Vegetation maintenance will consist of shrub removal and pruning.
