Proposed Fence Alignment “Concept 6”

Provincetown Municipal Airport
Provincetown, MA

“Southern Section”

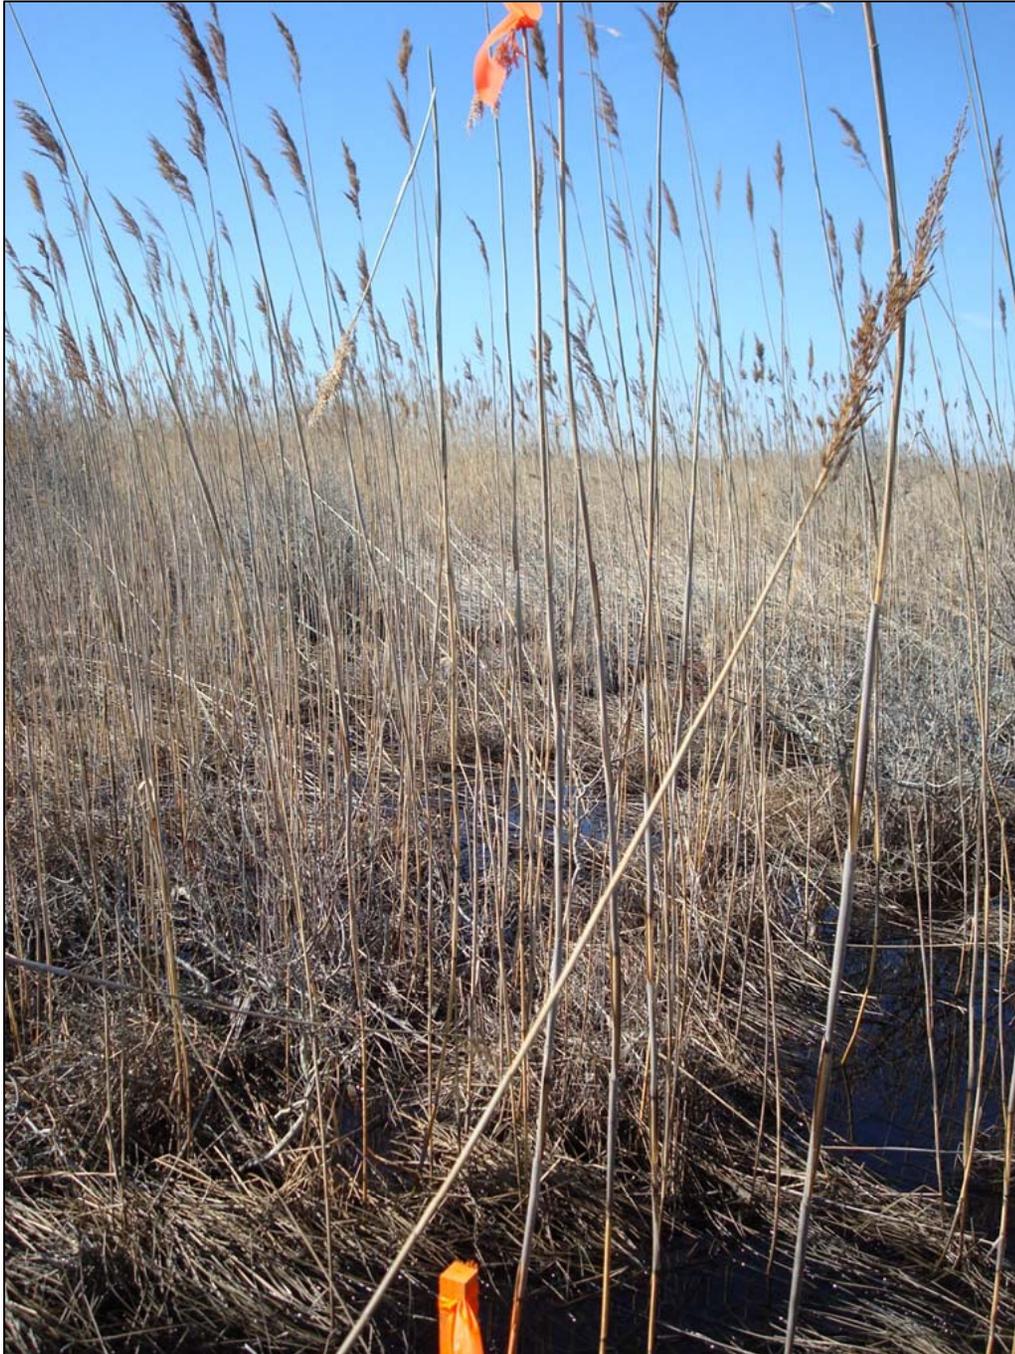
Additional view of the location of proposed fence alignment near fence stakes #1023 and #1021. Vegetation maintenance will consist of shrub removal and pruning.

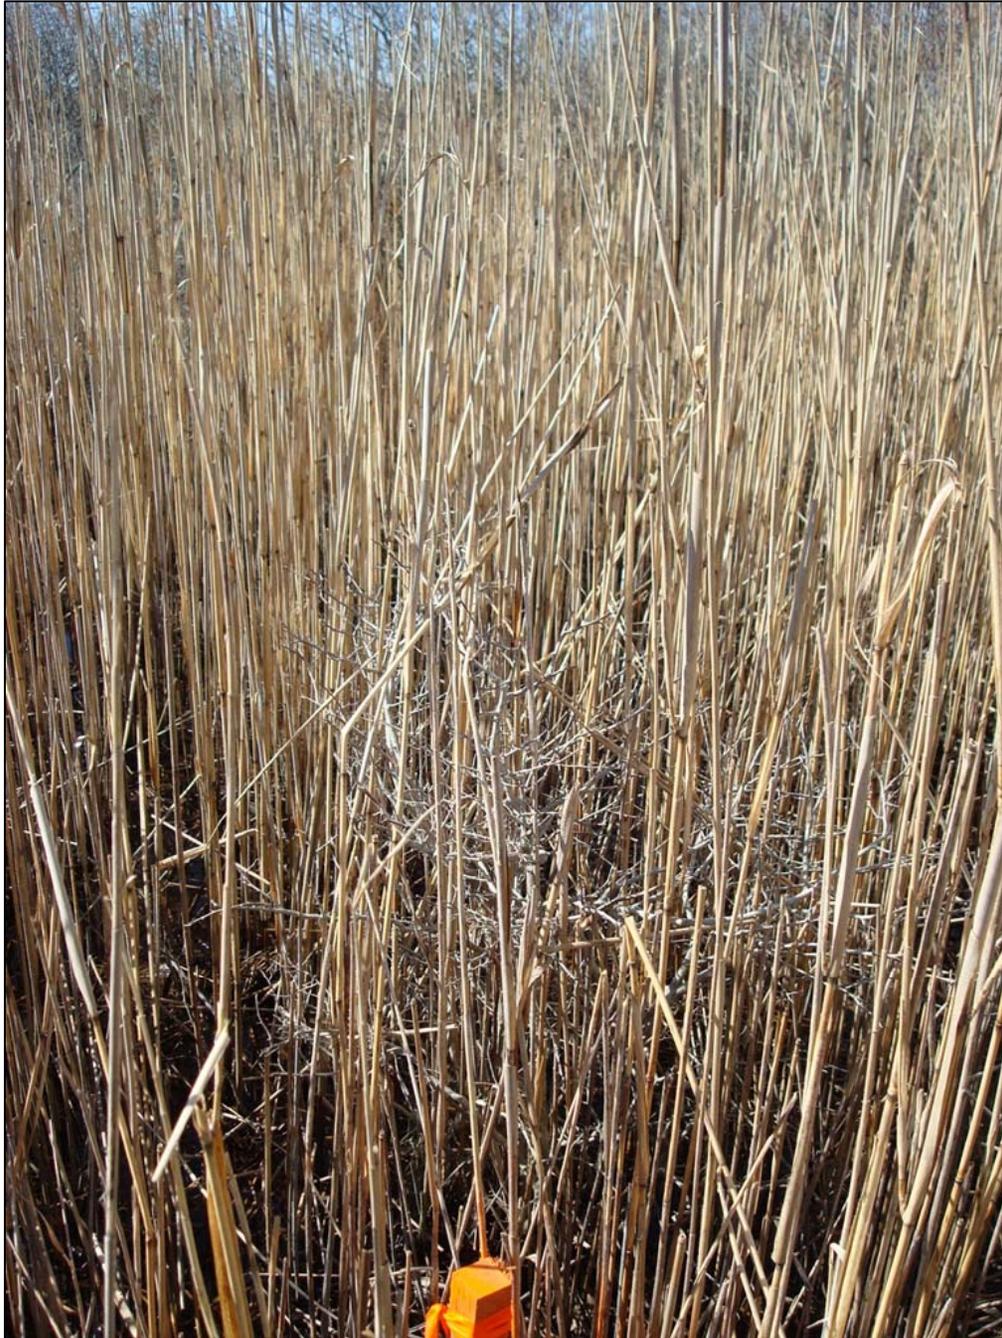
Approximate location of proposed fence alignment near fence stakes #1021 and #1019. Stake #1021 is visible. Vegetation maintenance will consist of the cutting of Phragmites.

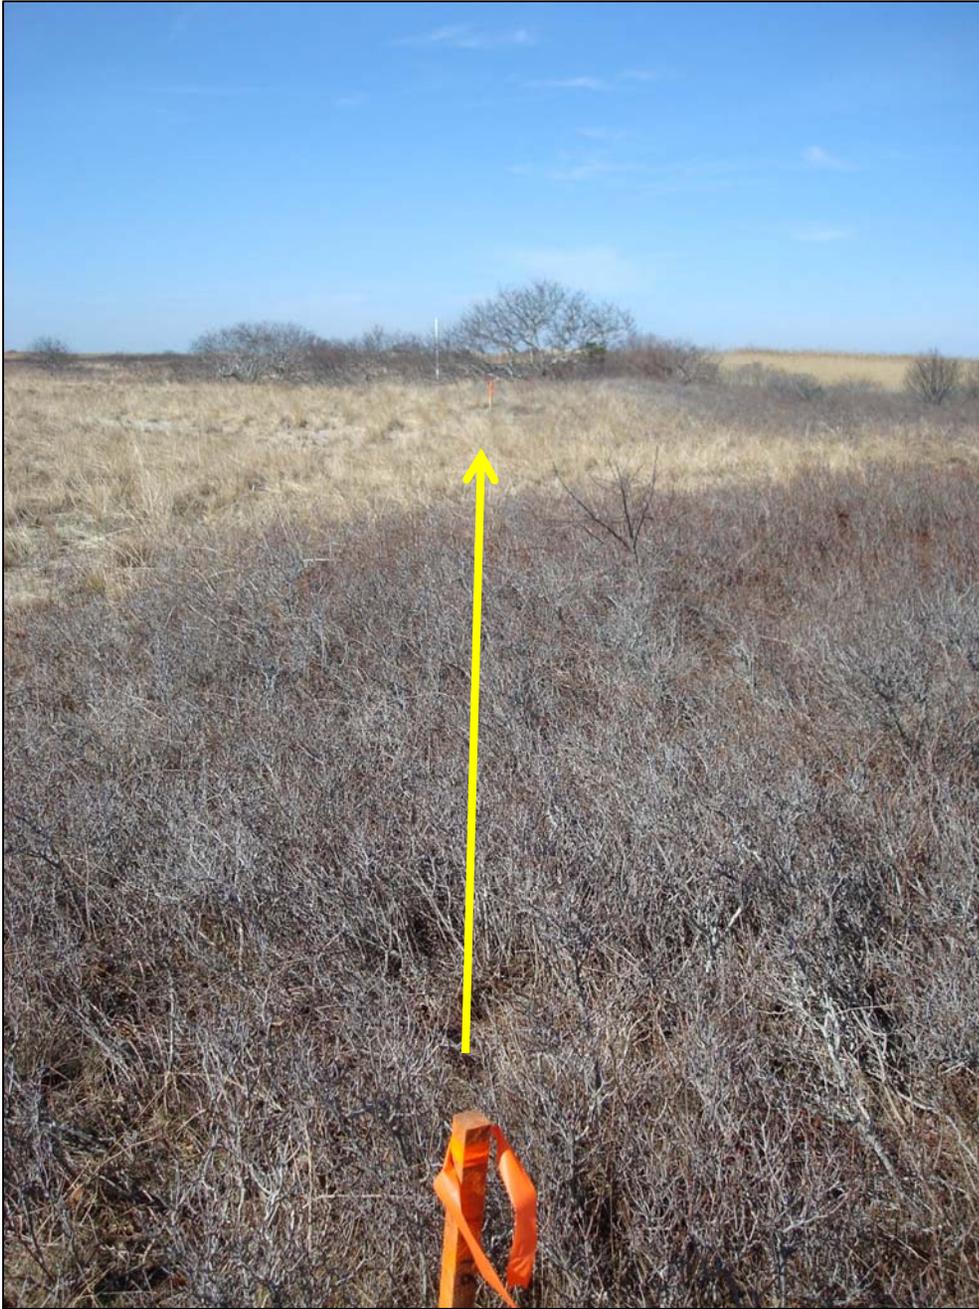
Approximate location of proposed fence alignment near fence stakes #1016 and #1014. Vegetation maintenance will be minimal in this area, with only occasional pruning of small shrubs.

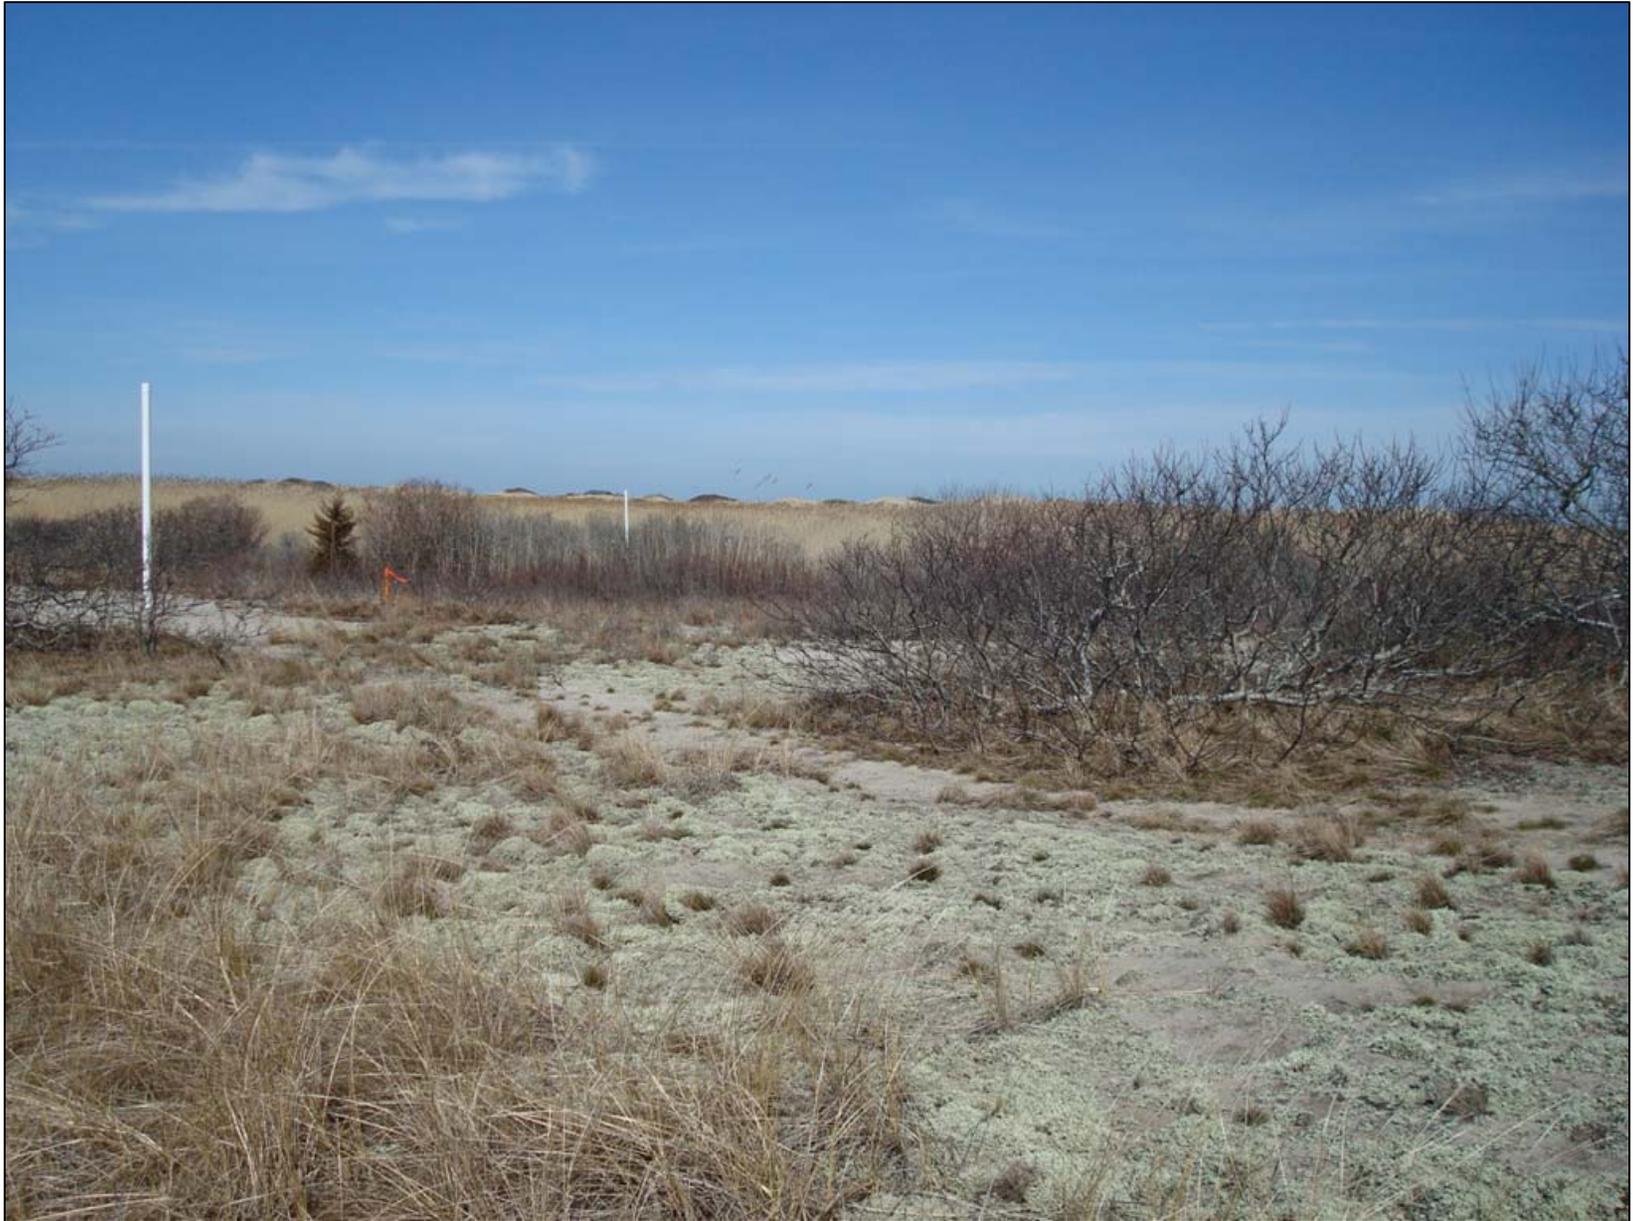
Fence stake #1112. Note black cherry (*Prunus serotina*) to the right.
