# Falmouth Road Safety Audit Sandwich Road: Carriage Shop Road to Hatchville Road

September 2011

Prepared by the Cape Cod Commission in cooperation with the Town of Falmouth and Massachusetts Department of Transportation

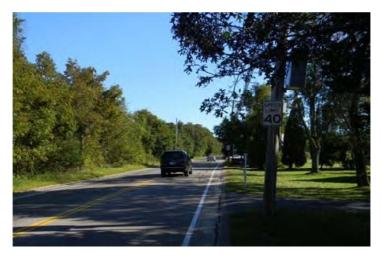
Observation: At the Carriage Shop Road intersection, 62.5% of crashes were between vehicles turning left from Carriage Shop Road and vehicles heading northbound on Sandwich Road. It was noted that although the speed limit is 40 miles per hour, vehicles are probably traveling faster along the straight stretch of Sandwich Road.

**Enhancement:** A speed study could be performed to detect

traveling speeds and when there may be peaks in violations. The police could then follow-up with targeted enforcement at times to provide a presence and expectation of enforcement in the corridor.

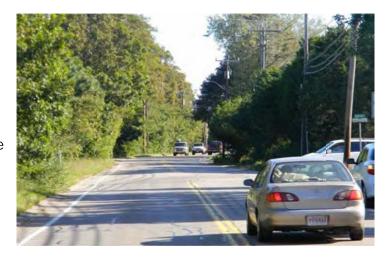
**Observation:** Sandwich Road southbound traffic turning left at Carriage Shop Road accounts for 21% (112 out of 541 vehicles). At the intersection 37.5% of crashes resulted in rear-ends to Sandwich Road southbound vehicles stopped or slowing to turn left onto Carriage Shop Road.

The northbound through vehicles on Sandwich Road numbered 595 conflicting with 64% or 158 vehicles entering from Carriage

Shop Road turning left onto Sandwich Road. At the intersection, 62.5% of crashes were between vehicles turning left from Carriage Shop Road and vehicles heading northbound on Sandwich Road.

**Enhancement:** Installation of intersection warning signs should provide greater awareness of the potential conflicts.

A left turn pocket for the Sandwich Road traffic turning left onto Carriage Shop Road may reduce rear-end crashes at this location. A review of left turn lane warrants can help to determine the need.

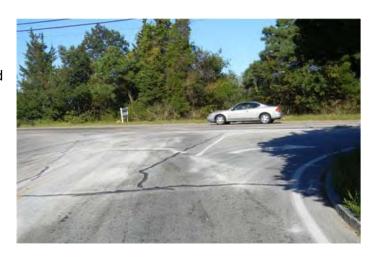
Sandwich Road northbound through vehicles and vehicles turning left onto Sandwich Road from Carriage Shop Road account for 62.5% of crashes at the intersection. It was noted that vehicles were driving over the painted narrow median at the end of Carriage Shop Road. Town staff noted that it had been painted earlier this summer, but recently there was a fluid leak and resulting clean-up

that dulled the painted median. A raised median may assist in delineation, but it was mentioned that truck traffic needs the wider area for turner. It was thought that rumble strips may be too loud at this spot.

**Enhancement:** Repaint the median.

A possible long term enhancement may be to install a slightly raised median for improved vehicular delineation.

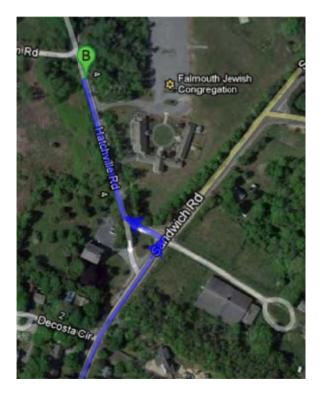
At the Sandwich Road and Hatchville Road intersection, an island exists with two way traffic on both sides. It was noted that it may be the cause of confusion—drivers that are not familiar with the area may not know which side of the island to use when traveling north on Sandwich Road and turning left at Hatchville Road.

It may be beneficial to look at traffic flow improvements and/or Global Positioning System (GPS) map directions to determine potential refinements.

A long term consideration may be to eliminate the island and convert the alignment into a right angled traditional intersection, or "T" intersection.
