ROAD SAFETY AUDIT

Town of Bourne

June 21, 2022

Prepared For:
MassDOT

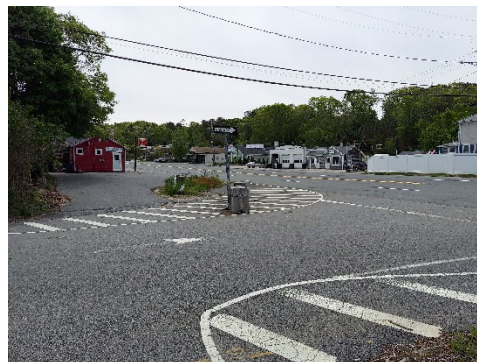
Image 7: Adams Street SB Single wide lane approach operates as two lanes
